# Bhopal – The company's report

based on the Union Carbide Corporation's report – March 1985

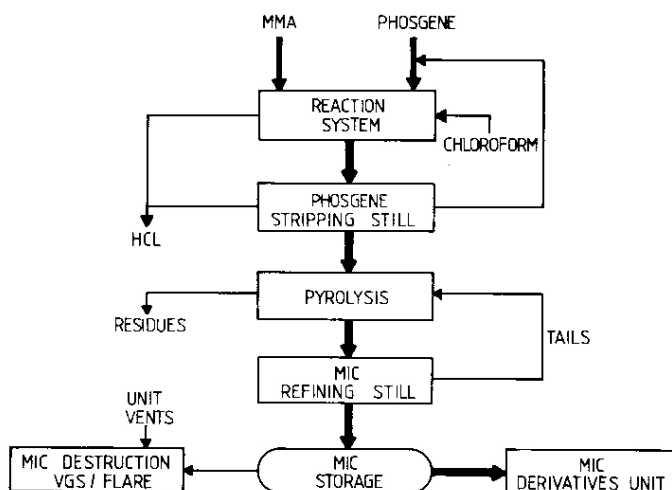
Figure 1.1 Simplified Process Flow Chart

A simplified flow chart for the process is given in Figure 1.1.

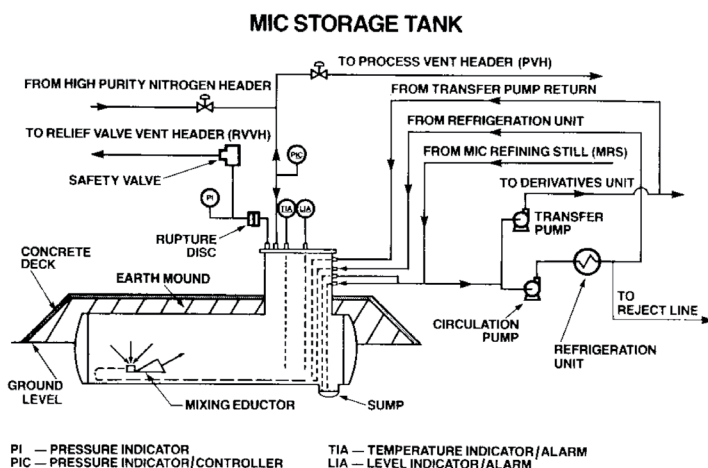
Figure 1.2 MIC storage tank and associated pipework.

All tanks were protected by safety valves set to relieve at 3.8 bar (54.5 lbf/in<sup>2</sup>) with rupture discs to provide a positive seal between tanks and vent pipework. A pressure gauge installed on the outlet side of each disc was used to check that discs were intact.

The residue in Tank 610, the tank in which the reaction took place, was found to contain a large number of complex organic compounds. Following extensive analysis and experimentation, the major components of the residue were reproduced and a theory proposed for the initial contents of the tank and the cause of the reaction.

Ingress of water into Tank 610 would have caused the initial reaction resulting in a marked temperature increase. This would have led to the decomposition of chloroform to yield chloride ions, the resulting mixture being corrosive to the stainless steel tank. (The ratio of iron, chromium and nickel salts in the sample was consistent with the composition of type 304 stainless steel). The iron salts would have catalysed further reactions which, although complex, are recognised, and would have formed all the other components found in the residue.

The temperature in the tank must have exceeded 200°C in its latter stages in order for the suggested reactions to have occurred. It has also been calculated that to discharge the contents of the tank in the two hours that the safety valve is thought to have been open, the pressure must have averaged 13.4 bar (194.5 lbf/in<sup>2</sup>) — well over four times the design pressure.
