## Learning lessons from eight gas explosions

EGAN Simon Mark, Corporate Process Safety Expert, Solvay, 85 avenue des Frères Perret, BP 62 – 69192 Saint-Fons Cedex, France

Eight cases of gas phase explosion in industrial facilities are presented, together with root causes and learning lessons for each one of them. The examples are drawn from the author's professional experience with Rhône-Poulenc (1975-2000), Rhodia (2001-2010) and Solvay (2011 onwards). Following the examples, the issue of flame blow-back in vent lines and inerting of process vessels are discussed. It is shown that avoiding injuries and fatalities caused by gas phase explosions in process units requires:

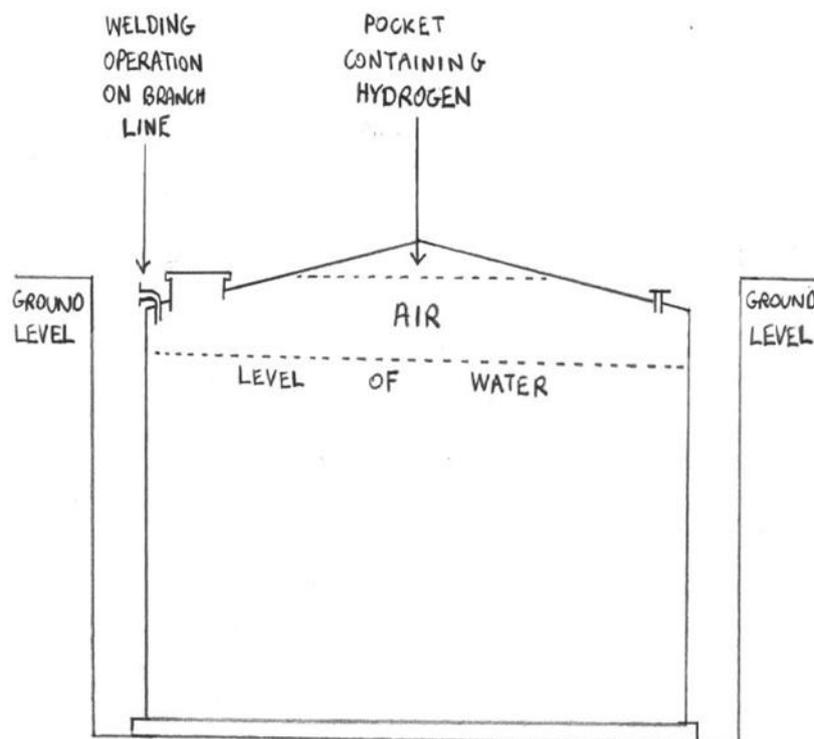
Figure 1 Sulphuric acid tank

The 50 m<sup>3</sup> tank was made of mild steel and situated in a pit below ground level (see Figure 1). It was used to store 96 % sulphuric acid. It became necessary to repair a line connected to the top of the vessel. The sulphuric acid was pumped out of the tank to another vessel. At this point, the tank was observed to contain a layer of sediment. Eight bags of sodium carbonate powder were added via the manhole. The tank was then filled with water to within 15 cm of the top. For various reasons the repair work was carried out six days after the addition of sodium carbonate and water to the tank. During this period and immediately before starting the repair work, checks for hydrogen were carried out inside the pit, at ground level and inside the tank. All the tests proved negative. Grinding work duly started on the line to be repaired. There was an explosion inside the tank. The tank did not rupture but it must have shaken violently because its ground fixation points gave way and the three people on the roof of the tank were thrown into the air. One of those persons was killed and the other two were seriously injured.

Clearly, the sulphuric acid was not neutralised. No attempt had been made to stir the contents of the tank in any way. No pH check was carried out on the mixture. Hydrogen forms when aqueous sulphuric acid is in contact with mild steel. This reaction may be written as follows:  $\text{Fe (s)} + \text{H}_2\text{SO}_4 \text{ (aq.)} \rightarrow \text{FeSO}_4 \text{ (aq.)} + \text{H}_2 \text{ (g)}$ . For 92-98 % sulphuric acid, which is the normal range for storage in mild steel, the corrosion rate is reduced by the formation of a protective layer of solid ferrous sulphate (FeSO<sub>4</sub>) which does not dissolve. But when water is added, forming more dilute acid, the ferrous sulphate dissolves and the protective layer is lost. Corrosion and the formation of hydrogen are then more rapid. It was calculated that the corrosion rate would have been about 10 mm per year, leading to the formation of 50 g (0.6 m<sup>3</sup>) of hydrogen over a six day period. Given that the Lower Explosive Limit of hydrogen is only 4 % v/v, this would be enough to make 15 m<sup>3</sup> of an explosive hydrogen-air mixture.

As hydrogen is much lighter than air it collected inside the conical top section of the tank, which was not vented. After the accident, tests showed that hydrogen was indeed present inside the conical top section. Hydrogen has a very low Minimum Ignition Energy (0.017 mJ) so it is not surprising that it was ignited.

Concentrated sulphuric acid can be safely stored in mild steel vessels but:

1. There should always be a vent at the highest point of the vessel.
2. Great care is needed when doing maintenance work. The tank must be emptied. The remaining sulphuric acid must be immediately neutralised with an excess of sodium carbonate or other suitable alkali. The mixture formed must have a pH over 7. The tank must then be thoroughly vented to remove all traces of hydrogen.

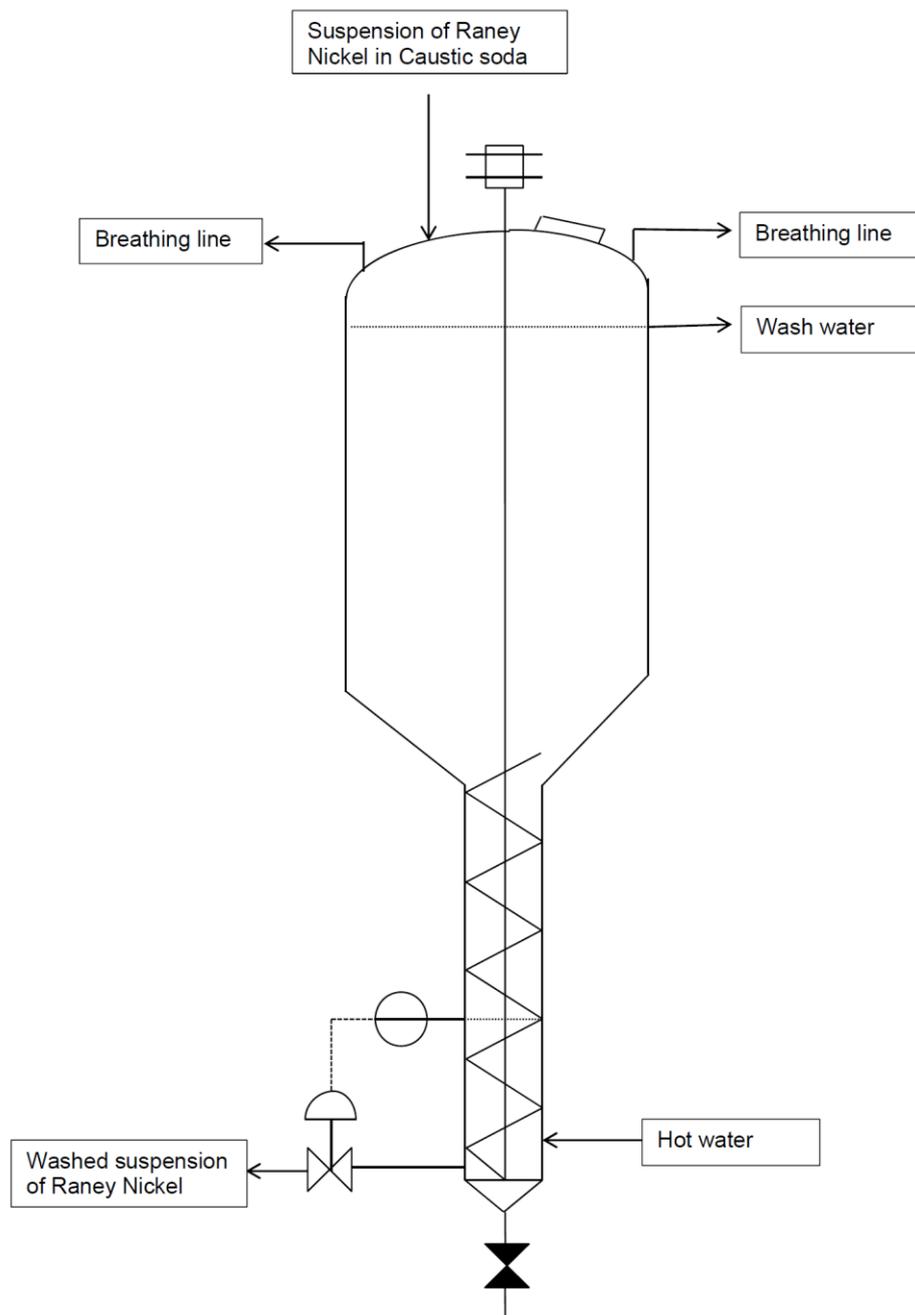
Figure 2 Continuous counter-current catalyst washing vessel

The vessel was used to wash activated Raney Nickel catalyst, used elsewhere in the plant in a hydrogenation process. Raney Nickel is an alloy of nickel and aluminium, bought in the form of granules. It is activated by treatment with caustic soda, which dissolves the aluminium and generates hydrogen:  $\text{Al (s)} + \text{NaOH (aq.)} + \text{H}_2\text{O} \rightarrow \text{NaAlO}_2 \text{ (aq.)} + 1.5 \text{ H}_2 \text{ (g)}$ . It leaves granules of nickel in a very finely divided form that is able to catalyse hydrogenation reactions. The vessel involved in the accident was used to carry out continuous counter current washing of a suspension of activated catalyst with hot water (see Figure 2). During the normal process, the suspension of Raney Nickel in caustic soda was fed in at top of the vessel at a constant rate. Hot water was fed in at bottom at a constant rate. A suspension of washed Raney Nickel catalyst was run off at the bottom to a mixing vessel, whilst the wash water ran off at the top. The incident started with a blockage in the washed catalyst run-off line. The vessel was emptied and rinsed through with water. The manhole was opened on top of vessel and an explosion occurred in or near the vessel. Three workers were standing on a platform next to the manhole. They fell to the ground: one of them was seriously injured.

The reaction of the aluminium in Raney Nickel with alkali generated hydrogen. This reaction was still going on the catalyst washing vessel because the pH was alkaline and traces of aluminium were left in the granules. Also common breathing lines with other vessels had not been blanked off, so a mixture of hydrogen and air was present in the headspace of the vessel. As discussed in the previous incident, hydrogen is very easy to ignite. Slight friction between metal parts when opening the manhole would have been enough to ignite the gas mixture inside the vessel.

All process vessels contain flammable gas or vapour until proven otherwise. Lines to other vessels should have been blanked off by placing metal discs (or "spades") into flanges. The vessel should have been completely filled with water or else thoroughly ventilated before opening it.

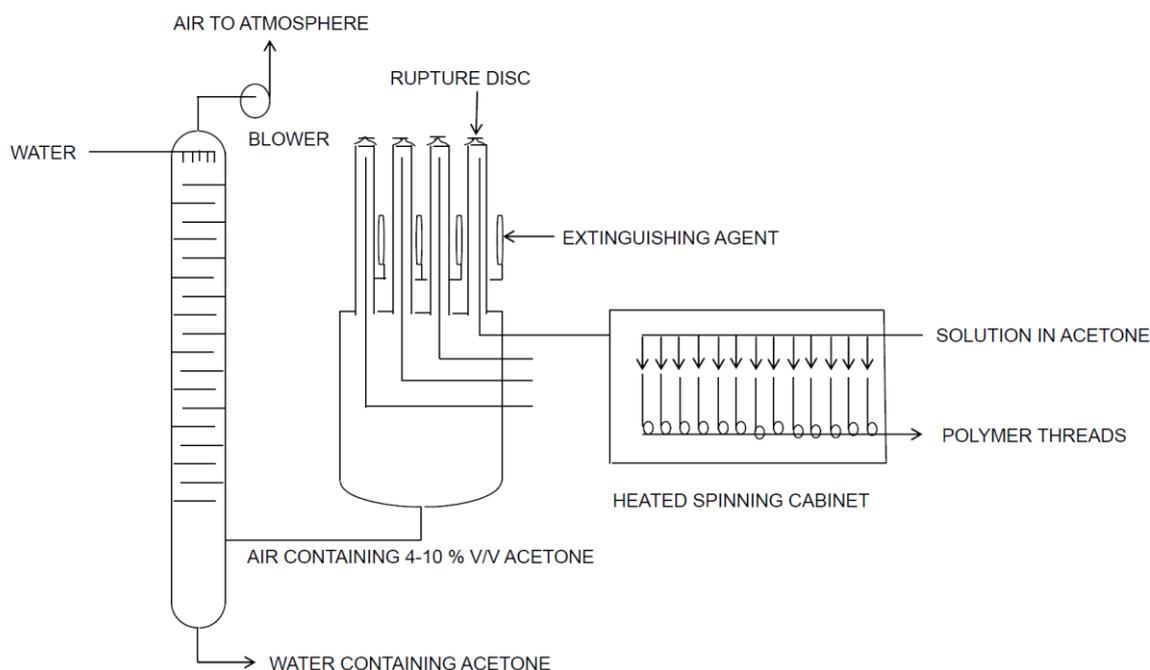
Figure 5 Spinning cabinet and off-gas treatment system (not to scale)

After the incident the burnt remains of a cloth, containing traces of a flammable solvent, were found in the cabinet. The solvent was identified. It has a Lower Explosion Limit (LEL) of 1.1 % v/v and a flash point of 70 °C.

On this occasion, a cloth impregnated with this lubricant was left in the cabinet for about two days because the cabinet could not be unplugged. The cabinet continued to be heated at 70 °C which corresponds to the flash point of the solvent. Now heating a liquid to its flash point does not cause ignition: it just means that the concentration of vapour in the air in contact with the liquid will reach the Lower Explosive Limit (LEL). Ignition still requires a spark or hot-spot.

In view of this, it was normal for the cloth impregnated flammable solvent and left in a spinning cell at around 70 °C for two days to catch fire.

1. This incident occurred because the official cleaning procedure was deliberately not followed by operating personnel. This was a violation. Procedures are necessary to guarantee safety. They need to be explained and enforced.
2. In all of our plants, we must ensure that the materials used for cleaning are compatible with working conditions and do not pose ignition risks.

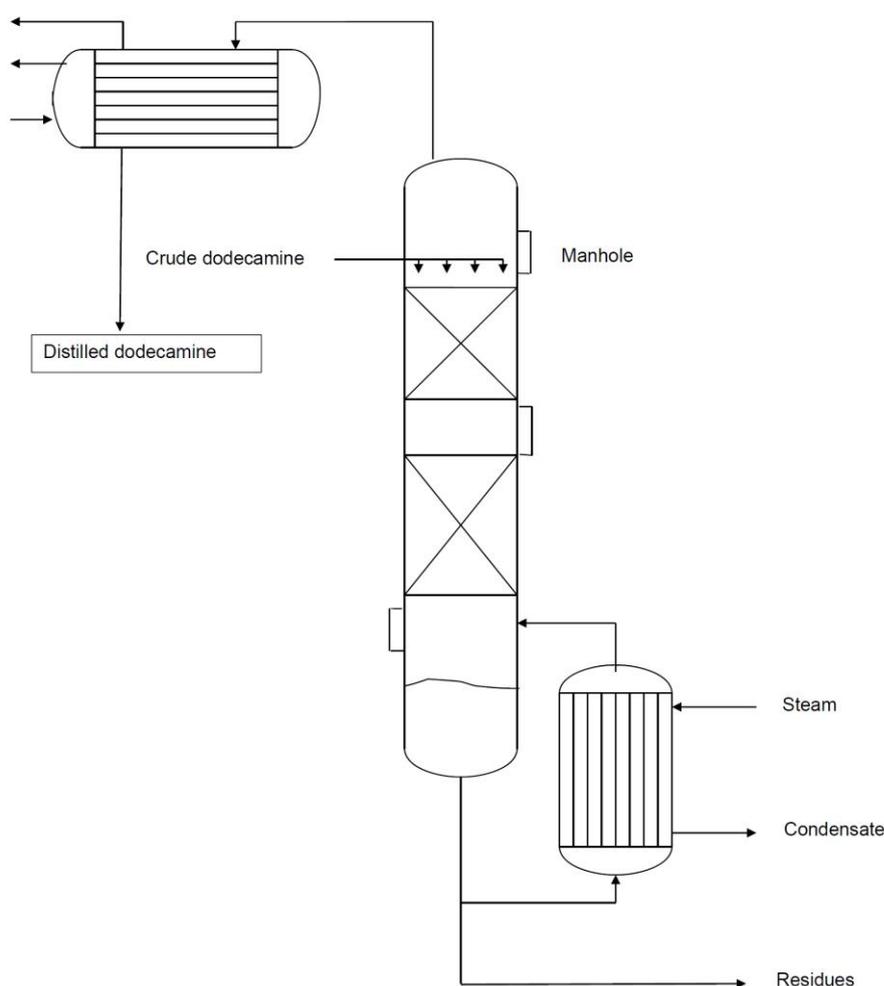
Figure 6 Dodecanamine distillation column

Following the modification, the distributor of the distillation column, where crude filtered product was fed in, was found to be blocked up. The column was shut down at 150 °C and the vacuum was released with nitrogen. A manhole cover near the top of the column was removed in order to clean the distributor. A jet of flame burnt one operator.

The finer catalyst was not completely removed during by filtration, especially as this was only one stage. Fine particles of catalyst remained in the crude product and caused blockage of the distributor. The column was at 150 °C when the manhole was opened. Inside was hot nitrogen containing dodecanamine vapours above the Lower Explosive Limit (the flash point of dodecanamine is 127 °C). The density of the gas mixture inside the column would have been about  $0.81 \text{ kg m}^{-3}$ , whereas the density of the air outside the column would have been about  $1.25 \text{ kg m}^{-3}$ . The difference in densities led to rapid mixing, forming a mixture of air, nitrogen and dodecanamine vapours within explosive limits. As air came into the column it came into contact with activated Raney Nickel. Now activated Raney Nickel becomes incandescent on contact with air and we suppose that this was the ignition source.

1. Vessels must be decontaminated before they are opened.
2. Differences in gas may lead to mixing, as in this case. In other cases layers of denser gas, containing heavy hydrocarbons, may persist in drains etc.
3. Activated Raney Nickel acts as a potent ignition source in the case of entry of air into equipment.

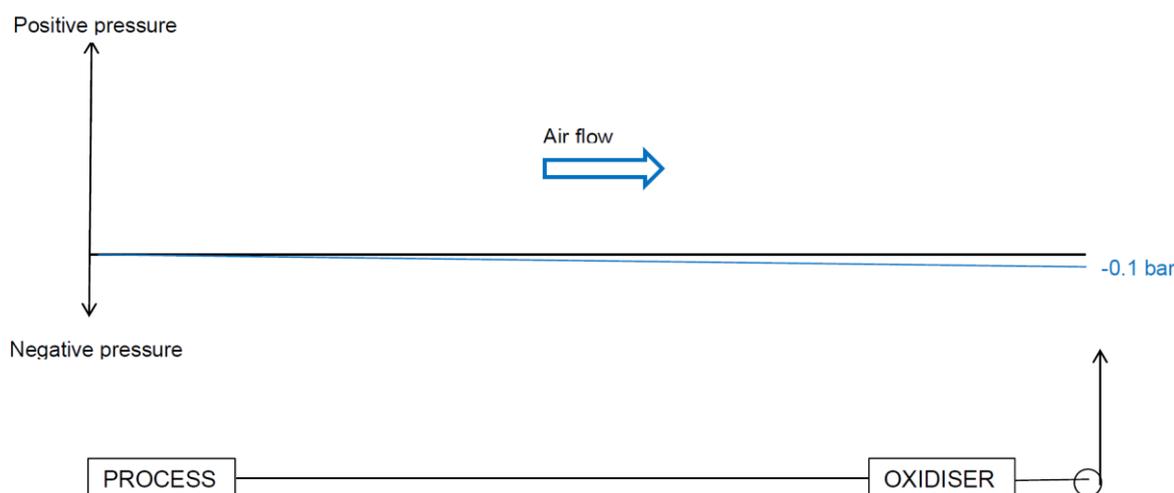
Figure 7 Off-gas treatment system - before ignition

The fundamental burning velocity of most hydrocarbons in air is less than  $1 \text{ m s}^{-1}$ . It might be thought that if the velocity of the off gas is well in excess of the fundamental burning velocity then blow-back cannot occur. Unfortunately it does occur and it is worth explaining why. A system consisting simply of a vent line from a process to a thermal oxidiser system is shown in Figure 7 (before ignition) and Figure 8 (after ignition). In each case the graph shows the pressure profile. The process system is supposed to operate at atmospheric pressure. The off-gas is extracted by a blower situated downstream of the oxidiser. Before ignition the pressure drops slowly along the vent line and the air flows from higher to lower pressure in the direction shown by the arrow. Then ignition of the mixture occurs at the entry to the thermal oxidiser. Even if the gas mixture is close to its explosive limits the pressure generated at the point where ignition occurs will be at least 2 bar gauge. So from the pressure peak at the point of ignition a flame front will spread in both directions. The flame front travelling forwards will be extinguished because the gas in front of it is inside the oxidiser and it not explosive as the hydrocarbons have been depleted on the hot ceramic bed. But the flame front travelling backwards towards the process system will feed on the explosive mixture in the line. It will accelerate to reach and even exceed the speed of sound in air (340 m/s) in which case a detonation wave will be formed with a pressure peak twenty or more times atmospheric. The important point is that the direction and speed of flow is determined by the pressure profile which changes completely once ignition has occurred.

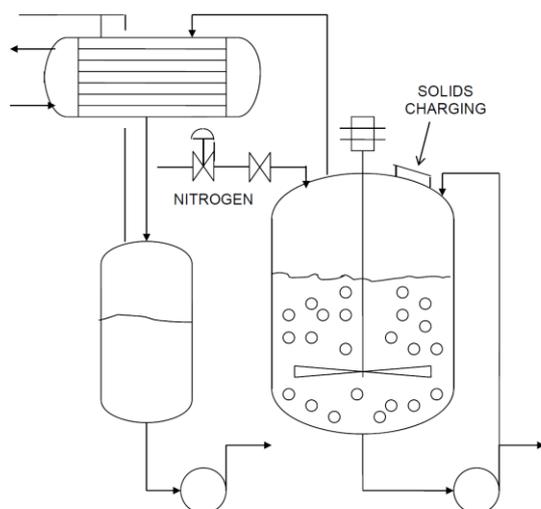
Figure 10 : Charging solids directly

The first example was a stirred reactor used in a batch process, where operations such as charging of liquids and solids, reaction and distillation were carried out successively (see Figure 10). The solvent was flammable and at one point in each batch cycle the reactor charging port was open and solids were added whilst the reactor already contained the flammable solvent. There was an obvious hazard of gas phase explosion so a steady nitrogen purge was applied during this operation. As part of the HAZOP study we decided to lower a portable oxygen meter into the headspace during the solids charging operation and some of us were surprised that the reading was 21 % O<sub>2</sub>.

To maintain a nitrogen atmosphere, solids must always be added via a hopper with a rotary valve etc.

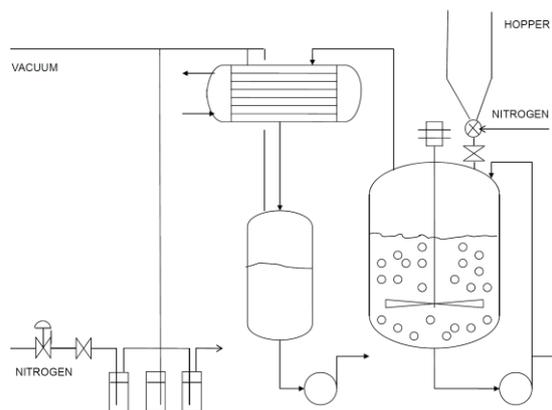
Figure 11 : Charging solids via a hopper with a rotary valve

The second example was a reactor used in a similar type of process, except that solids were added via a charging hopper. The solids were transferred from the hopper to the reactor via a rotary valve and nitrogen was injected into the body of the valve during the addition (see Figure 11). The reactor was maintained above atmospheric pressure with nitrogen at all times during the process. As part of the HAZOP study we decided to sample the headspace during the first batch of a new manufacturing campaign. As in the first example, the oxygen level was 21 %.

At start of a manufacturing campaign the vessels may well contain air, so we must pull vacuum then purge with nitrogen three times to get a low oxygen level.
