PSM Lessons from a Major Reformer Furnace Failure

RDC Prior, SHExcellence CC, Johannesburg, South Africa

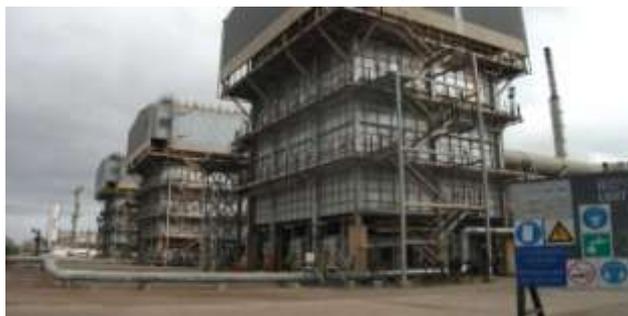
When cold, the Primary Furnace was inspected and of the 228 tubes, 139 were visually damaged, 23 were damaged as measured by Eddy Current tests leaving 66 still serviceable. The gas feed line to the Reformer tubes was distorted and there was some damage to the feed superheater. Apart from loss of production the material replacement cost of the tubes alone is expected to exceed R70 million (GBP 5 million). The Primary Reformer and some of the damaged tubes are shown in Photographs 1 and 2.

Photograph 1 – Primary Reformer Furnace

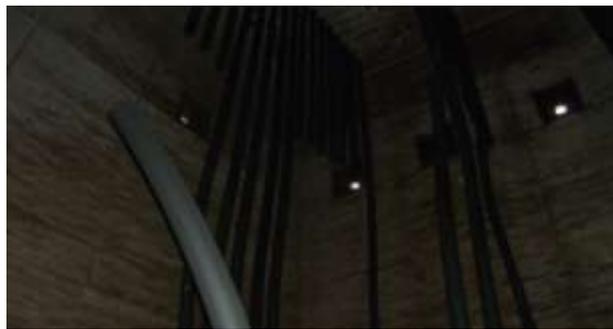
Photograph 2 – Damaged tubes in Furnace

After the Unit had cooled down it was observed that many tubes had ruptured and the feed pipe from the Superheater 06-EM-101 to the Furnace tubes was distorted. Later metallurgical tests showed that only 66 Furnace tubes were still serviceable and that damage had been observed on the heater 06-EM101. The Furnace walls and roof were essentially undamaged. A few concrete slabs on the floor had broken. The cost of replacement of the damaged equipment is likely to be in excess of R70 million (GBP5 million).

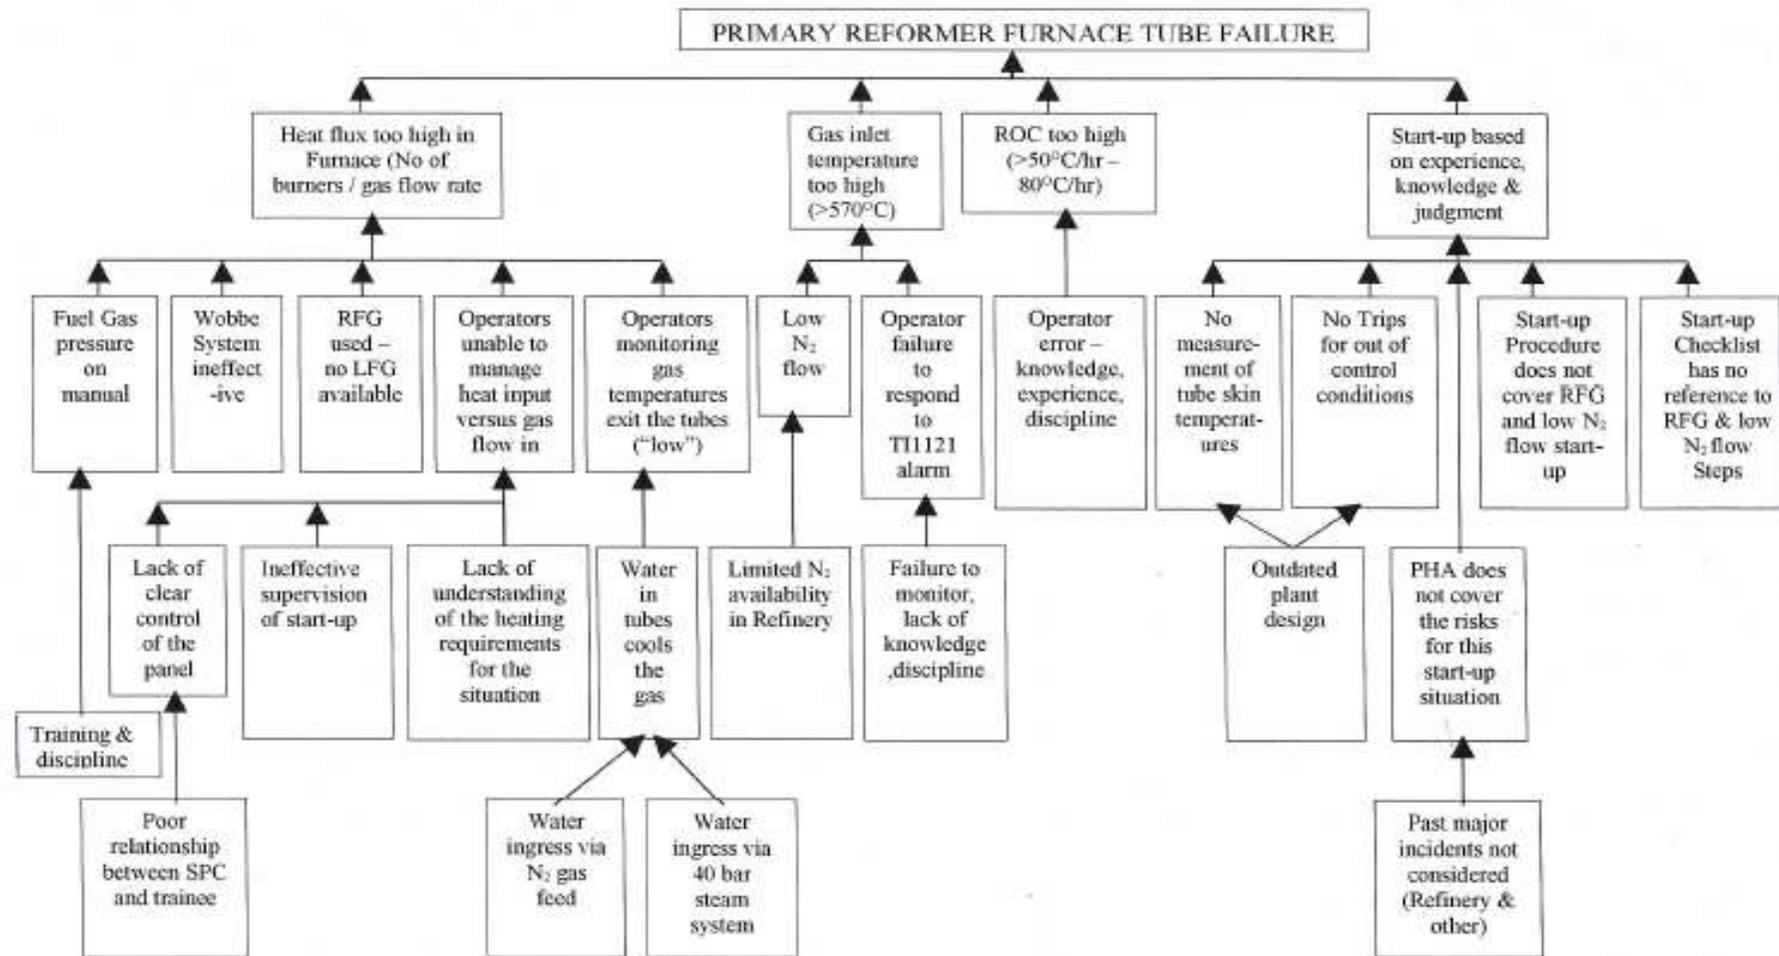
A detailed investigation was carried out into the accident. Key people were interviewed, documents and operating data reviewed and physical evidence such as damaged tubes subjected to metallurgical analysis. The timeline was constructed. A root cause analysis was carried out. This is depicted in Appendix 1. It became very clear that the furnace tube damage was due to prolonged overheating during the nitrogen heating phase of the start-up procedure. The catalyst in the furnace was green in colour indicating that the catalyst had been exposed to water (condensate). This has serious effects on catalyst performance and could affect gas flow and temperatures in the furnace. Root causes were established in the Hardware, Systems and People sectors of the analysis.

Appendix 1 – Fault Tree analysis for Furnace Tube Failure – May 2013

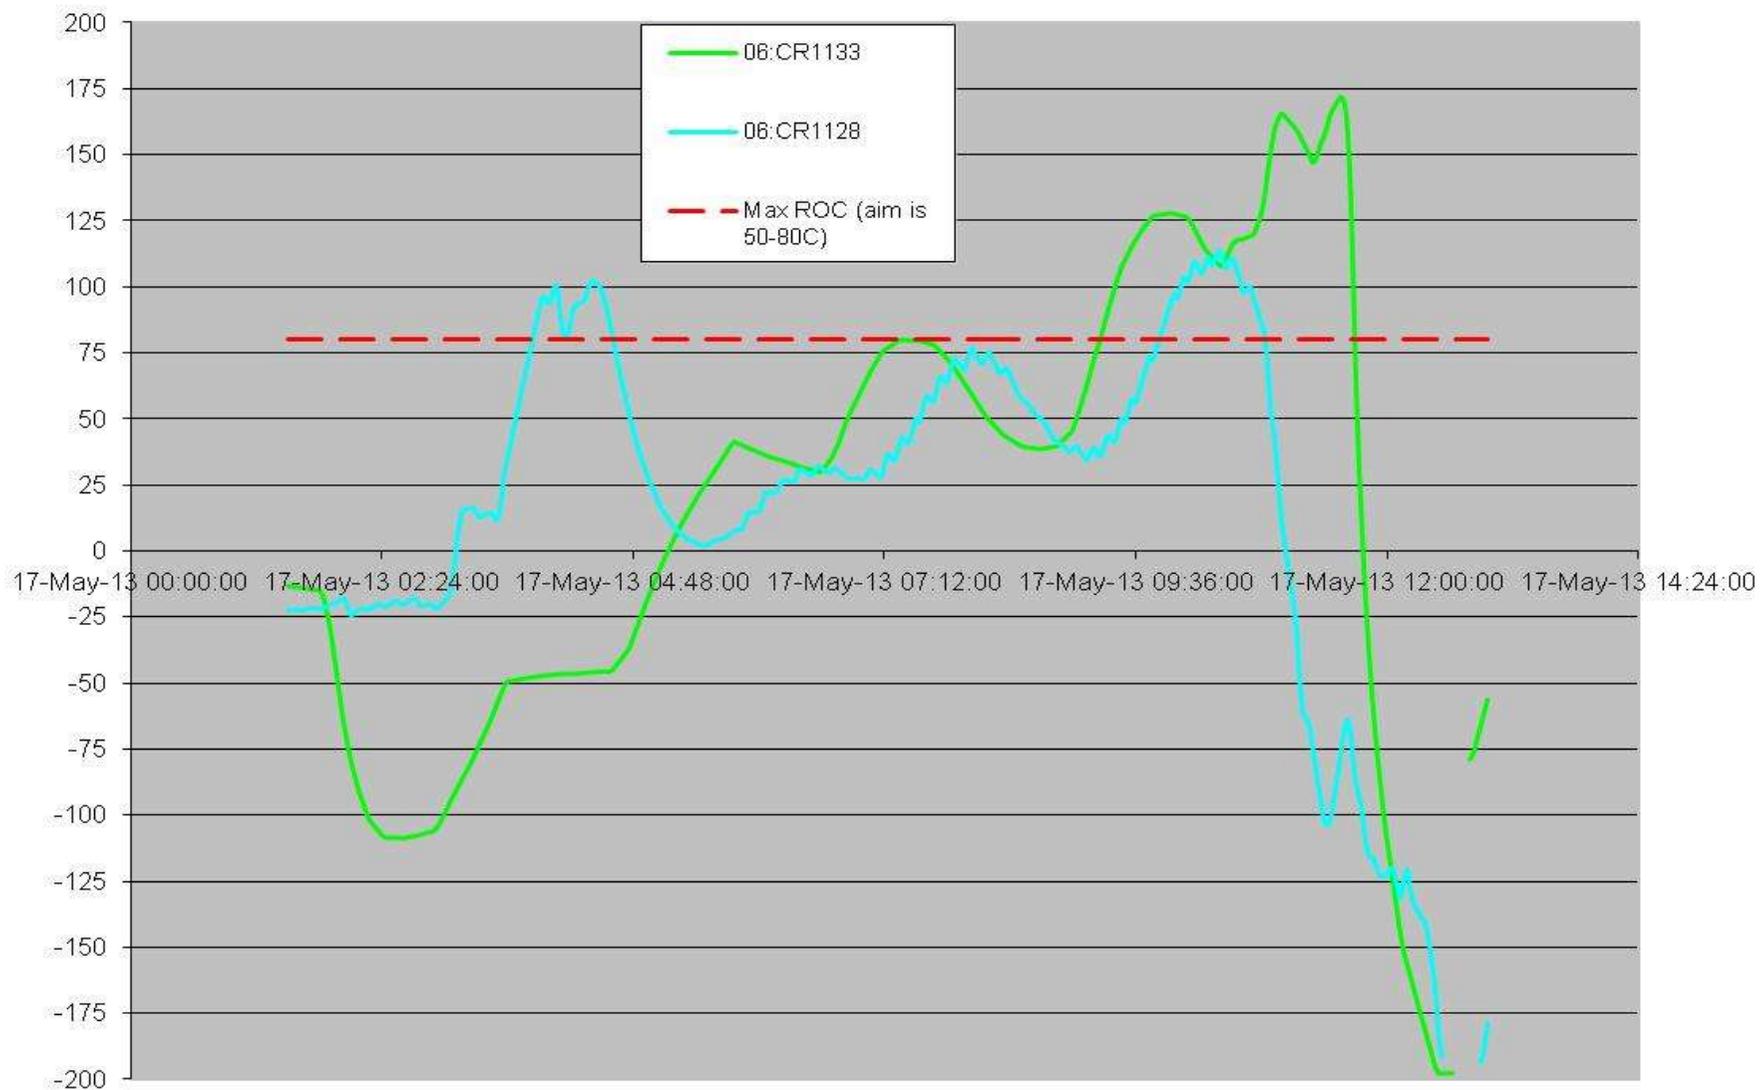
- The Rate of Change (ROC) of the temperature of the feed gas exceeded the prescribed limit of 50°C per hour by significant amounts for extended periods. The graph in Appendix 2 shows the ROC for the morning period. This was not reacted upon by the operators.

Appendix 2 – ROC of temperatures during start-up of Furnace no 1

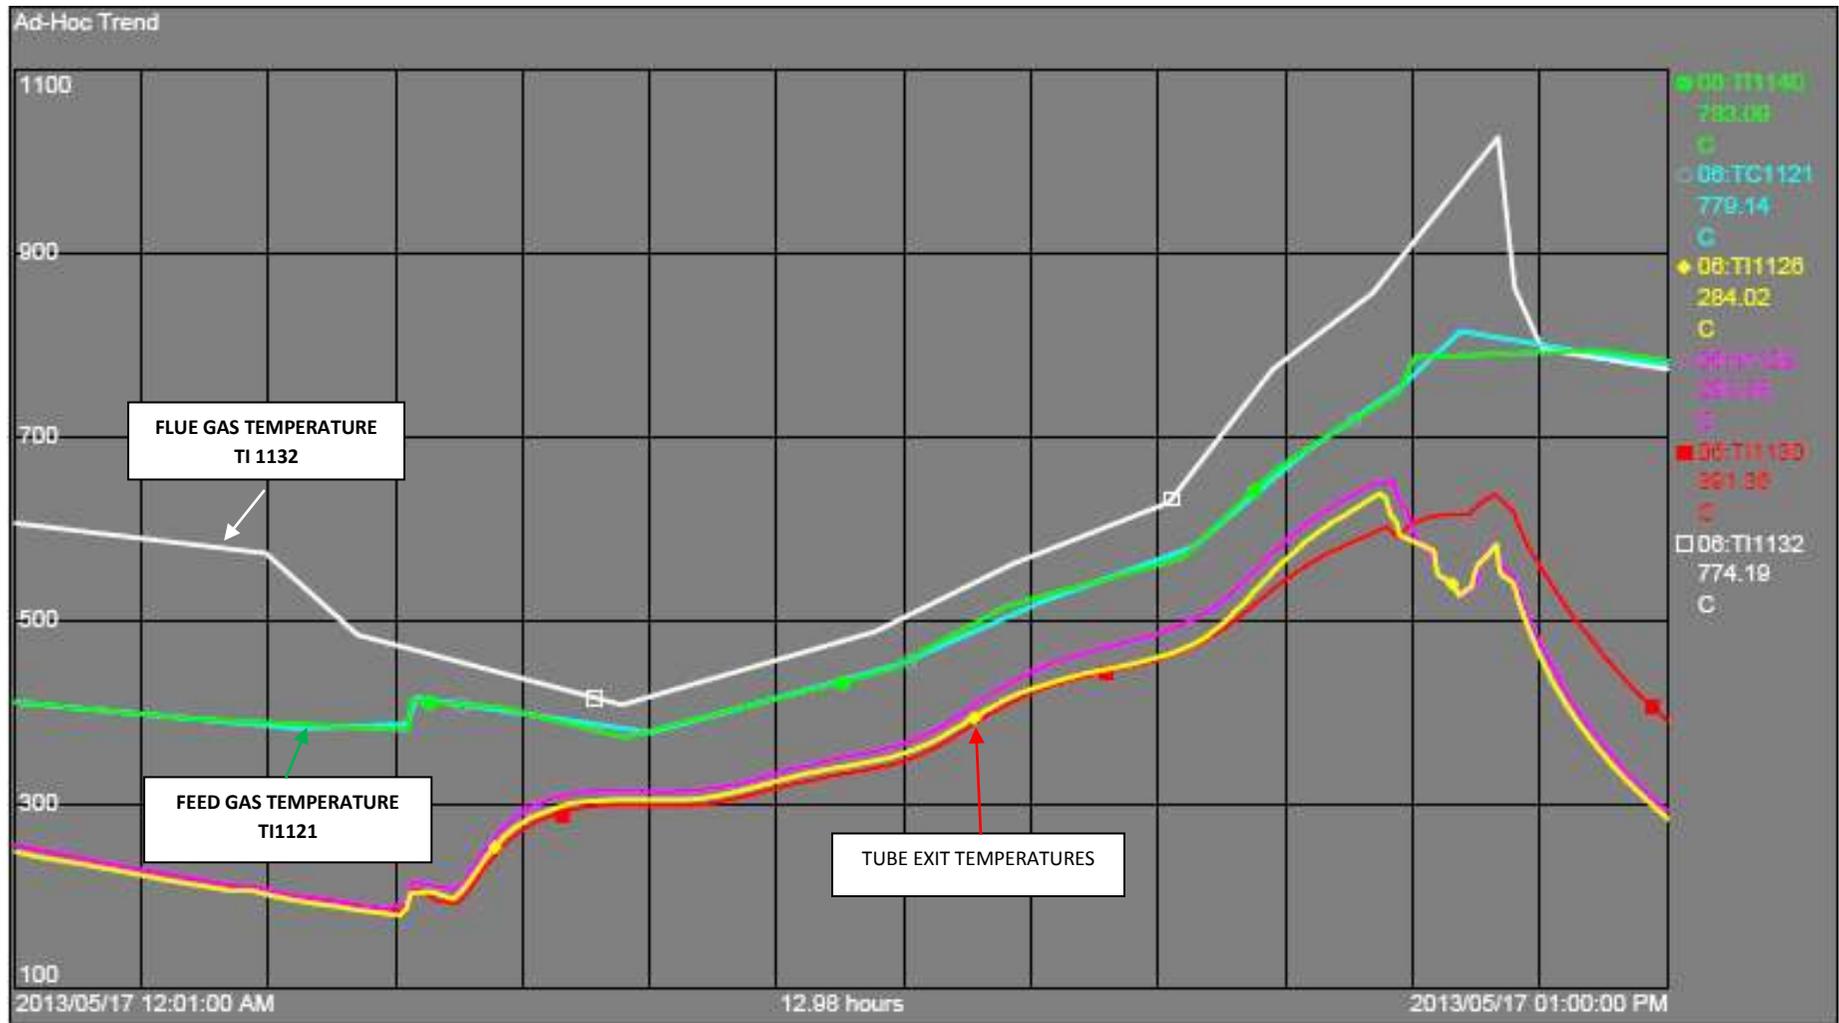
- The inlet gas temperature upper limit of 570°C was exceeded by several hundred degrees for some hours during the start-up. There was panel information on this information but it was not seen as critical. The graph in Appendix 3 shows the temperatures.

Appendix 3 – Key temperatures recorded during start-up of Furnace No 1 in May 2013
