Runaway Chemical Reaction at Corden Pharmachem, Cork

S. J. Gakhar and S. M. Rowe, Chilworth Technology Ltd, Beta House, Chilworth Science Park, Southampton SO16 7NS

M. Boylan and P. Conneely. Health and Safety Authority, 3rd Floor, 1A, South Mall, Cork

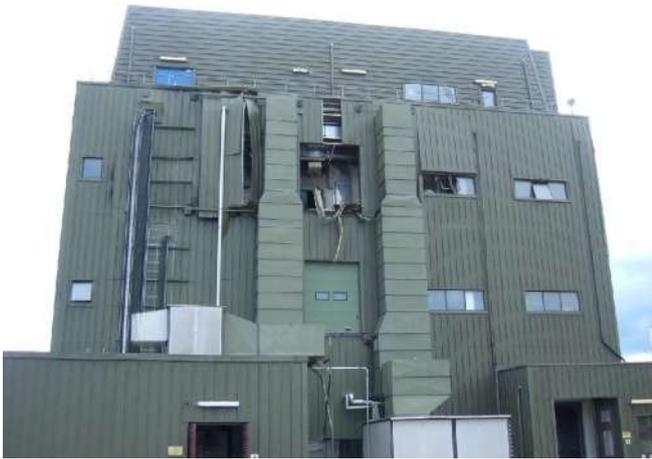
Most building damage was on the north side of Building PB2 (Figure 1). Sections of the cladding were completely displaced, with a roller shutter door found on the ground by the drum storage area on the north side (Figure 7). There was debris on the ground extending a considerable distance from the building. Internally, most of the damage was to the 2nd floor and 3rd floor of PB2 with the 2nd floor (where the main part of the reactor that failed was located) sustaining the worst damage (Figure 2). Most of the damage on the 3rd floor was to the roof (Figure 4) caused by the fact that the direction of release was primarily upwards through the reactor solids charge chute (Figure 3). The energy was sufficient to result in cracking to the concrete block walls (Figure 5). In addition to damage consistent with overpressure energy, there were significant black deposits covering much of the equipment, ground and walls on the 2nd and 3rd floors.

Figure 1: PB2 north side

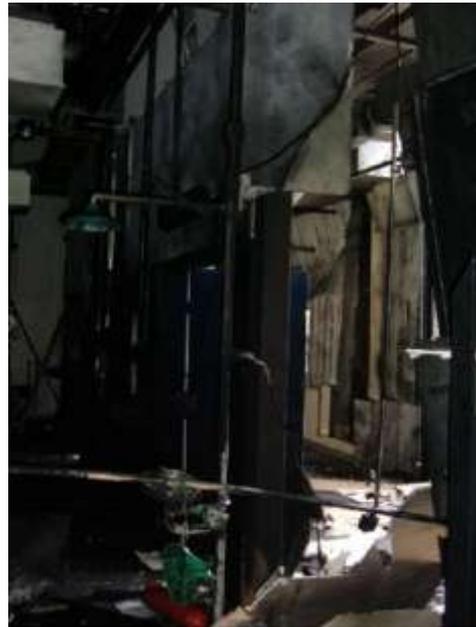
Figure 2: Internal damage

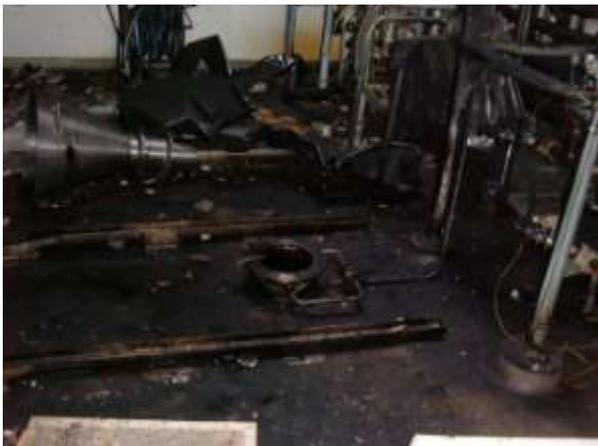
Figure 3: 3rd floor charge chute

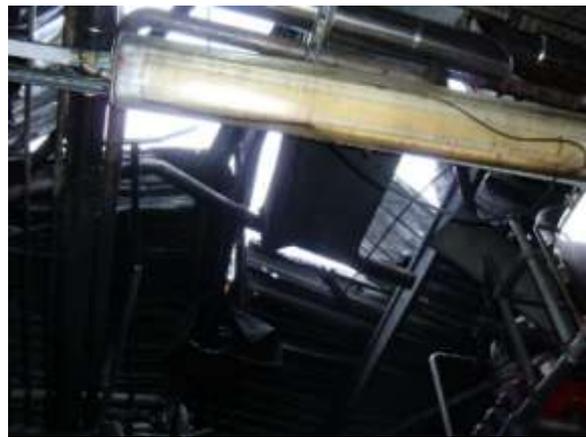
Figure 4: 3rd floor roof damage

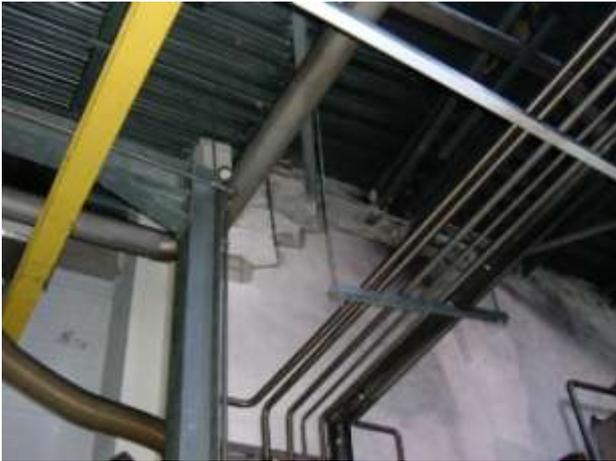
Figure 5: Cracks in concrete

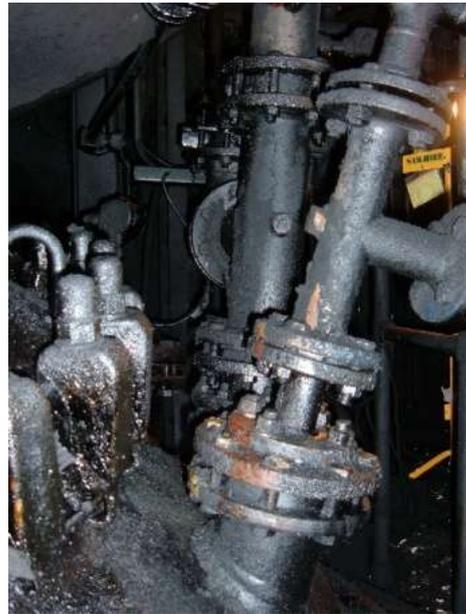
Damage to process equipment was mostly confined to K6003 on the 2nd floor with the vessel dished end deforming, significant flange manway distortion, rotation of nozzles (Figure 6) and complete 'blow out' of the manway gasket leaving a gap of about 10 mm through which reactor contents were ejected. The top cover on the Solids Charge Chute was completely torn off from the top of the chute. This required the shearing of four bolts. The cover was found on the ground outside on the south side of the building (Figure 8). The Solids Charge Chute butterfly valve was also sheared off and transported up the Solids Charge Chute. This was found on the 3rd floor (Figure 9).

Figure 6: Nozzle rotation

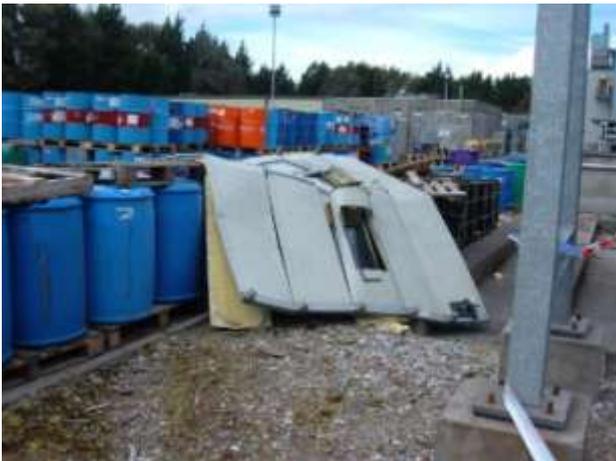
Figure 7: Roller shutter door

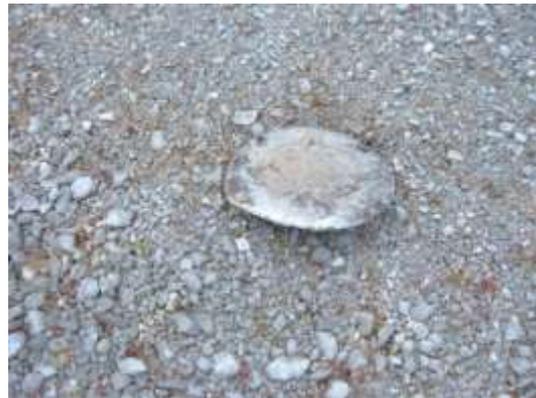
Figure 8: Solids charge chute lid

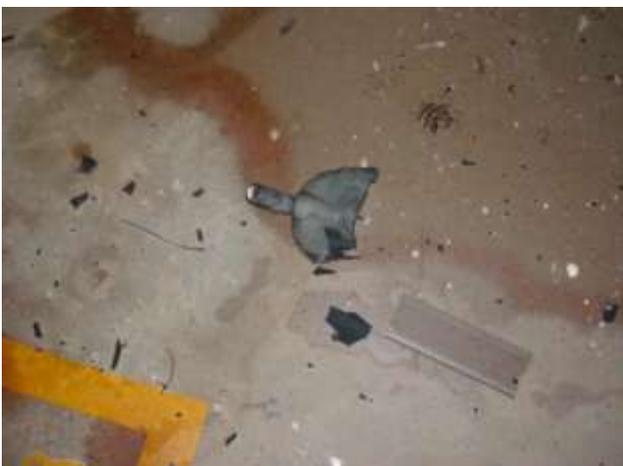
Figure 9: Butterfly valve

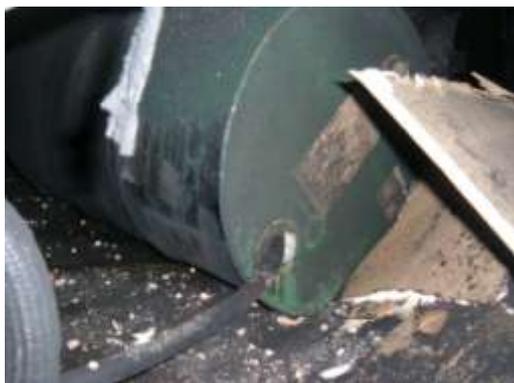
It was clear from DCS trends, that vacuum had been pulled on K6003 just prior to the incident. This vacuum was also evident on the 'normal batch' trend and depicts DECC addition which is carried out under residual vacuum. Other evidence that liquid had been added included observation of DECC drums near the reactor (Figure 10) and agitator torque sensing trends i.e. increased torque due to increased viscosity just after the vacuum was pulled.

Figure 10: DECC drum with reactor feed line inserted

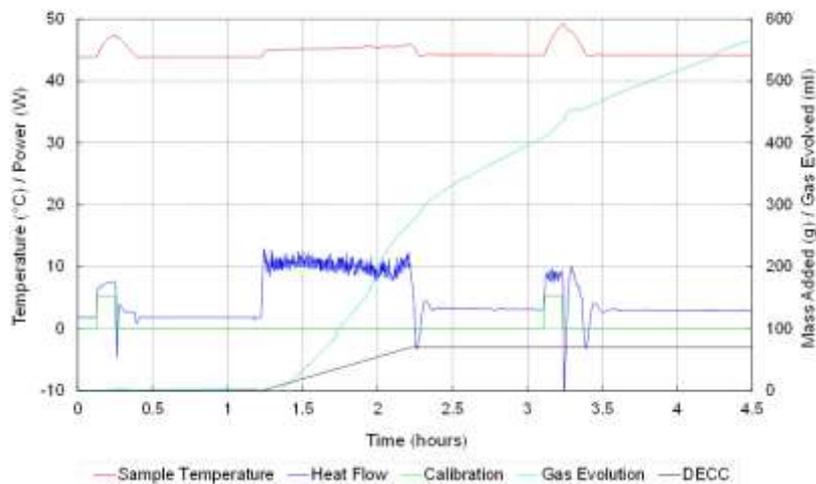
Figure 11 shows the graphical output from the RC1 calorimeter which clearly shows almost instantaneous exothermic behaviour as soon as DECC is added (denoted by the increase in power). It also shows that the power drops off to the base level quickly after all the DECC is added indicating low levels of accumulation at 44°C. Table 1 shows the results of the RC1 test without acetone and compares them to the RC1 results available prior to the incident. The ARC test on the intermediate salt with no acetone showed two clear decomposition exotherms (see Figure 12). The first exotherm started immediately, i.e. at 44°C and reached a peak temperature of 122°C and peak pressure of 18 barg. The second started at about 159°C although peak conditions could not be established because the test had to be stopped through risk of rupturing the ARC test cell. However, the pressure was in excess of 26 barg when the test was stopped. Table 2 compares the ARC test results with previous thermal stability testing available prior to the incident.

Figure 11: RC1 results for DECC addition at 44°C

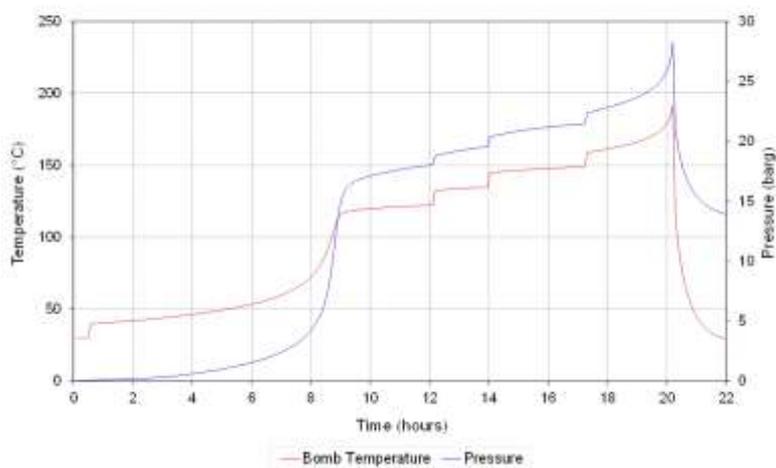
Figure 12: ARC test results on salt / PNO mixture

The reaction without acetone is exothermic with a higher heat of reaction and adiabatic rise than the normal process. In addition, the ARC test indicates that without acetone, there is a decomposition reaction starting from 44°C (and likely below). This is likely to be the intermediate salt decomposing. The second decomposition exotherm is likely to be the PNO decomposing and the onset is broadly consistent with previous tests.
