## **BUNDING AT BUNCEFIELD: SUCCESSES, FAILURES AND LESSONS LEARNED**

Aidan Whitfield<sup>1</sup> and Dr Mike Nicholas<sup>2</sup>

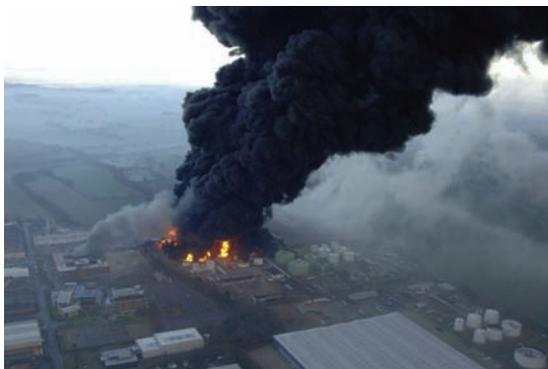
**Figure 1.** Buncefield. Aerial picture of terminal fire & smoke plume (Photographed by Chiltern Air Support Unit)

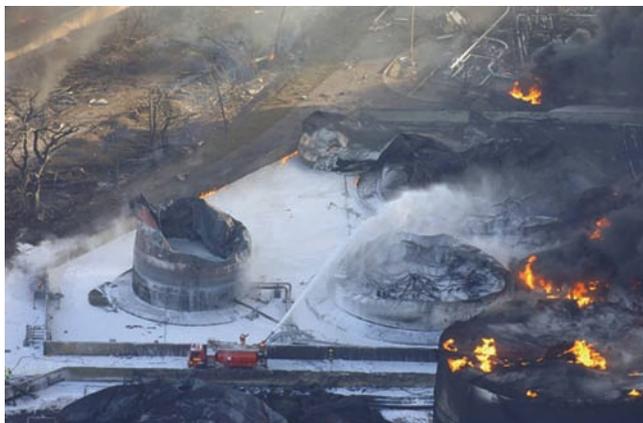
**Figure 2.** Buncefield. Firefighters applying foam to tanks and bunds (Photographed by Chiltern Air Support Unit)

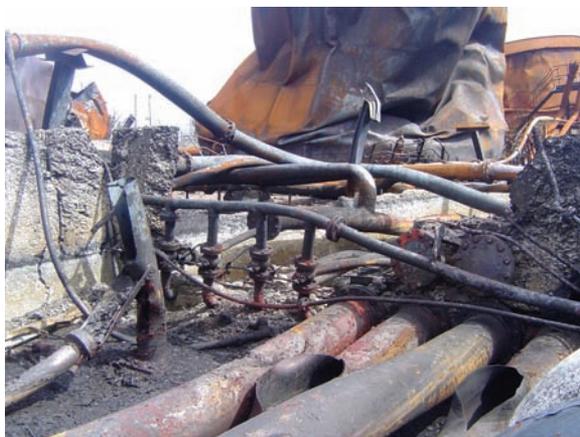
- Many of the bund walls suffered loss of containment at the pipework penetrations and there was leakage due to the loss of seal between pipes and the bund wall.

**Figure 3.** Buncefield. Catastrophic bund wall failure at pipe penetrations

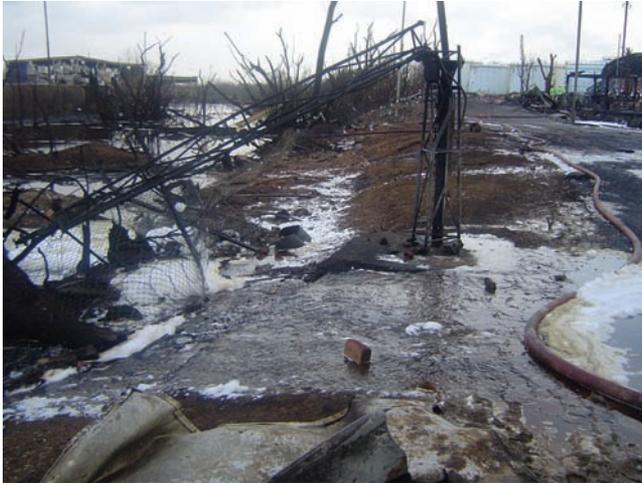
During the initial stages of the fire, many of the bunds performed well. They contained both leaking fuel and fire-water, which allowed the fire service to operate close to the burning tanks and reduced the escalation of the fire. However loss of integrity of some bund walls developed over the following days, which allowed fuel and contaminated fire-water to flow out over the site. The fire services minimised the impact of this by recirculating firewater and pumping it into other non-damaged bunds. Despite their efforts, a significant volume of liquid escaped into Cherry Tree Lane, a public highway that runs through the site. It then flowed under a bridge under the M1 motorway, where it soaked into the ground.

Cherry Tree Lane has a number of road drains connected to deep chambers, one of which contains a borehole at least 40 metres deep that penetrates the chalk aquifer. The on-site drains and road drains provided pathways for fuel and contaminated firewater to pollute the groundwater.

**Figure 4.** Buncefield. Contaminated fire water flowing off-site into Cherry Tree Lane

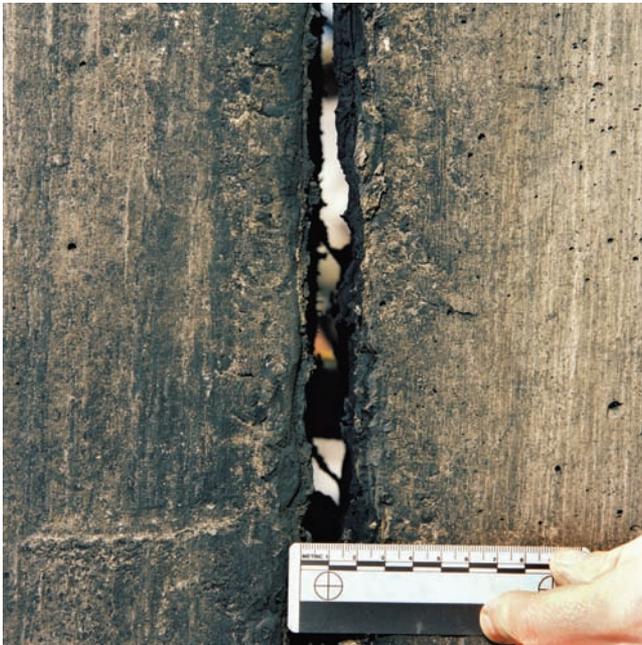
- Damaged product pipework provided pathways for liquids to escape from bunds or to flow from one bund into another.
- The performance of the expansion and construction joints between concrete slabs varied between bunds. The joints that performed best had metal waterstops cast into them. The joints that had been modified by the installation of a metal plate in the inside face were provided with some degree of protection. In a number of bunds the joint materials were badly damaged resulting in loss of integrity.

**Figure 5.** Buncefield. Loss of integrity at a bund expansion joint

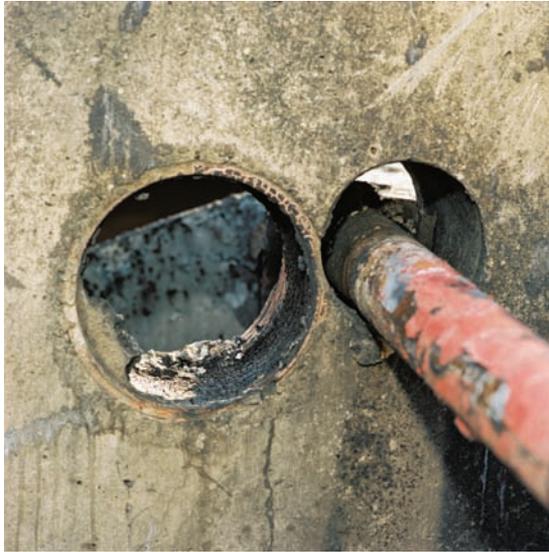
**Figure 6.** Buncefield. Loss of integrity at pipe penetrations

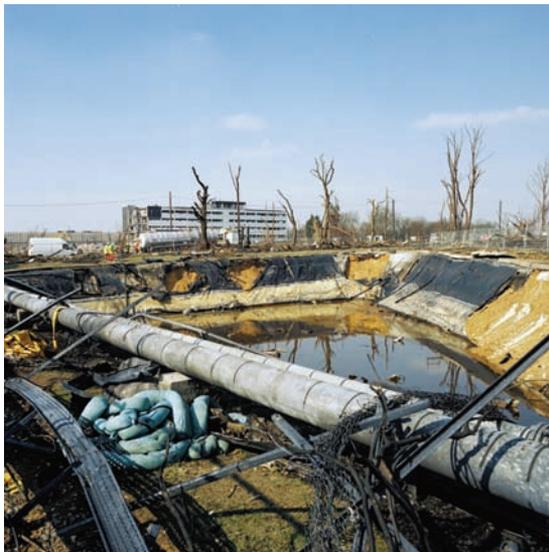
- In at least two locations, the concrete bund floor buckled and broke.
- The tertiary containment systems did not contain fuel and fire-water within the boundaries of the terminal. Loss of power to pumps and inadequate drainage and lagoon integrity and capacity were key contributors to this.

**Figure 7.** Buncefield. Damage to a lagoon liner revealing ground behind
