## ACCEPTANCE CRITERIA FOR DAMAGED AND REPAIRED PASSIVE FIRE PROTECTION

KEYWORDS: PFP, Damage, Repair, Cementitious, Intumescent, Acceptance Criteria.

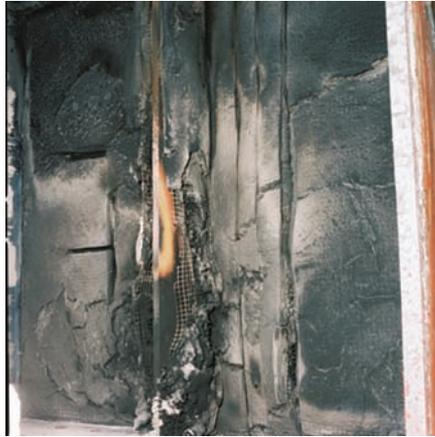
**Figure 5.** Specimen for test 10 (after test)

Figures 1 and 5 show the specimen for trial 10 before and after testing. The purpose of this test was to determine the effect of gouging, cracking and disbondment on Chartek IV.

The left panel was physically damaged (gouged), but was bonded to the steel substrate. After the test, slight enlargement of the gouges was observed. Thermocouple temperatures and thermal images confirm that the main hot spot was recorded behind the horizontal

(25 mm × 200 mm) gouge above the centre line. The time until a 140°C temperature rise was seen behind this gouge was 4 minutes. The highest temperature rise after 60 minutes was 325°C.

Prior to the test, the right panel was cracked and the coating was deliberately disbonded from the steel substrate. After the test this panel was much more damaged than the left

panel (above), the material was bowed out from the substrate and cracked. There was considerable enlargement of the induced cracks, particularly the 2 mm crack. The highest temperatures were recorded at the lower ends of the cracks, in the high erosion zone. Thermal images confirm that there is a hot area around all three cracks in the high erosion zone. The time until a 140°C temperature rise was seen behind the cracks was 9 minutes. The highest temperature rise after 60 minutes was 262°C.

The web was physically damaged (cracked) and the coating was deliberately disbonded from the steel substrate. Temperatures rose very rapidly behind the (5 mm) crack on the web. Major damage was caused, with bare steel being exposed for the bottom two thirds of the web. A 400°C temperature rise was achieved after 5 minutes. The maximum temperature rise of 705°C was achieved after 25 minutes, with the temperature rise at 60 minutes being 656°C. These temperatures are consistent with the Chartek IV being stripped off leaving bare steel exposed to the jet fire.

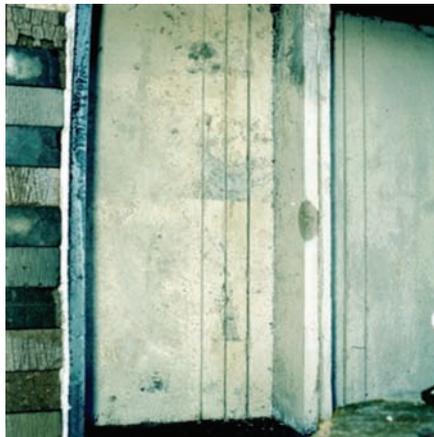
**Figure 6.** Specimen for test 07 (before test)

Figures 6 and 7 show the specimen for trial 07 before and after testing. The purpose of this test was to determine the effect of cracking and disbondment on Mandolite 550.

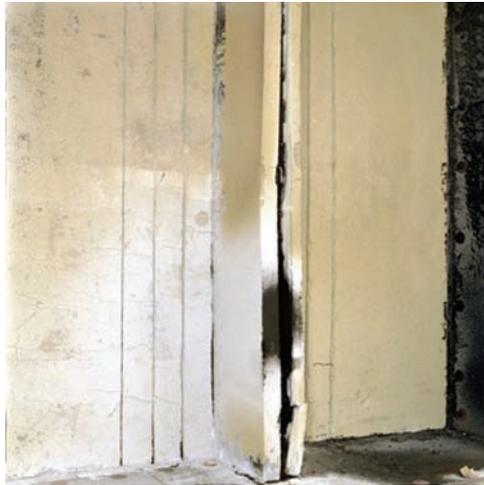
**Figure 7.** Specimen for test 07 (after test)

The left panel was physically damaged (5, 3 and 1 mm induced cracks), but was bonded to the steel substrate. On completion of the test, the dimensions of the cracks remained unchanged. The highest temperature rise of 166°C after 60 minutes was recorded at the top of the 5 mm crack.

The right panel was also physically damaged (5, 3 and 1 mm induced cracks). In addition, the coating was deliberately disbonded from the steel substrate. On completion of the test, the dimensions of the cracks remained unchanged but, in this case, the coating bowed out from the substrate in the bottom two-thirds of the panel. The highest temperature rise of 222°C after 60 minutes was recorded at the bottom of the 5 mm crack.

The thermal image at 60 minutes suggested that the whole of the right hand panel (with cracked, disbonded material) was hotter than the left panel (with cracked, bonded material). This may account for the coating bowing out from the substrate.

The web was physically damaged (cracked) and the coating was deliberately disbonded from the steel substrate. Initially the web temperatures around the high erosion positions were higher than the temperatures in the high heat flux positions. Towards the end of the test the temperature at the centre of the web in the high heat flux zone exceeded the others. Bare metal was visible behind mesh on 95% of front face of the

web and on the sides of the web; the PFP material was (mainly) intact but coming away from the substrate, due to the erosion forces from the jet. If the reinforcement had not been intact, it is likely that the PFP would have fallen off. A full-depth crack was observed along the width of the web at the bottom right hand side. The highest temperature rise after 60 minutes was 473°C behind the middle of the 5 mm crack on the web.

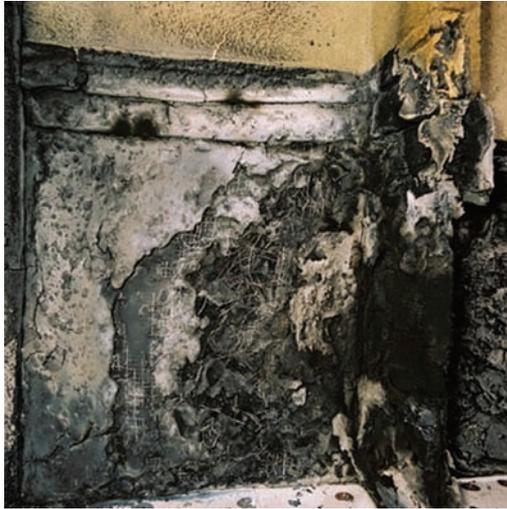
**Figure 9.** Left panel after test (11)

The left panel incorporated a stepped repair joint. On this joint, fully expanded firm char was formed that was intact except for a crack near the edge of the panel on the left hand side where a small gap was visible where the Chartek had come away from Mandolite (see Figure 9).

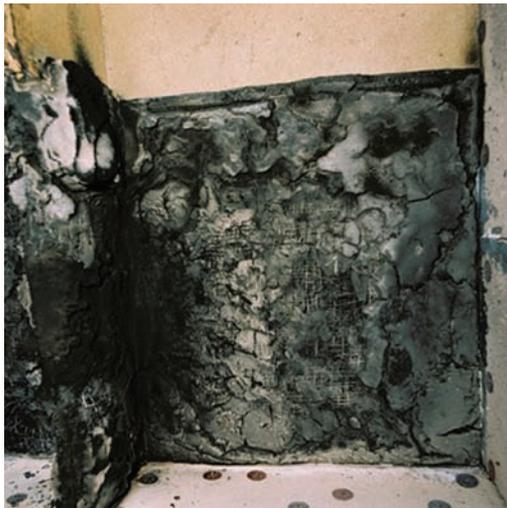
**Figure 10.** Right panel after test (11)

The right panel incorporated a chamfered repair joint. At the interface between the Mandolite 550 and chamfered Chartek VII (see Figure 10), the Chartek had not come away from the Mandolite. However, there was a slight crack along the base of the Mandolite and along the Chartek. On the right side of the joint the char was more eroded and the mesh was exposed over a small area.

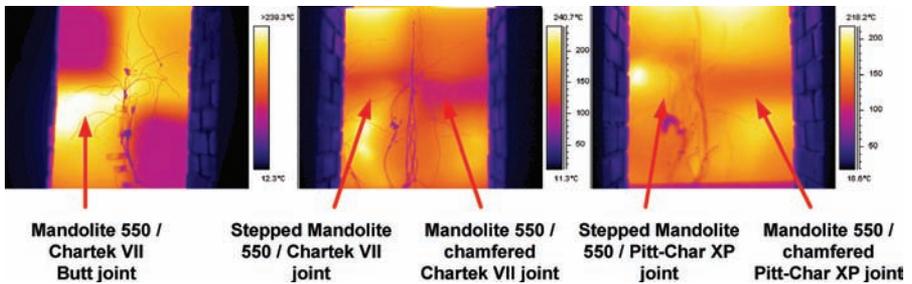
**Figure 11.** Thermal images (at 60 minutes) of repair joints

Overall, the temperature plots and thermal images indicated that, although both types of joint appeared acceptable, the chamfered joint performed better than the stepped joint. Thermal images comparing all three repairs are illustrated in Figure 11.
