HAZARDS IN THE MARITIME TRANSPORT OF BULK MATERIALS AND CONTAINERISED PRODUCTS

J B Kelman, Head, Fire and Explosion Department,
CWA International, Balmoral House, 9 John St. WC1N 2ES London.

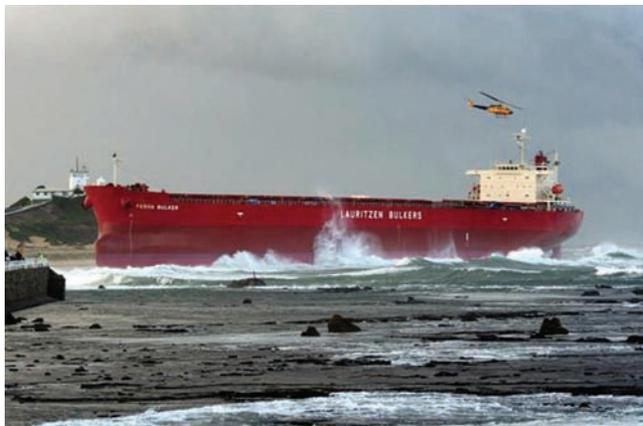
Groundings and strandings resulting from adverse weather tend to have more serious consequences. The recent events surrounding the *Pasha Bulker* in Australia show the danger in which a ship may find itself, even if, in this case there was no cargo onboard, see Figure 1. However, for the process industry relying, in this case, on coal, the extended stranding of the *Pasha Bulker* still resulted in costly delays. In the similar, earlier case of the *Sygna*, also waiting off Newcastle in adverse weather the result of the stranding was a total loss.

Figure 1. Pasha Bulker aground off Newcastle, Australia, 2007

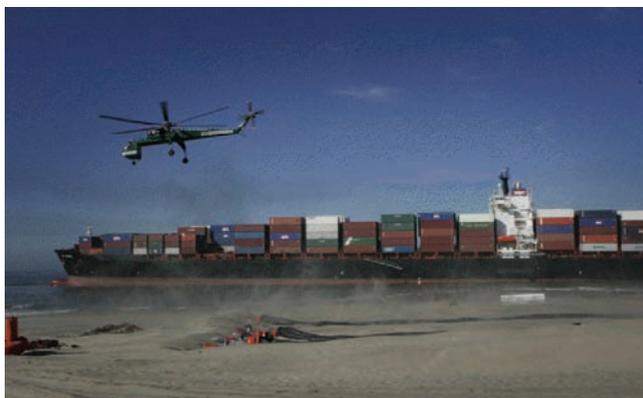
The subsequent trans-shipping of containers also exposes container cargoes to additional hazards through repeated non standard handling, such as helicopter lifts in the case of the *APL Panama*, see Figure 2, and poor security of containers in regions not designed for container storage.

Figure 2. Container removal from the *APL Panama* on Ensenada Beach, Mexico, January 2006

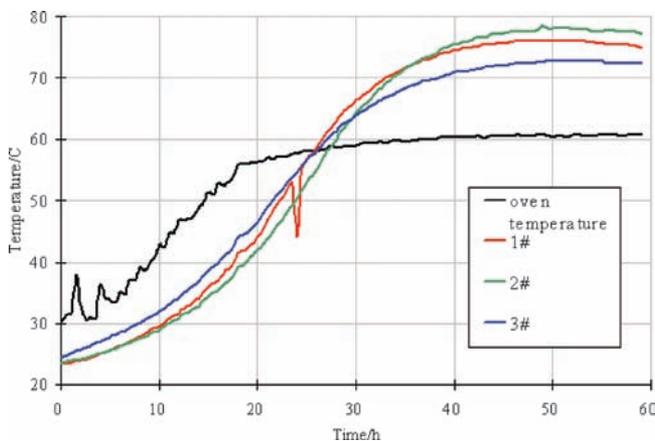
Figure 3. The self heating characteristics of Ni-MH batteries

Results from testing Ni-MH batteries when heated, indicate that at temperatures above 90 centigrade the batteries begin to vent hydrogen. This combination of thermal runaway and hydrogen venting provide a potentially disastrous combination of events in a confined space. Increasing temperatures and the release of hydrogen gas develop an explosive environment.

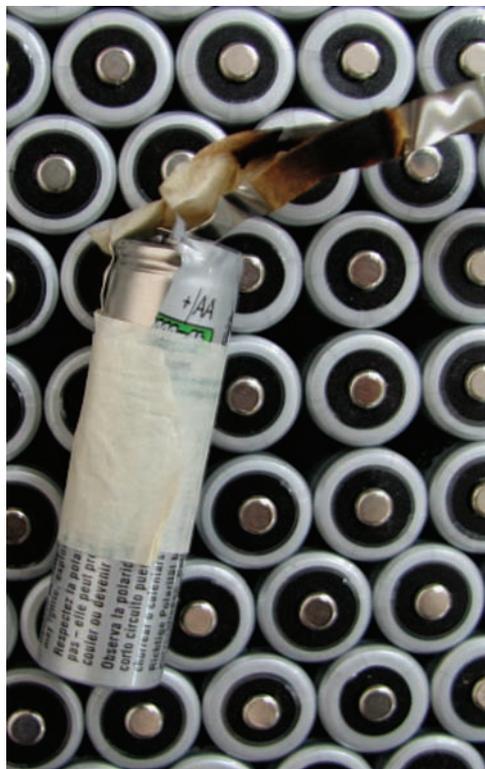
It appears most probable that the high fuel tank temperatures in the machinery space immediately below the container of batteries prompted them to undergo thermal runaway. The near sealed environment of the container prevented both the dissipation of the heat generated by the batteries and the diffusion of the hydrogen. Consequently the hydrogen build up occurred in close proximity to the heating batteries. Short circuit tests on Ni-MH batteries show that temperatures may be reached that will char and ignite paper. Figure 4 shows batteries close packed for shipping with two sample batteries placed on top. The batteries on top have been subject to a hard short circuit, which has caused to charring to the paper on the short circuit strip. The high discharge capacity of these types of batteries

Figure 4. Packaged batteries with hard shorted cell showing paper charring

mean that a short circuit is capable of generating temperatures high enough to ignite cellulose products. It is likely that the progressive heating of the batteries resulted in short circuits that provided the mechanism to ignite the now explosive mix of hydrogen in the container.
