DUST EXPLOSION IN SUGAR SILO TOWER: INVESTIGATION AND LESSONS LEARNT

On 21 July 2003 a dust explosion occurred in the Sugar Silo Facility at British Sugar Refinery in Cantley, Norfolk. The plant was not operational at the time of the explosion and was actually undergoing maintenance. This paper is produced by HSE/HSL and British Sugar and describes:

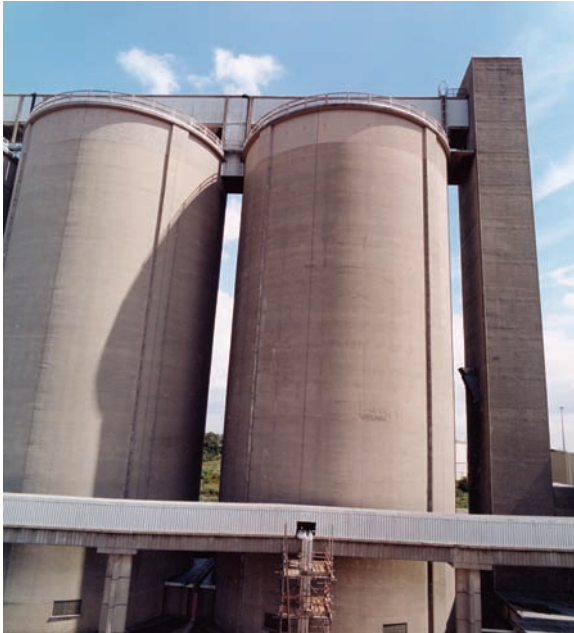
Figure 1. Photograph showing bucket elevator and adjacent silos

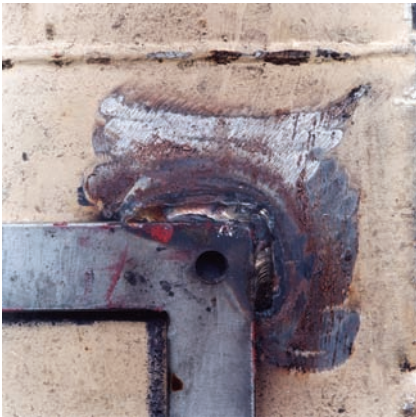
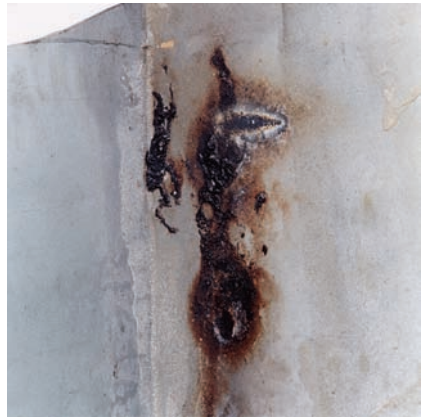
As already described, the work underway involved the welding of metal frames to the outside of the casing of the Silo Feed Elevator. Figure 2 shows a close up of a typical weld. This work was carried out under a permit and a risk assessment had been carried out. However, this risk assessment assumed that there was no potential for an explosive atmosphere because the plant was not operational, and hadn't been for some time, and the work was been carried out on vertical sections of the elevator well away from areas where any material may have settled.

Figures 2 & 3. Close up of weld on outside and inside of case showing burnt sugar residue around weld and second area away from weld

Figure 3 shows a photograph of a typical weld viewed from reverse side, inside the elevator, which clearly shows that the heat of the welding process had transmitted through to the inside of the casing. In addition, the photograph shows black residues of charred sugar. Almost every weld examined showed similar charred residues.

1. Greater care is required when carrying out hot work to avoid a repeat of this incident. In particular, consideration should be given to the presence or creation of a flammable/explosive atmosphere inside equipment when performing work on the outside.
2. Based on the K_{st} value measured for the sugar dust and guidance in the literature (Holbrow 2002)⁴, the level of explosion venting on the elevators needs to be increased.

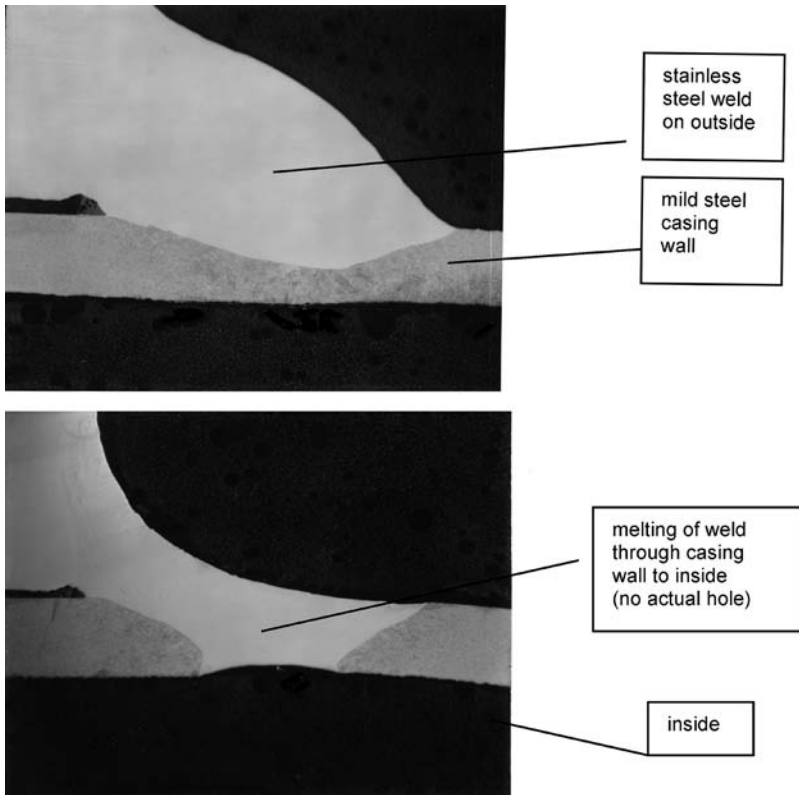
A metallurgical examination was performed on the section of the elevator being worked on at the time which showed that during the welding, molten metal had penetrated through onto the inside of the casing producing temperatures approaching 1500°C. This penetration (stainless steel through mild steel) is clear from the section through one of the welds shown in Figure 4.

Figure 4. Sections through welds on sample

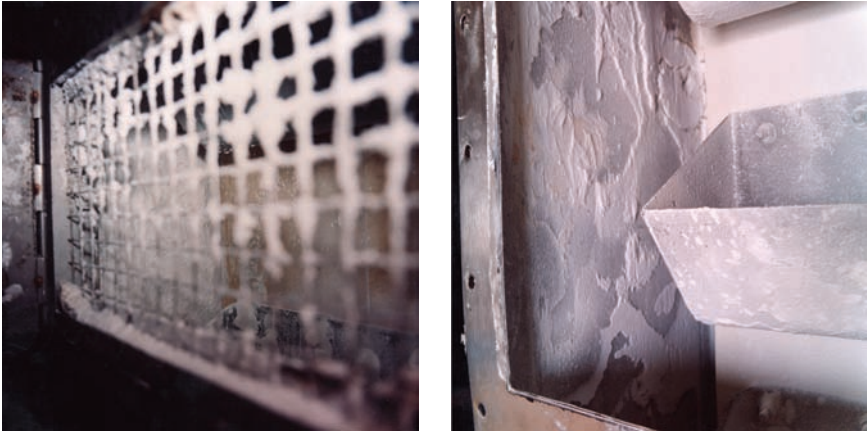
At the time of the explosion the plant was not operational. As already mentioned, there was evidence of sugar on the vertical surfaces inside the elevator system. The Lower Explosive Limit (LEL) for icing sugar/sugar fines is around 60 to 100 g/m³ (according to the BIA Report)¹. In this incident it was assumed that explosive atmosphere was provided from the sugar coating the interior of the walls of the elevator, ignoring any sugar dust on the elevator belt or in the buckets. Based on the dimensions for the elevator section the amount of sugar required was calculated to be approximately 12 g/m² of surface area. Using a volume packing fraction of 50%, this gives a layer thickness of approximately 0.5 mm to achieve the LEL. Figure 5 shows a photograph taken looking into the up leg of Import/Export elevator which was not involved in the explosion. Clearly, there is considerably more than 0.5 mm of sugar coating the inside of the elevator, and so if the Silo Feed Elevator were similar the LEL would easily have been achieved. Figure 6 shows evidence of similar deposits after the explosion in the Silo Feed elevator.

Figures 5 & 6. Photographs taken looking into the hatch on the Import/Export Elevator showing heavy build up of sugar on walls and up-leg of Silo Feed Elevator through hatch at Level 2.5 showing residual sugar fines on casing wall and bucket and less evidence of caramelisation

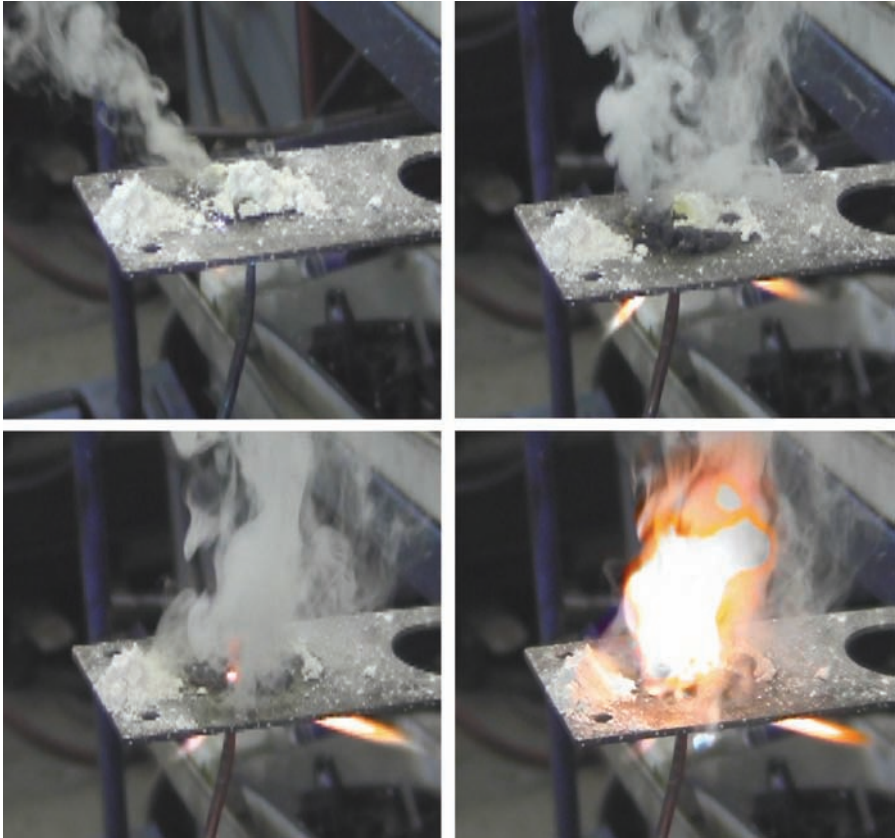
Figure 7 shows a series of frames from a video recording of a test heating a sugar sample on a 1.5 mm thick metal plate. The plate is heated below with an oxy-acetylene welding torch. The sequence of events shown is (1) the heating chars the sugar and produces flammable vapours, (2) When the metal beneath reaches red heat (as would have the case in the incident) the vapours ignite and cause sustained burning of the layer even when the welding torch beneath is removed. The third frame in the sequence (bottom left) shows the moment of ignition, a small flame kernel starting around the hot spot on the plate.

Figure 7. Frame grabs from video of heating of sugar deposits leading to ignition

However, it is also possible that the explosion did not commence immediately. A viable alternative sequence of events is that the sugar in contact with the heated region charred and then began to flame as demonstrated in the tests shown in Figure 6. This flaming could have persisted for several seconds and then ignited a cloud produced after a delay. This would have provided time for the welding work to finish and further work to

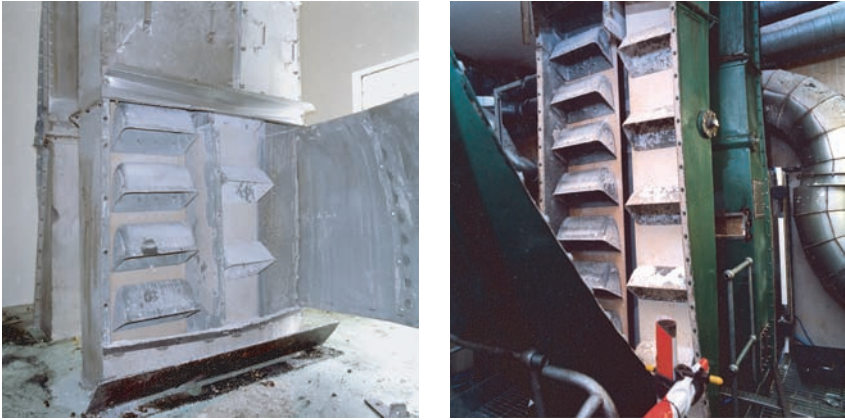
The explosion damage to the combined elevator becomes progressively more severe towards the base. At the top there was little, if any, damage apparent to the top (head) of the elevator. Moving down the elevator at level 2 where the damage is more apparent, both legs are clearly distorted and some panels have become partially detached on the up leg.

Figures 8 & 9. Damage to Production/Bulk Export Elevator on level 2 to Production/Bulk Export Elevator just above ground level

Figure 8 show the elevator one floor level above the base where the bottom panel shown has opened up on the up and down legs. Figure 9 shows the damage to this elevator just above ground level. The elevator case opened up here and vented the explosion into the area at the base of the tower destroying the wooden partitions, entering adjacent rooms, blowing the exterior door off in this area causing injury to a worker who was close by. It also pushed down the exterior wall, caused other structural damage indicating that the flat roof in this area lifted and then resettled.

Considering the Production/Bulk Feed Elevator, clearly much greater damage occurred suggesting a greater reduced explosion pressure was achieved than in the Silo Feed Elevator. From Holbrow et al (2002)⁴, an explosion in this elevator in isolation could again be expected to produce a reduced explosion pressure of approximately 1 bar using the same approach as above.

However, the damage to this elevator was much more severe because:

- i. The effects of the explosion in the Silo Elevator vented into and so pre-pressurised the interior of the Production/Bulk Export Elevator and produced a turbulent dust cloud. Although the authors know of no work on the effects of dust explosions in linked bucket elevators, the general principles of explosions in linked vessels are described by Holbrow et al (1999)⁵ entitled "Dust explosion protection in linked vessels: guidance for containment and venting". The high turbulence and higher pre-explosion pressurisation in the second vessel (in this case the second bucket elevator) combine to give a much higher K_{st} value. This in turn impacts on the effectiveness of the vents, much larger areas being required. This effect is illustrated by reference back to Holbrow (2002)⁴, which shows that for a K_{st} of 211 bar ms⁻¹ (20% increase) the reduced explosion pressure for a 12 m vent spacing is 3 bar and increases for greater vent separations. This in itself explains the severity of the damage. Note that secondary

- ii. The bucket spacing on the Production Elevator is much greater than for the Silo Feed Elevator, which would lead to greater explosion pressures according to Holbrow (2002)⁴.
- iii. Because of the wider casing of this elevator and apparently similar bolt spacing to the Silo Feed elevator, the former is probably weaker and so more susceptible to damage.

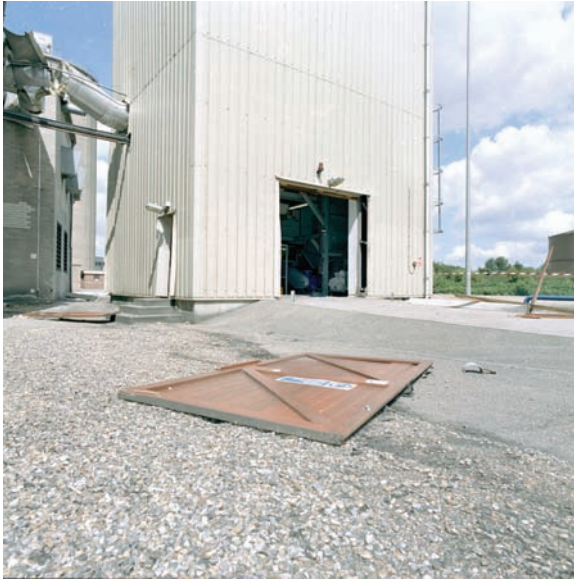
Figure 10. Building housing Airmaster filter. Note damaged ductwork at 3-way junction

At the end of the duct system is the Airmaster dust collection system. Both explosion vents on this system had operated and the filters and filter housing were disrupted. The doors of the building housing the dust collector had been blown off their hinges (see Figure 10). The ducting in this area was severely damaged. At the rear of the building a hole had been blown in the cladding where a piece of the ducting from inside had been blown through the wall and projected for tens of metres across the area outside.

Because the casing of the Production/Bulk Export Elevator failed, the explosion vented in to the space at the base of the tower causing damage and injury. In addition, the explosion entered the Import/Export area of the plant causing damage and starting a fire. The explosion then propagated through to the Airmaster filter system where again pressure-piling and enhanced turbulence would have led to higher K_{st} , so that explosion vents were inadequate and reduced explosion pressure was greater than allowed and damage resulted.
