ABNORMAL OCCURRENCE: IRON REDUCTION

PJ DUGGAN

Zeneca Specialties, P.O. Box 42, Hexagon House, Blackley, Manchester, M9 82S

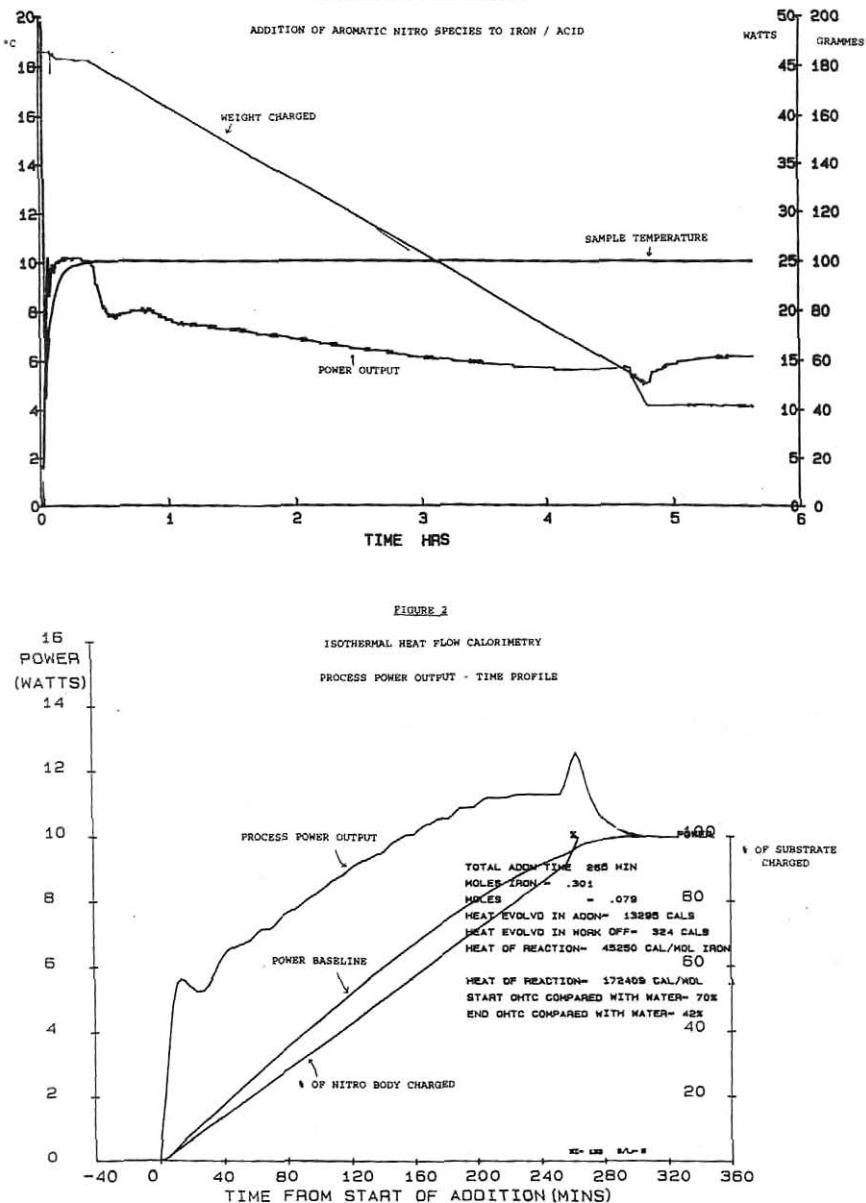
As part of the routine hazard assessment, the process was examined in a power compensation heat flow calorimeter. Figure 1 is the raw data output and shows the addition rate of the aromatic nitro body together with the corresponding power output profile for the process carried out at 10°C. It can be seen that the addition was carried out over four hours and that the evolved process power output was immediate with little indication of any accumulation of reagents having occurred.

In order to determine the effect of the change in grade of iron, the heat flow calorimeter experiment was repeated using old grade iron. The power output trace was found to be identical to the original power output trace, ie figure 1 in which there was no indication of any accumulation of materials.

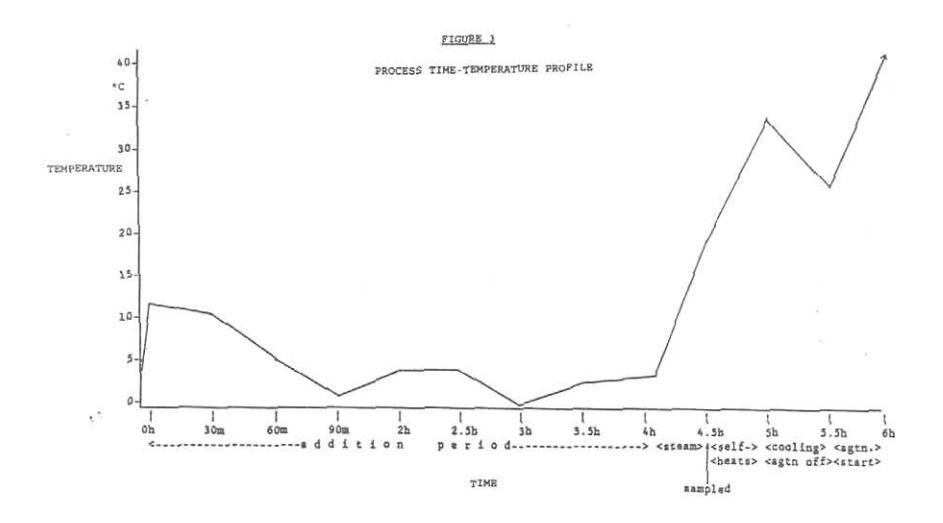
On the day of the abnormal occurrence, the addition of the aromatic nitro species had been carried out as usual, ie over four hours to the batch at 0 to 5°C. The addition was started with the batch at about 5°C and was accompanied by an initial temperature spike of about 5 to 10K before the batch temperature was brought under control by the vessel cooling system, see figure 3. Accordingly it was assumed that the reaction was progressing in the normal manner.

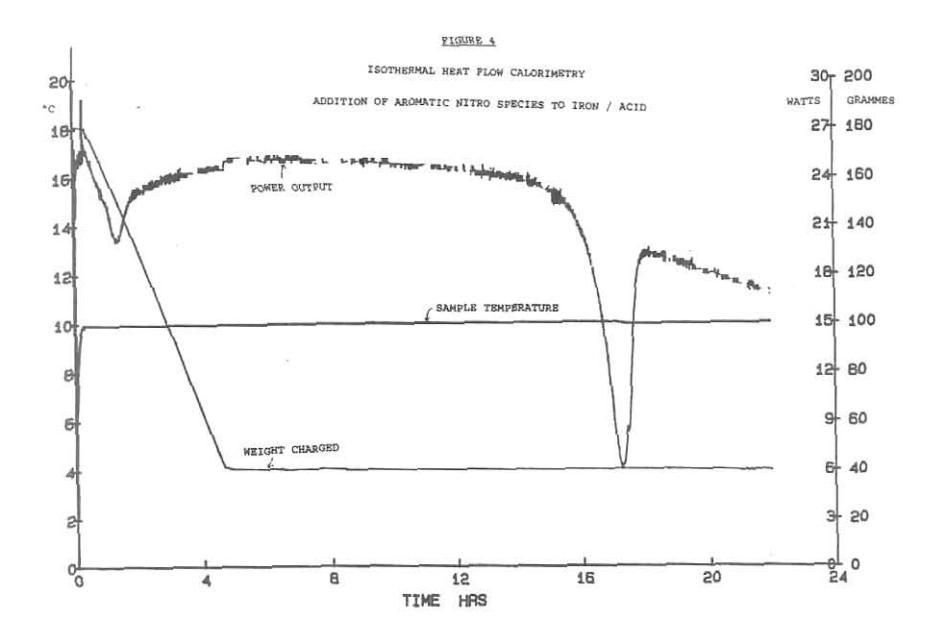
The original heat flow calorimeter experiment was repeated using the same materials as used in the incident batch. Figure 4 shows the rate of addition of the nitro body to the batch and the resultant power output profile from carrying out the addition at 10°C. The power output trace shows that when the addition was started it was accompanied by an exotherm. This is normal behaviour. However, after about 30 minutes the amount of evolved process energy decreased suddenly and no further process energy was evolved throughout the addition period. The batch was then agitated at 10°C for a further 12 hour period when suddenly a very strong exotherm was found to occur. Analysis of the heat flow process power output trace showed that 70 to 80% of the total process power output occurred in the second exotherm period.

Following the heat flow calorimeter experiment, the result of which were in accordance with the incident batch, we looked for an explanation as to why the reaction has suddenly stopped part way through the addition. The incident batch was the first batch in a new campaign which was to consist of several batches. The supplier of iron had advised us of a change to the specification of iron and now the material was supplied in a finer, ie larger surface area, grade.

The new grade was examined further and perhaps due to the greater activity of the finely divided material the surface of the iron was found to be oxidised to an extent of about 75%. This is in line with the amount of accumulation which resulted from its use in the reduction acetylation process.
