# The explosion of No. 5 Blast Furnace, Corus UK Ltd, Port Talbot

8 November 2001

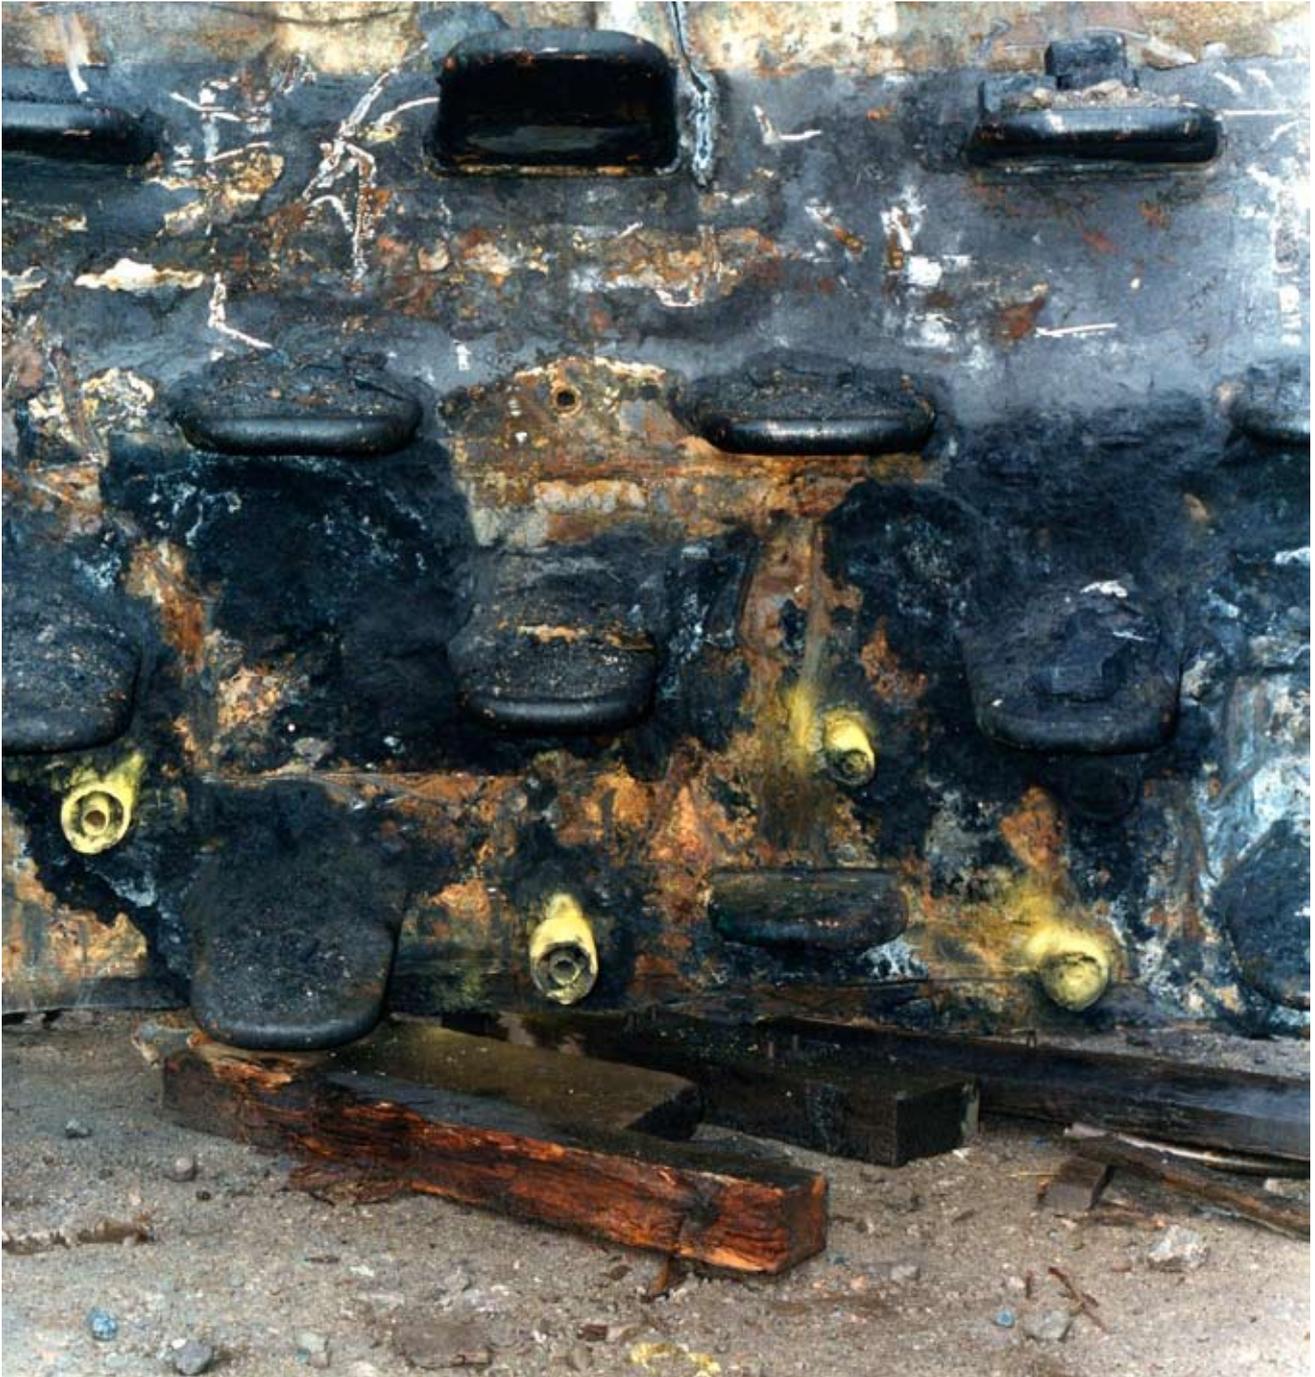
**Figure 9** Examples of coolers: a section of dismantled furnace shell (minus the refractory lining). The yellow-sprayed coolers are Sorrelors, the darker lozenge-shaped coolers are plate coolers

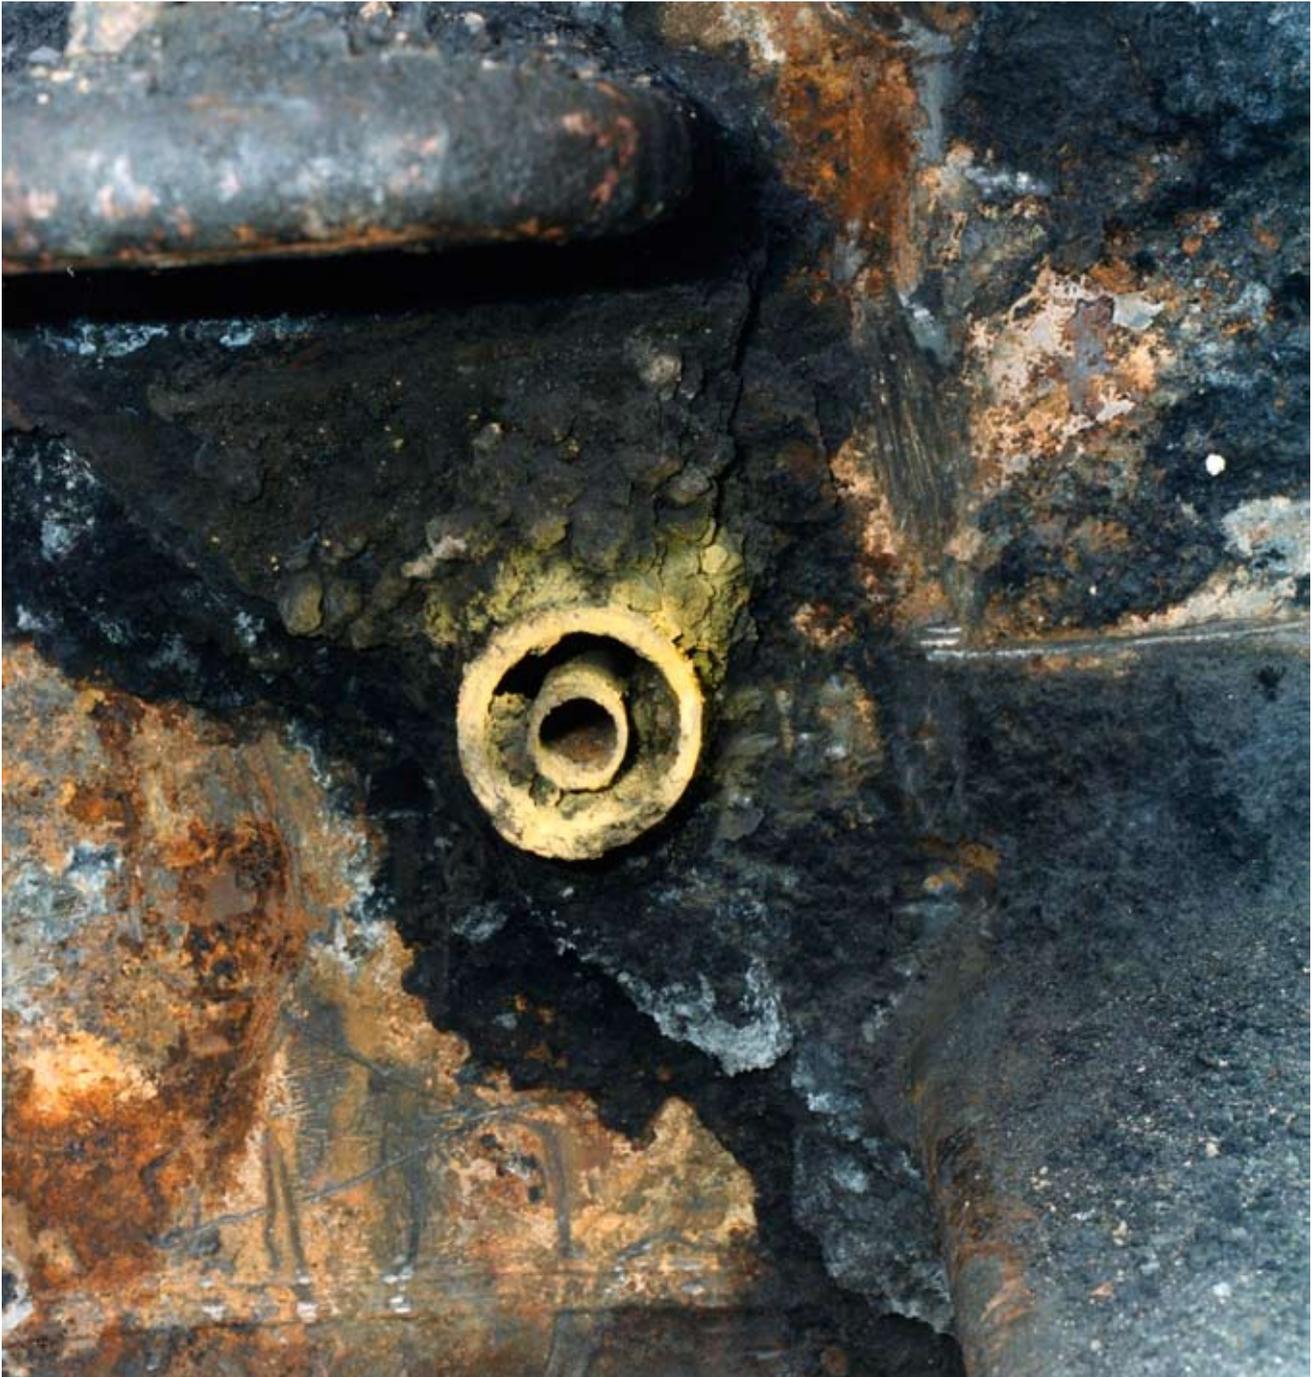
**Figure 12** Example of burnt-out Sorrelor cooler

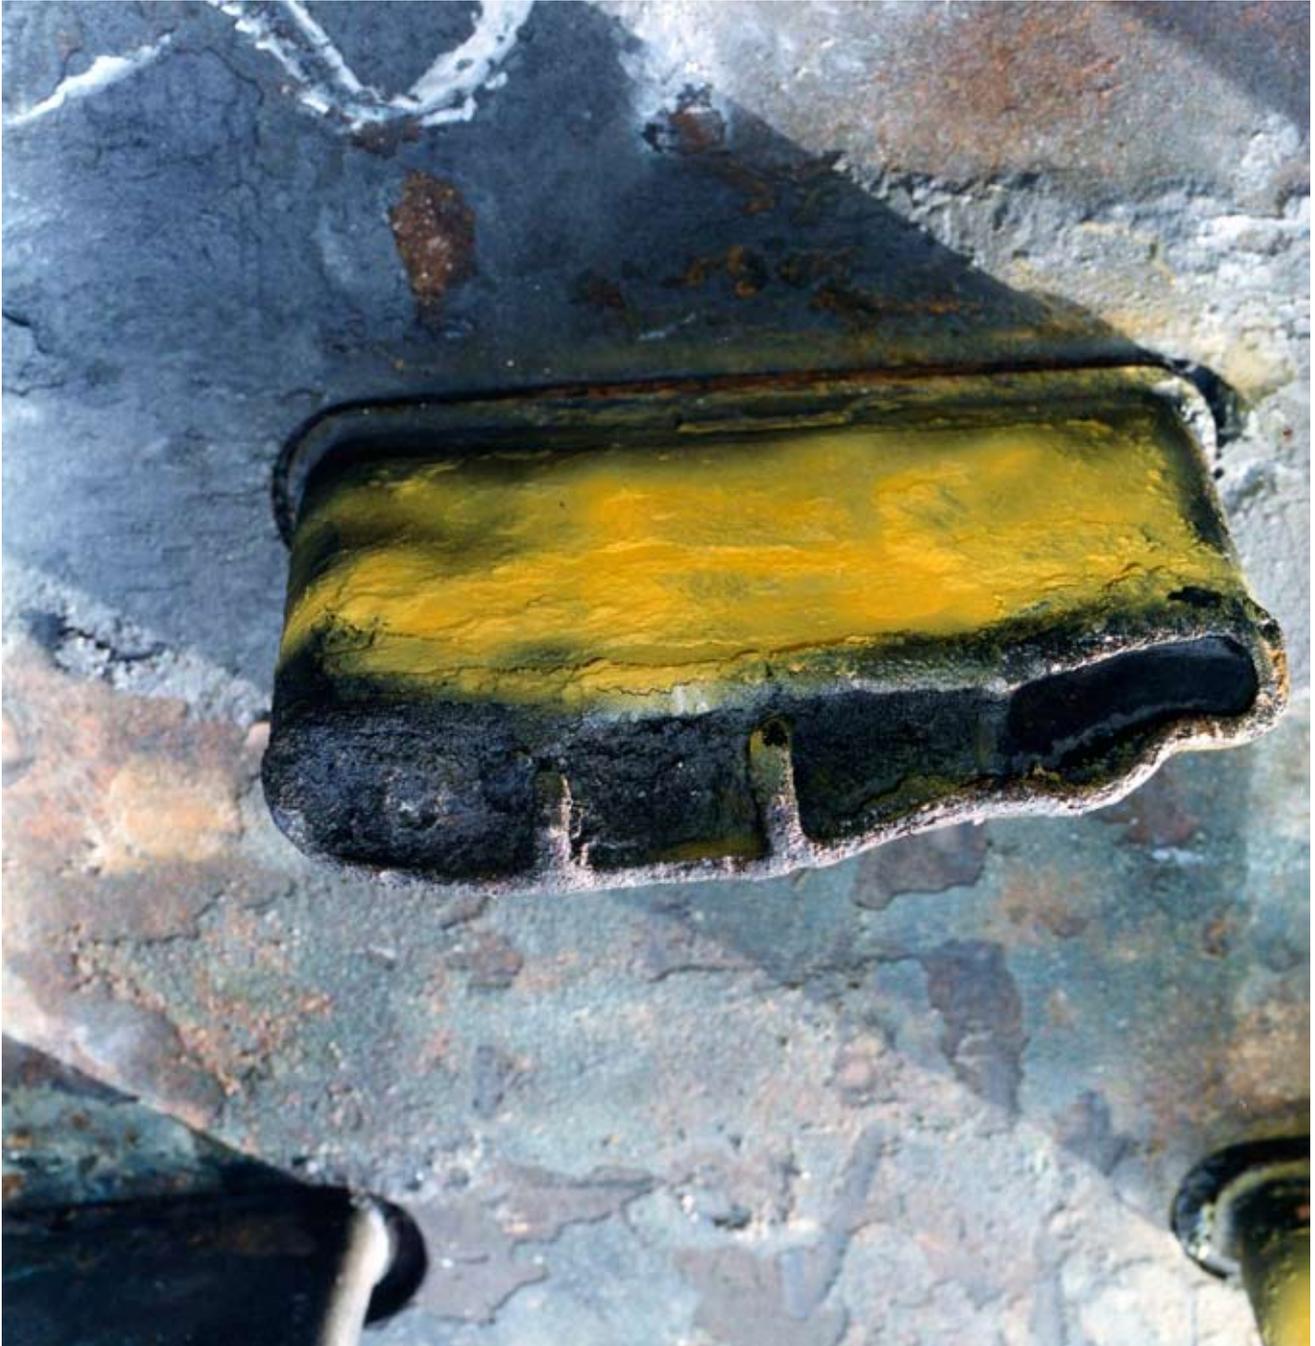
**Figure 13** Example of burnt-out plate cooler

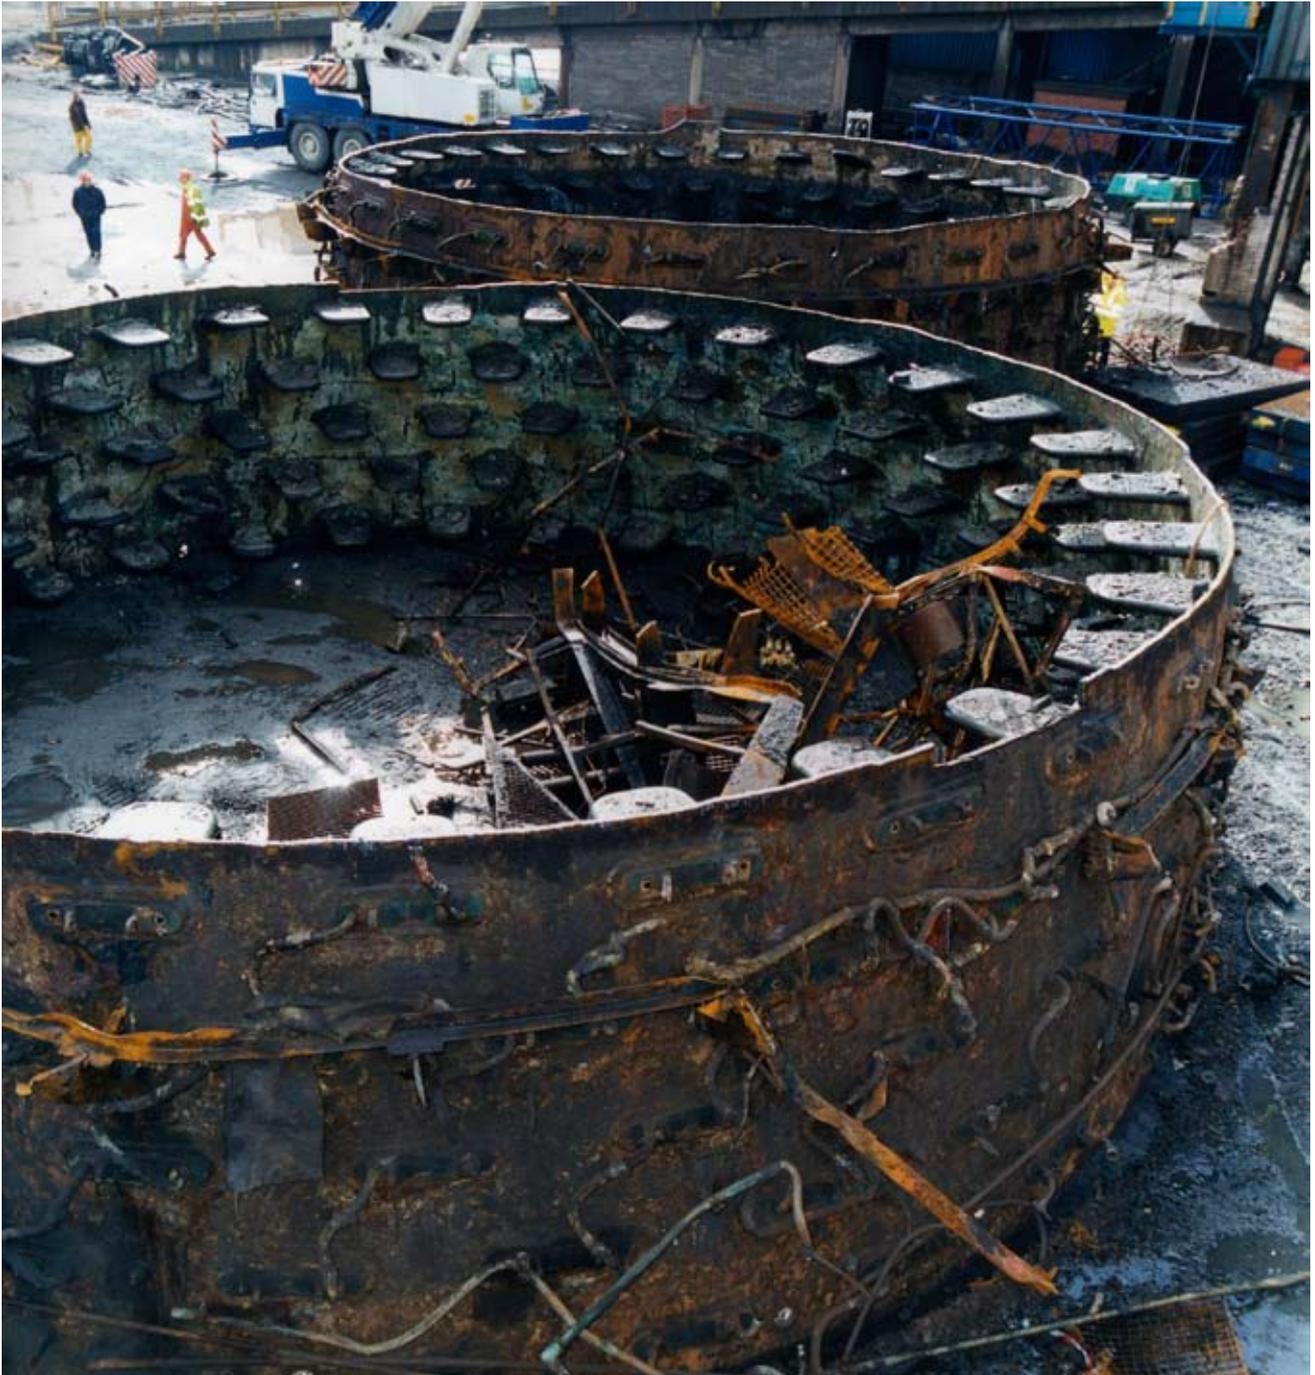
**Figure 14** Dismantled furnace section showing coolers

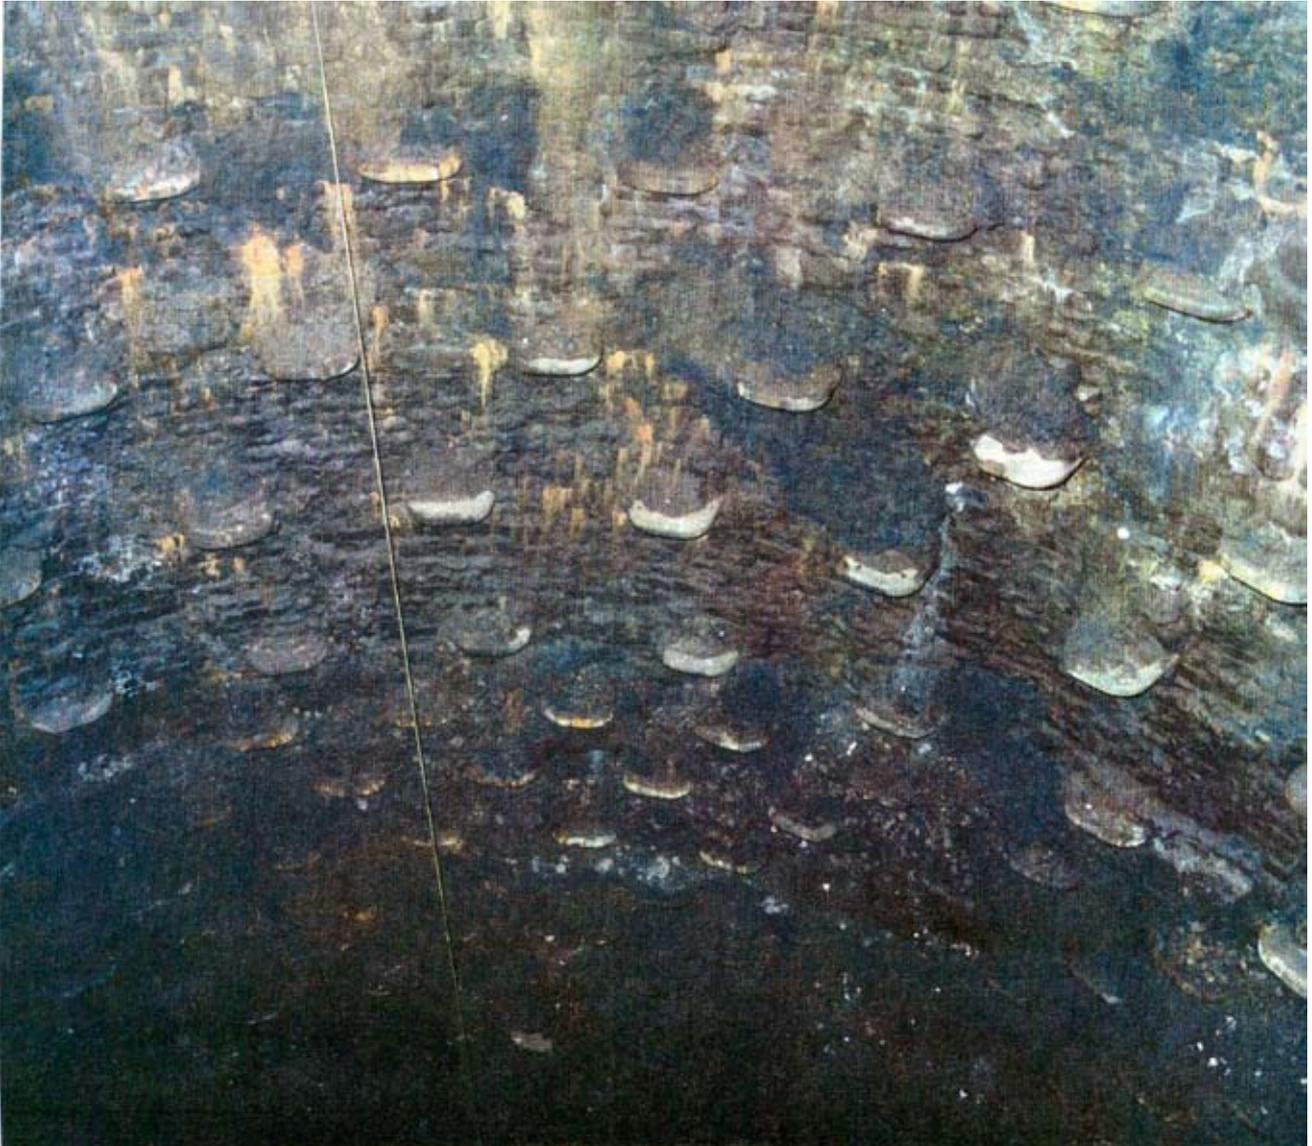
**Figure 15** Interior of furnace stack prior to refractory removal
