ALKOXYLATION RUNAWAY REACTION INCIDENT AT BAKER PETROLITE, HARTLEPOOL

S. Gakhar*, D. Carr†

On 12th October 1999, a runaway reaction occurred in a 22 m³ reactor during an alkoxylation reaction using Propylene Oxide. The subsequent pressure increase caused the bursting disc to rupture and a few tonnes of Propylene Oxide was released to atmosphere. The release occurred despite the presence of a knockout pot designed to capture released material. Although the incident caused no injury and only minimal plant damage, it did result in substantial costs both in terms of investment in corrective measures, and business loss. The incident and its causes are described along with improvement measures implemented to prevent recurrence and provide better protection against overpressure and environmental release. Improvement measures included improvements to process control, a re-design of the pressure relief system of all reactors in the plant, and the installation of a quench tank. The methodologies used to design the improvement measures are described. The paper also describes a later incident which provided a full scale test of the new quench tank.

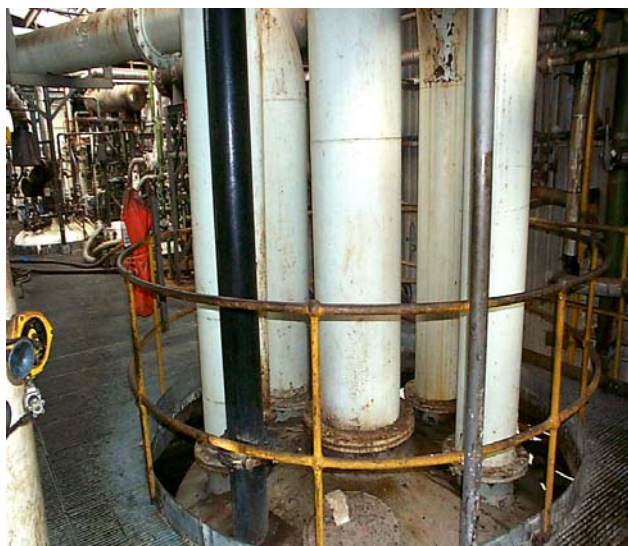
V7 was a vertical vessel of approximately 27 m³ in volume and atmospheric pressure rated. It was located inside the reactor building and contained approximately 2000 kg of water (intended to provide some degree of quench and dissolution of EO or PO) maintained at a constant level by a ball cock level control device. Each of the six reactor vent lines entered the knockout pot separately. The outlet from the knockout pot was 0.6 m diameter and routed vertically to atmosphere via the roof of the building in which the reactors were housed. The discharge height was approximately 10 m above ground.

Figure 1. V7 knockout pot

Prior to the incident, Baker Petrolite had six stainless steel reactors of varying capacity in their reactor plant building. Most of the reactions carried out in these reactors involved Alkoxylation reactions, although other products were also made. Four reactors have top entry agitators and two reactors have external re-circulation loops. Each reactor was protected from overpressure by a relief system comprising of a graphite bursting disc and a vent line. Each vent line was routed independently to a common knockout pot (V7). A Photograph of V7 is given in figure 1.

This incident clearly showed that the knockout pot (V7) was ineffective and steps were taken to commission the design of a replacement.

One of the most important improvement measures was how to prevent further releases of PO or EO to the atmosphere. Clearly V7 was ineffective as a knockout pot as it contained very little of the relieving fluid during the incident. Because of the high volatility of EO and PO, it was decided that in the event of pressure relief, EO or PO would flash to vapour and thus a knockout pot or catch tank would be ineffective in preventing atmospheric release. However, EO and PO are highly soluble in water, so it was decided to design and install a quench tank. A quench tank has a number of advantages over a simple knockout pot in that it would

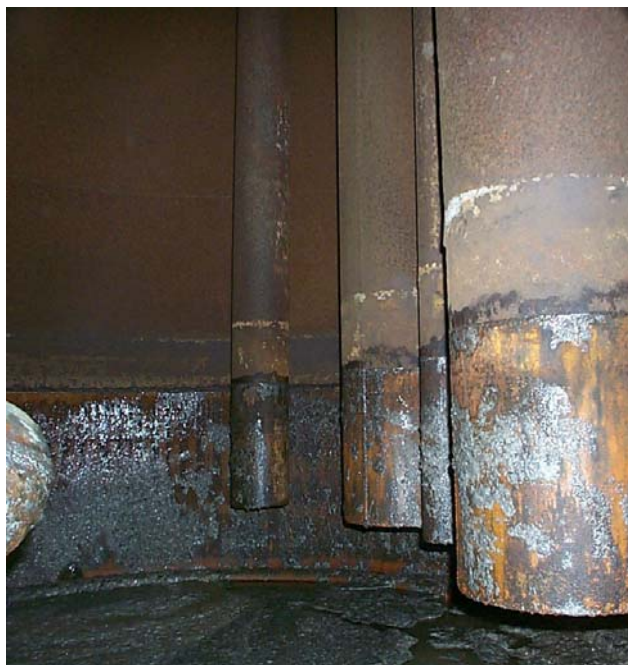
A mass balance indicated that approximately 4775 kg of liquid and vapour was released to atmosphere. This included approximately 1300 kg of water from the knockout pot. This indicated that about 3475 kg was lost from reactor V6. The water in V7 was removed probably by a combination of vaporisation and displacement. The amount of pure PO released to atmosphere was difficult to determine. Subsequent calorimetry on a similar process indicated that in order to reach the disc burst pressure, approximately 30–40% of the PO charged would need to accumulate and much of this would have relieved to V7 due to its volatility. This would have amounted to a few tonnes. It was difficult to predict how much pure PO was released to atmosphere as some may have reacted with water in V7 to form Propylene Glycol. However, due to the short contact time and design of V7 (dip tubes into water only) only a fraction is likely to have reacted so much of the PO remaining in the reactor was assumed to have been released to atmosphere.

The amount of material released from V6 was about 30% by weight of the total. This indicated that homogeneous two-phase flow almost certainly didn't occur although some liquid was entrained in the venting stream. There was no visible damage to V6, V7 or the vent line from V6 to V7. In addition, V6 passed a subsequent pressure test indicating no distortion of flanges etc. Although this didn't necessarily indicate that the relief system was adequately sized i.e. design pressure not exceeded, it did demonstrate that the relief event didn't subject V6 to a pressure beyond its yield. Lack of any visible damage to V7 was perhaps more surprising due its atmospheric design pressure rating. This was probably attributable to the fact that the discharge line from V7 was large in diameter i.e. 0.6 m, straight and short in length, thus giving minimal back pressure. Figure 2 shows the internals of V7 after the incident. The original water level can be clearly seen from the watermarks on the dip pipes.

Figure 2. Inside of V7 after incident

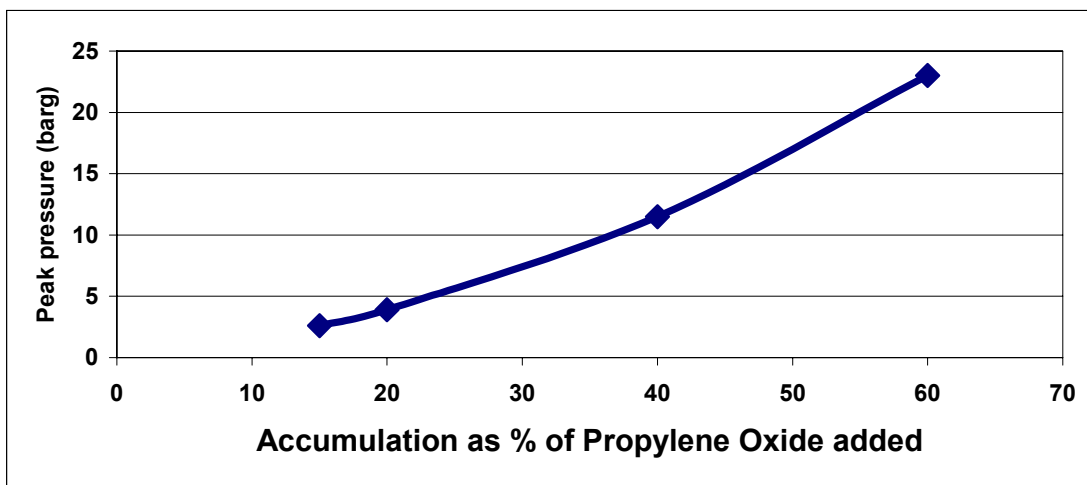
Adiabatic dewar calorimetry was carried out on a similar PO process to determine the effect of accumulation of PO on peak reaction pressure and rate of temperature and pressure rise. The results are presented in figure 3. The minimum reactor design pressure is 8.6 barg and the disc burst pressure is 7.7 barg on all reactors. This indicates that provided the accumulation is not allowed to increase beyond about 30%, the disc burst pressure shouldn't be exceeded. Subsequent isothermal calorimetry indicated that addition of PO at 60°C and at the then maximum allowable feedrate of 3500 kg/hr, resulted in accumulation levels at least as high as 40%. Using DIERS methodology^{2,3}, the required vent diameter at 40%

accumulation was calculated to be 0.7 m. The vent diameter on V6 and other similar sized reactors was 0.3 m and it was not practical to increase to 0.7 m due to space restriction on the reactor top dish.

Figure 3. Peak reactor pressure as a function of propylene oxide accumulation

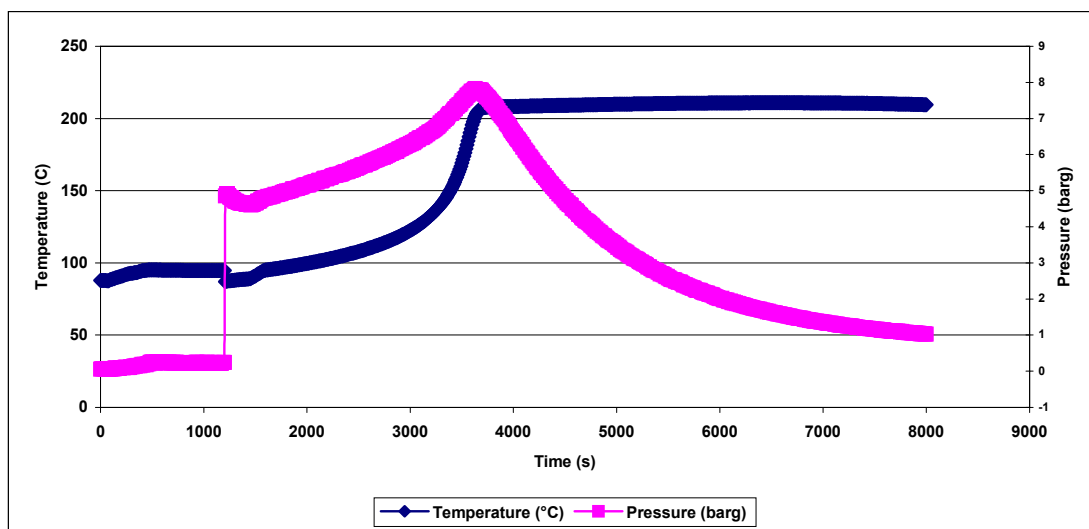
A detailed risk assessment was then carried out for the process involved in the incident. One of the outcomes of this assessment was to review the low temperature trip settings and maximum allowable feedrates of EO and PO. Further calorimetry work was undertaken. At 95°C, isothermal calorimetry showed that addition of PO or EO at a maximum rate of 2000 kg/hr would result in a maximum accumulation level of about 15% i.e. 15% of the reaction heat was released at the end of the addition of PO/EO. From figure 3, this indicated a peak pressure of 2.6 barg for the PO product tested, which is below all reactor design pressures. The equivalent maximum pressure in the case of EO (based upon a typical process) was 7.8 barg, again below the design pressure of all the reactors, although not below the disc burst pressures. The adiabatic results for EO at 15% accumulation are shown graphically in figure 4.

Figure 4. Adiabatic dewar data for a typical EO reaction at 15% accumulation

As a result, the low temperature trip was increased to 95°C. In addition, restrictor orifices (ROPs) were fitted to the EO and PO feed systems to restrict feedrates to 2000 kg/hr. Whilst it was shown that 2000 kg/hr was acceptable as a maximum feedrate, 1500 kg/hr has been adopted as a maximum operating rate to provide an additional margin of safety particularly for the EO processes and to keep peak pressure below disc burst pressure. A margin of safety was also required to account for the fact that the PO and EO processes tested were being assumed to be representative of a range of PO and EO reactions carried out. However, the two selected were considered to be worst case representations of the PO and EO processes respectively. The ROPs, low temperature trips and agitator sensors and interlocks are clearly safety critical in terms of preventing accumulation to levels whereby a relief system upgrade was not required.

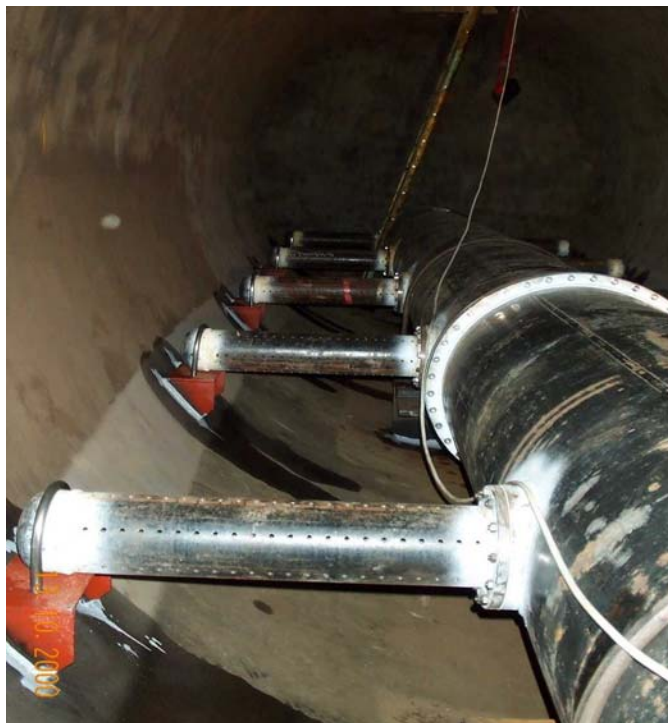
To design the sparger for the tank, guidance given in the CCPS guide on Pressure Relief and Effluent handling⁵ was used. This was found to be a very useful and practical source of information. The final design consists of a central manifold made of 0.76 m diameter pipe, with twelve 0.15 m diameter pipe branches. The holes were drilled into the branches uniformly around the circumference to even out reaction forces as much as possible. In total, 1540 holes of 10 mm diameter were used. The final sparger arrangement inside the quench tank is shown diagrammatically in figure 5.

A sparger with side arms was used to maximise contact area with the quench fluid. A single central pipe would probably have been adequate but this wouldn't have as good use of all available water volume and would thus be less efficient. The sparger was positioned as low as possible within the tank to maximise depth of submergence and thus maximise the likely contact time for heat and mass transfer. However, the sparger had to be positioned sufficiently far above the base to permit the side branch length to be long enough to fit on the required number of holes whilst achieving minimum hole spacing in line with recommended guidance. All in all, the design process was iterative.

Figure 5. Sparger inside new quench tank

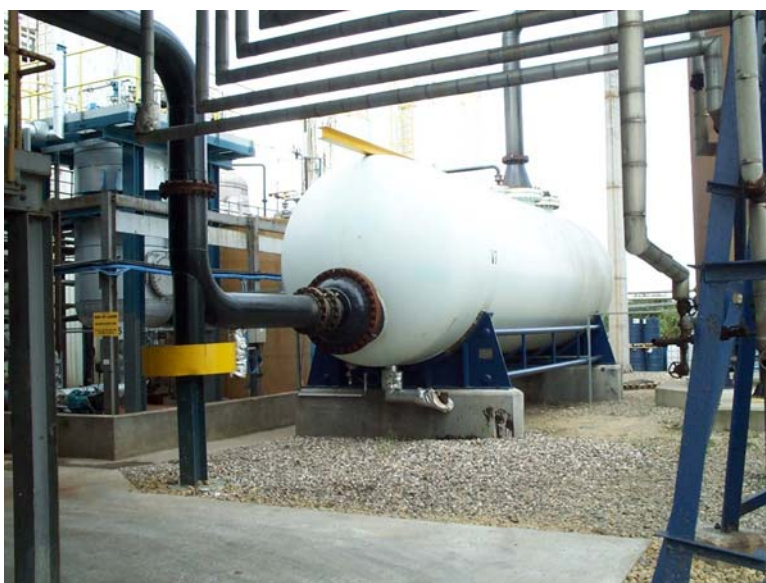
The relief line from the reactors entered axially primarily to facilitate installation of the 0.76 m central manifold into the tank. The side branches were fitted onto the central

manifold within the tank. This required construction of a new manway on one dished end of the vessel. The design pressure rating of the tank needed to be maintained. Special supports were designed to secure the sparger arrangement within the tank to withstand likely reaction forces. The tank itself rested on saddles and it was shown that the friction generated by the weight of the tank would be sufficient to withstand axial reaction forces as the vented liquid first came into contact with the quench fluid. However, additional restraints were fitted to provide greater security. The final installed quench tank is shown in figure 6.

Figure 6. New quench tank

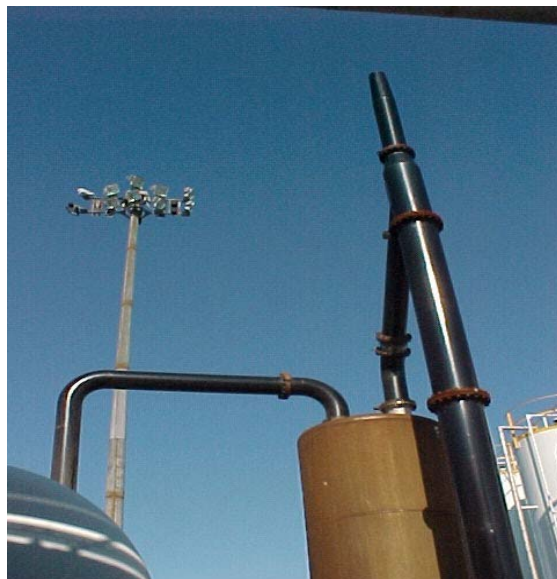
Another factor to consider was the effect of the nitrogen padding in the reactor. The nitrogen wouldn't be dissolved within the quench fluid and would need to disengage from the liquid. Because the reaction products were effectively surfactants, it was considered likely that some foaming would occur during sparging. It was considered possible that the foam would prevent disengagement of the nitrogen gas without carry over of foam out of the new tank. Whilst release of foam to atmosphere did not carry a high risk, it was considered unacceptable to risk any release to atmosphere. For this reason, a second tank was installed to catch any foam or liquid which might get entrained by the nitrogen. Installation of this tank was an accepted option for the Health and Safety Executive. A photo of the second containment tank is given in figure 7.

After consideration of wake effects of nearby tank farms, it was decided to install a stack of 0.6 m diameter, 15 metres high with a 0.3 m diameter tip to increase vertical velocity and aid dispersion. This gave a comfortable clearance of the LFL/2 plume envelope from the light and other obvious ignition sources. Also, at no point would the ground level concentration have exceeded the IDLH concentration. The final stack design is also shown in figure 7 in relation to the elevated light.

Figure 7. Secondary containment vessel and vapour discharge stack

The next step was to design the final atmospheric stack from the second containment vessel. It was decided to adopt a pessimistic approach and design the stack on the basis that no EO would be absorbed by the quench fluid. Dispersion modelling was performed using PHAST version 6⁶. The modelling considered the stack height and diameter required to avoid a potentially flammable cloud impinging upon a nearby elevated light. It was also necessary to avoid ground level concentrations both on and offsite which could cause acute harm to people. The concentrations of interest were the Lower Flammable Limit (LFL) for flammable effects and the Immediately Dangerous to Life and Health (IDLH) concentration for toxic effects. For EO, these concentrations were 30000 parts per million (ppm) and 800 ppm respectively. To provide an added margin of safety, the flammable cloud at LFL/2 was modelled. Weather conditions 1.5F and 5D were used which are present 70–80% of the time in the area.

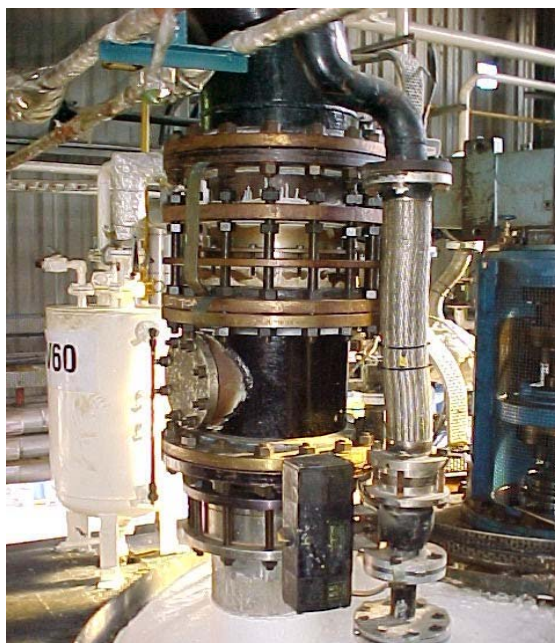
The most difficult challenge was in the design of the flexible connections. Bellows joints were not capable of withstanding the reaction forces, particularly in the event of two-phase flow. The final design used a vertical sliding joint arrangement, which provided just enough movement to allow correct function of the load cells at the same time providing sufficient strength along its axis to withstand at least 20 tonnes force. An example of the final design is given in figure 8. Prevention of discs rupturing in the reverse direction required consideration of two factors

Due to the complexity of the system and the wide range of likely relief scenarios and products, it was difficult to evaluate such pressures with confidence. However, the existing graphite discs had a reverse pressure capability of only a fraction of the forward burst pressure. Therefore it was decided to replace the discs with stainless steel reverse acting discs of a design to provide a higher reverse pressure strength than forward burst strength. This was certainly adequate to handle the maximum vent static pressure which would not exceed forward burst pressure. It was estimated that the fluid static pressure when it first contacted the quench fluid would be about 4 barg. The reverse pressure capability of the new discs was in excess of 8 barg which was more than twice the static pressure at the point of quench fluid contact. This was considered adequate in the absence of a more complex analysis. In order to inspect the discs in situ, a manhole was installed as shown in figure 8.

Figure 8. New sliding joint arrangement on pressure relief pipework
