HOW TO POUR PRODUCTS ON THE FLOOR OR DOWN THE DRAIN

No. 139

IMPERIAL CHEMICAL INDUSTRIES LIMITED
PETROCHEMICALS DIVISION

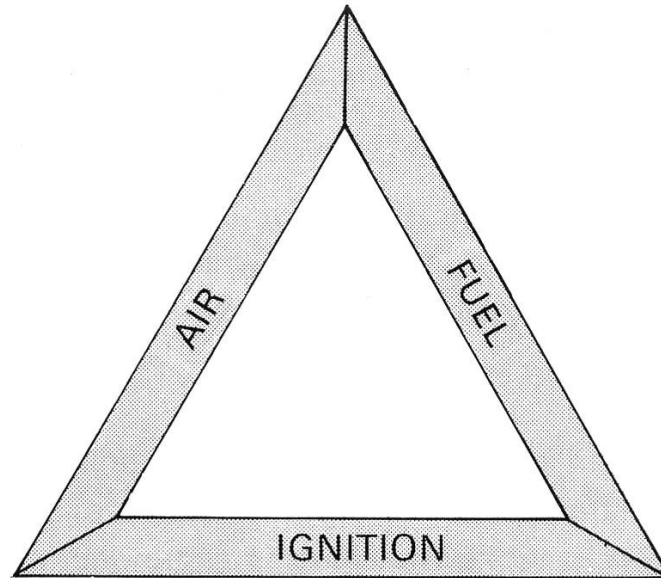
WHAT IS WRONG WITH THIS DIAGRAM?

This fire triangle is familiar. For a fire or explosion we need AIR, FUEL and a SOURCE OF IGNITION. Take one away and the fire cannot occur.

Though true in theory, this is not true in an industrial situation. Once fuel and air are mixed in the right proportions, a source of ignition is liable to turn up. So we should never allow fuel and air to mix in flammable concentrations, except in a few cases where the risk is accepted.

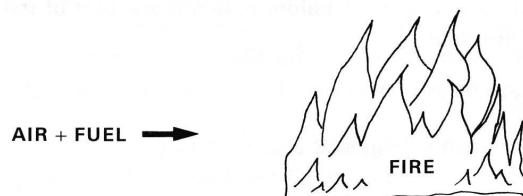
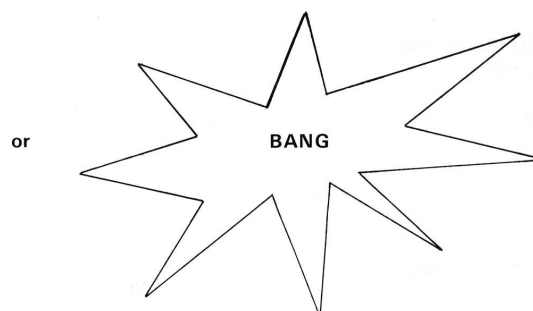
Instead of the fire triangle, I suggest
