THE BEHAVIOUR OF MASONRY AND CONCRETE PANELS UNDER EXPLOSION AND STATIC LOADING *

M Beak, S A Colwell, D Crowhurst, and B R Ellis
Building Research Establishment, Bucknalls Lane, Garston, Watford, WD2 7JR

This paper describes tests on masonry and reinforced concrete panels undertaken to examine how these panels fail under loads generated by gas explosions and static pressure. The strength of the panels was calculated using traditional yield line theory and compared with results obtained from explosion and static tests. The failure pressure of the panels under dynamic load did not compare well with the failure pressure from the static tests or the yield line calculations. It is concluded that using static tests and quasi-static load approximations for determining the response of the panels to a dynamic load are not appropriate and could underestimate the load bearing capacity of masonry and concrete panels subjected to lateral loads.

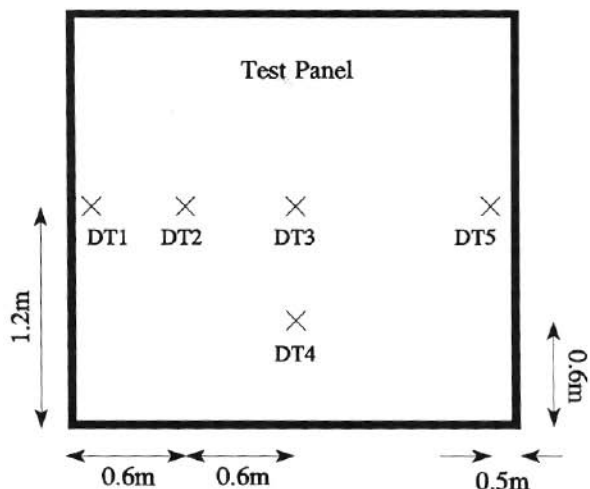
Figure 1. Displacement Transducer locations

During each explosion, the internal pressure/time history and the displacement/time history of the panel were recorded. Figure 1 shows the locations of the displacement transducers on the panel. High speed film, video and photographic records were taken of each test.

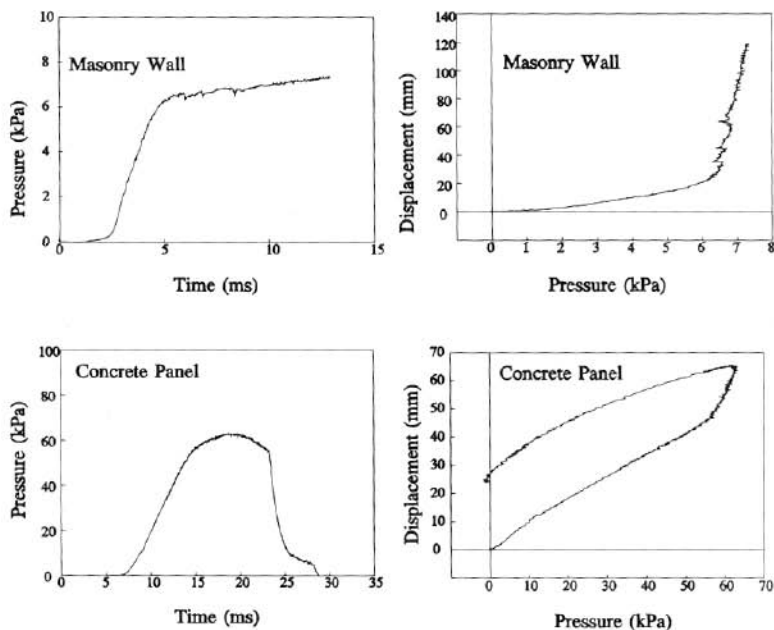
Figure 2. Pressure/time and Displacement/time curves for static tests on masonry and concrete panels

The pressure/time histories for the static tests on Masonry Panel 4 and Concrete Panel 4 are presented in Figure 2. The corresponding displacement/pressure curves are also shown.

Despite the damage caused by the first static test, the pressure/displacement curve for the second test, (see Figure 2), shows that the displacement increased almost linearly with pressure up to approximately 52 kPa. Above 52 kPa the displacement increased much more markedly for relatively small increases in pressure.

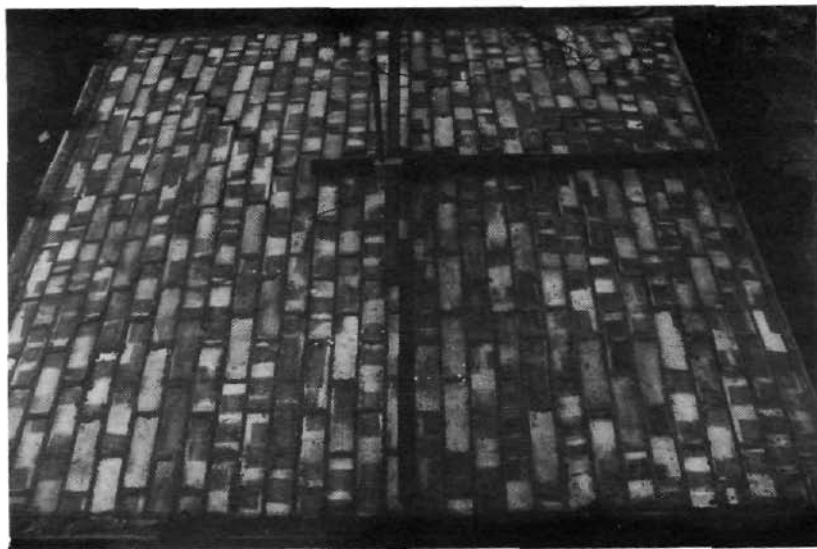
Figure 3. Failure of masonry wall during static test

Under static load the displacement of the masonry panel initially followed the pressure increase, increasing slowly, although not quite linearly. Above approximately 7 kPa, the estimated failure point of the panel, the displacement increased much more rapidly with increased pressure, this behaviour was as expected. The failure mode of the panel is shown in the photograph in Figure 3. A 'yield line' failure pattern is observed which was similar to those obtained for the explosion tests.

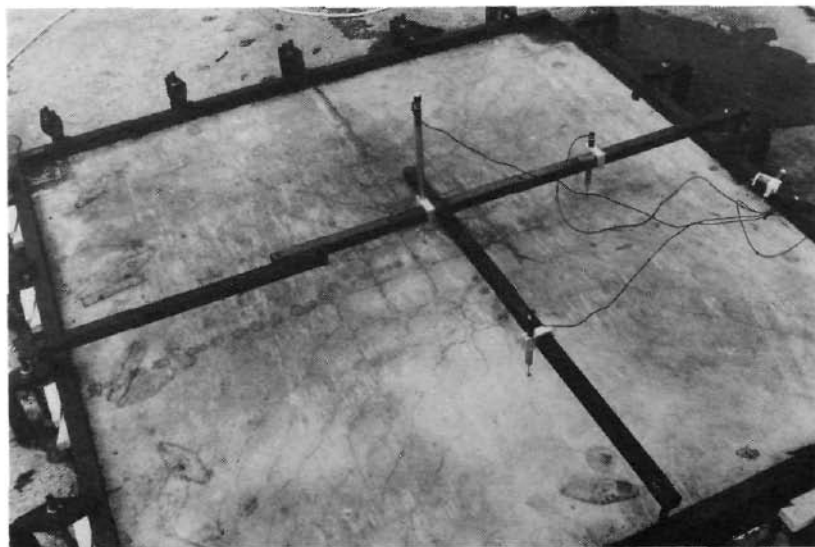
Figure 4. Photograph during final static test on concrete panel showing external crack pattern

During the first static test a leak developed in the hydraulic system and the test was stopped at 19 kPa pressure. After the test the natural frequency was measured and found to be lower, 26.86 Hz, indicating that the panel had been damaged. In the second static test the pressure was increased to more than 60 kPa. At this stage the damage to the panel was quite extensive and the test was stopped. Figure 4 shows a photograph of the panel after the second static test. The development of yield lines can be seen.

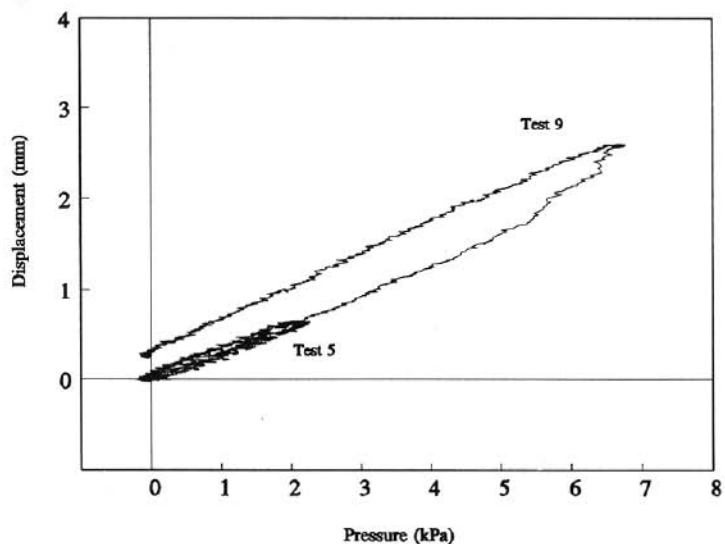
Figure 6. Pressure vs. Displacement for Tests 5 and 9, Masonry Wall 1

It can be seen from Table 2 that there was no apparent loss of stiffness between Test 1 and Test 10, ie the natural frequency remained effectively unchanged. Figure 6 shows the displacement/pressure curves for Test 5 and Test 9. This shows an essentially linear section up to about 5 kPa, after which the gradient of the curves change. The overall relationship between pressure and displacement is therefore non-linear. This is reflected in values of the ratio of pressure to displacement (evaluated for maximum loads and displacements) which decreased as the applied load was increased. This non-linear behaviour would need to be taken into account in the application of a numerical model.

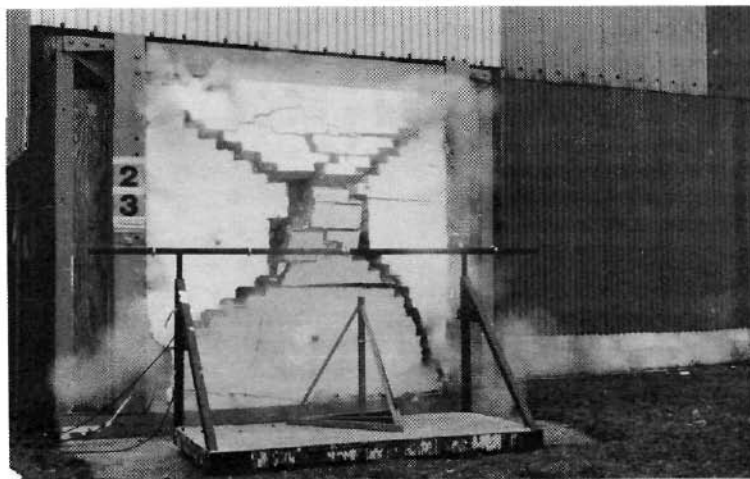
Figure 7. Failure of Masonry Wall 2

During explosions 19 to 22 the panel was subjected to pressures nearing its ultimate capacity. Damage was observed and was clearly indicated by the reduction in natural frequency. After explosion 19 diagonal cracks occurred, in general following joint lines, although one or two bricks cracked. Well defined cracks were evident from the top two corners towards the centre, with slight cracks from the bottom left (viewed from outside) but none from the bottom right. Explosion 20 produced cracking from all four corners and during explosions 21 and 22 the cracks grew larger. The panel failed in Test 23, at approximately 16 kPa.

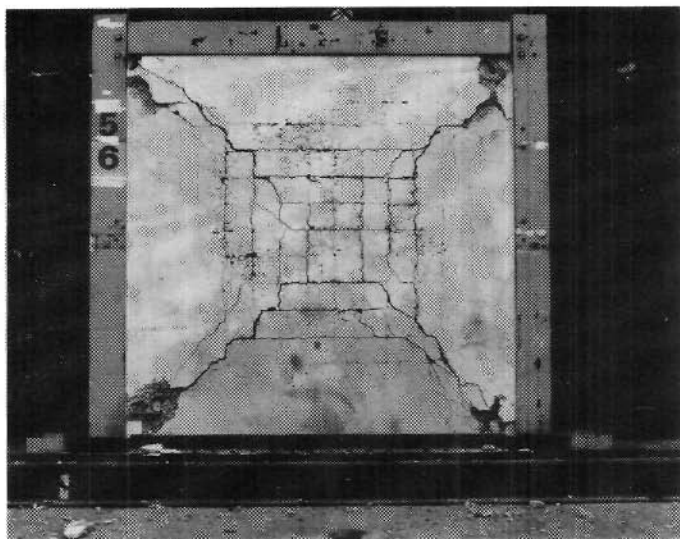
Figure 8. External damage to concrete panel.

Test 52, caused no further damage. Test 53, produced a small increase in permanent deflection and crack width. Test 54, finally caused a large increase in deflection, the cracks opened considerably and concrete was crushed and blown out in the region of the corners, the gaps being large enough to get a hand through. The damage to the panel is shown in Figures 8 and 9.

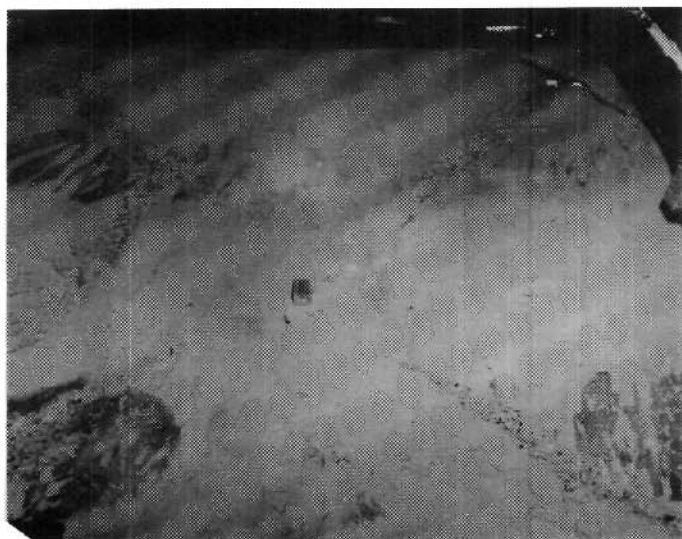
Figure 9. Internal damage to concrete panel.

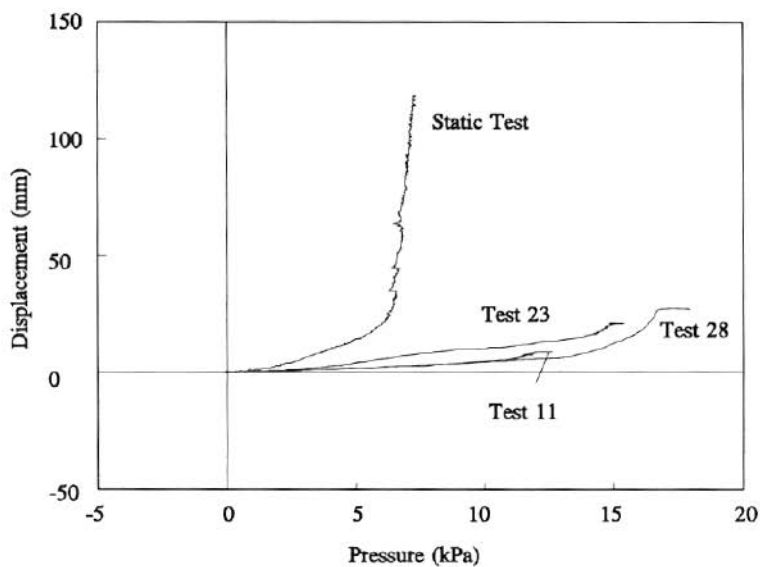
Figure 10a. Pressure/displacement curve - masonry wall

The validity of the quasi-static approximation can be assessed by comparison of the pressure/displacement curves from the static and explosion tests as shown in Figure 10. It is apparent that the deflections of both the masonry and concrete panels under dynamic loading were significantly less than would be expected on the basis of the equivalent static load derived

predict the initial 'elastic' response of a panel. However, as can be seen from the pressure-displacement graphs (shown in Figure 10) for the destructive tests on each panel, the ultimate response is non-linear. For accurate modelling these non-linearities would need to be taken into account, the particular non-linearities would be dependent in part upon any damage previously sustained.

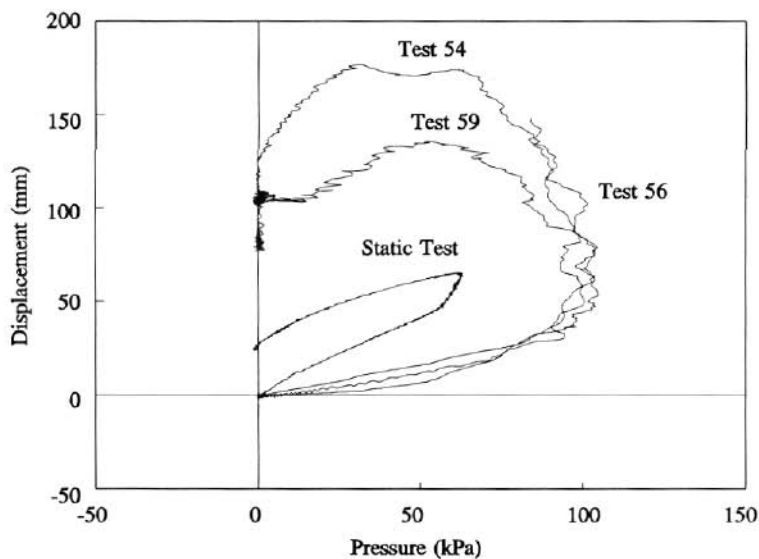
Figure 10b. Pressure/displacement curve - concrete panel
