## Safety practice

# Corrosion under insulation – a continuing threat to industry

Andrew Duncan and Andrew Piercy, Intertek Production & Integrity Assurance

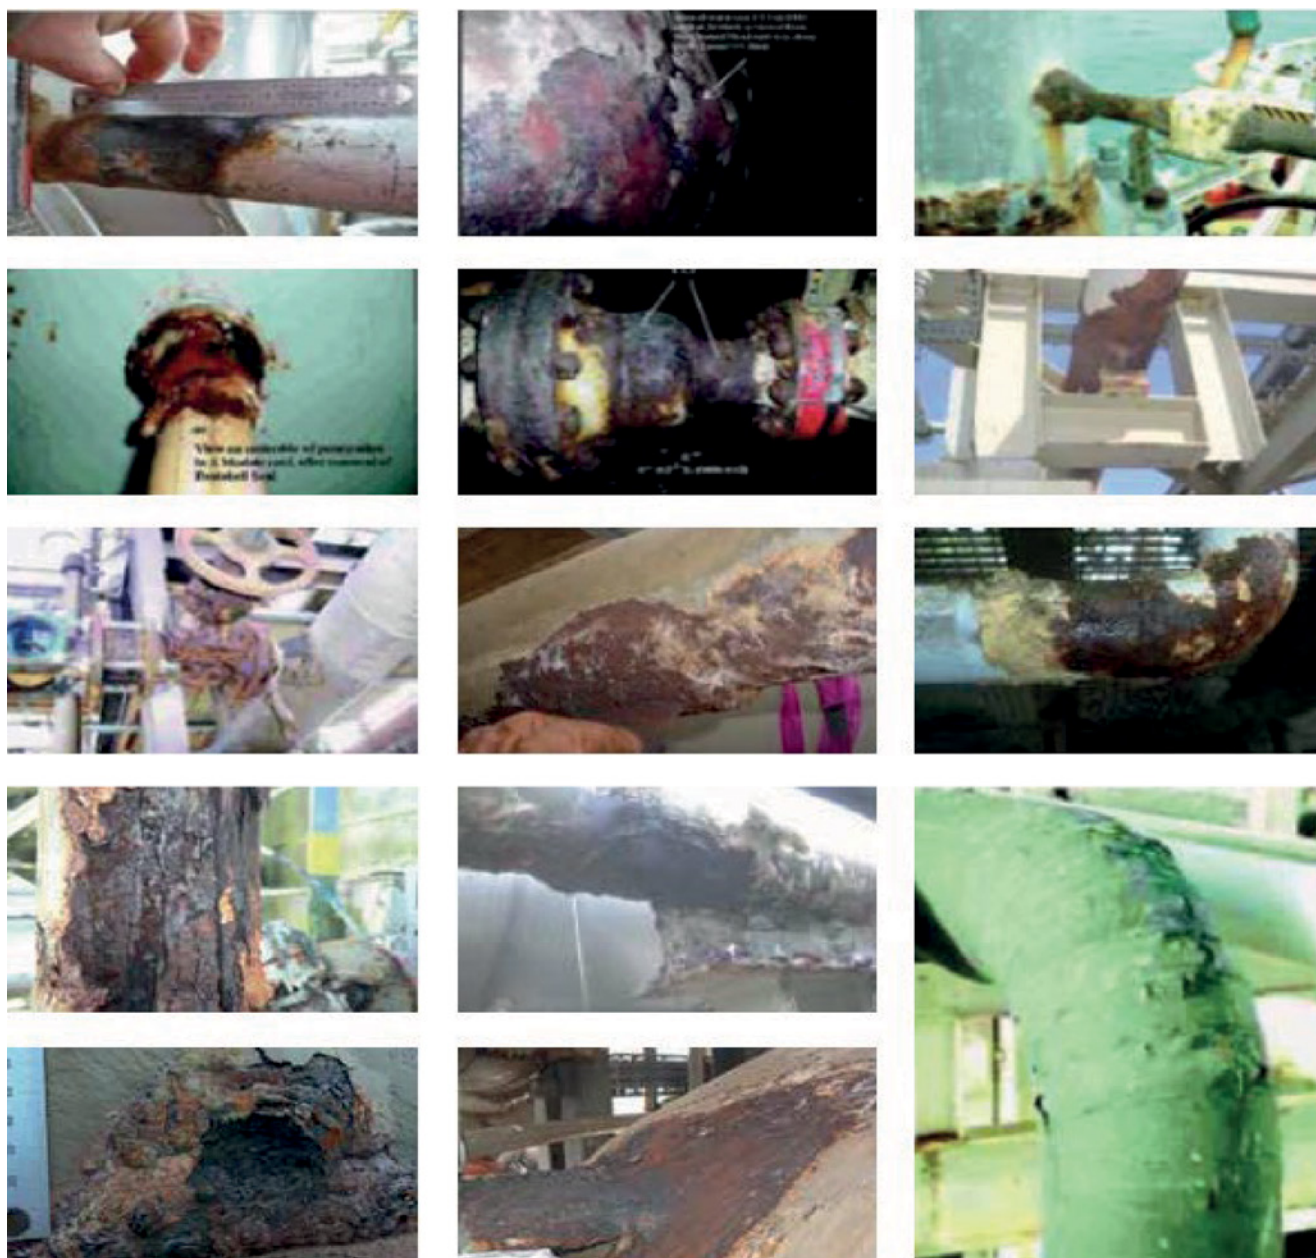
Figure 1: Images of CUI (Reproduced with kind permission from the Energy Institute from their Guidance on Corrosion Management <sup>1</sup>)

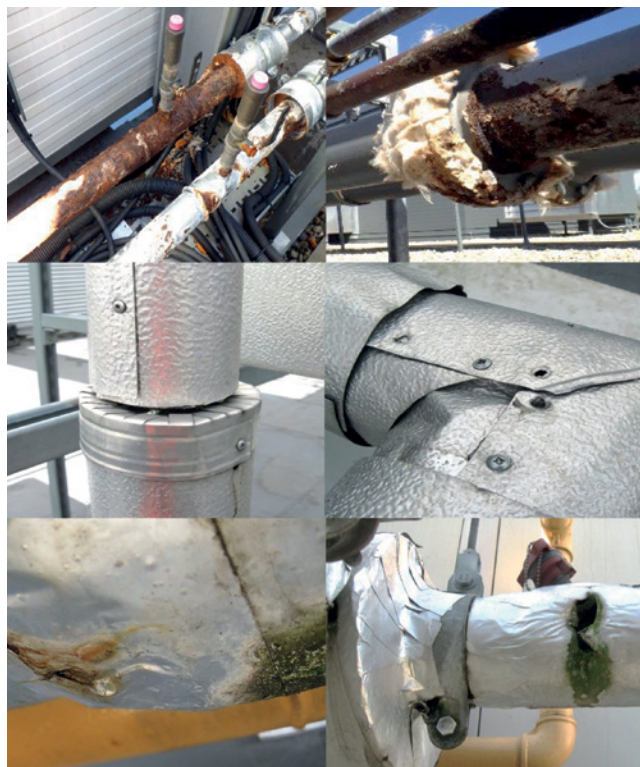
Figure 3: Examples of rooftop pipework CUI problems and poor insulation installations are shown below

Rigid phenolic foam insulation can leach acids when wetted, producing extremely corrosive conditions to both carbon steel and copper. While compressed mineral fibre does not usually leach acid species and should not contain appreciable chloride ions, if the insulation is wetted, this creates a poultice effect and a high time of wetness thus encouraging corrosion. If the insulated pipework is close to the coast, the environment will be classed as marine (Corrosivity Class C5<sup>3</sup>) and thus significantly more corrosive if the insulation becomes wet. Even if carbon steel pipework is galvanised, zinc corrosion protection performs poorly under constantly wetted conditions, increasing the zinc consumption rate and producing voluminous, non-protective 'white rust'.

BS 5970 provides visual examples/illustrations of good practice and specific guidance on how to minimise the risk of water ingress to insulation by addressing, for example, cutting and fit, orientation of seams, direction of overlaps, staggering of layered joints, use of sealants and the use and positions of rivets and fasteners. The insulation manufacturers also produce guidance and installation documents for their products. All of these can have an impact on whether CUI can or will occur. The most common areas for CUI are where the insulation is punctured by pipe supports and brackets or is incomplete around flanges, ports, instrumentation and valves.

Some examples of rooftop pipework CUI problems and poor insulation installations are shown in Figure 3.

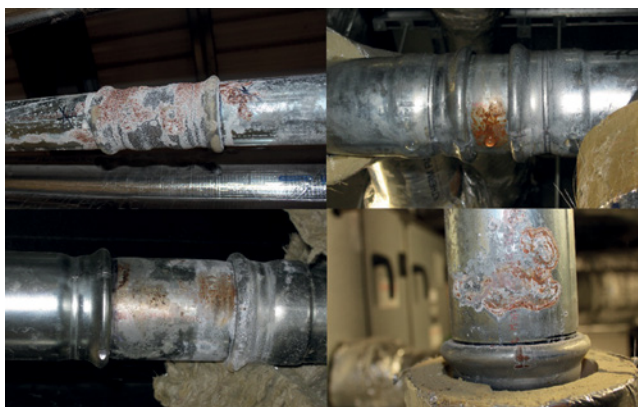
Figure 4: Examples of lightly corroded galvanised TWCS pipework are shown below

Internal building piping systems CUI problems are not usually encountered due to wetting of the pipework and insulation from external sources. Sources of moisture and wetting of insulation and pipework surfaces within buildings are typically from pipework leaks or condensation. Leaks can occur from mechanical joints after initial installation or maintenance. If these leaks are not detected, the installed (or reinstated) insulation can quickly become saturated with water. Just as with the externally situated pipework, once the insulation is wetted the pipework will begin to corrode. However, Intertek's experience from site and laboratory investigations of these types of CUI problems on carbon steel/galvanised steel is that the corrosion tends to be relatively localised to the joints. If these leaks are in plant rooms, for example, where maintenance personnel are regularly in attendance, it may be detected or noticed, and the corrosion stopped by cleaning, repairs, and re-insulation. However, if pipework is running through ductwork or above false ceilings, the first indications of a problem might not be found for a long period of time. Examples of lightly corroded galvanised TWCS pipework are shown in Figure 4.
