## Chemical Incident Investigation, Millennium Inorganic Chemicals (MIC), Stallingborough UK, 2010

On 5th March 2010, reaction vessel D650 at the Millennium Inorganic Chemical works at Stallingborough suffered a catastrophic failure, releasing its contents both over the ground below and an operator present there. A large dense white cloud of corrosive and toxic gas was created.

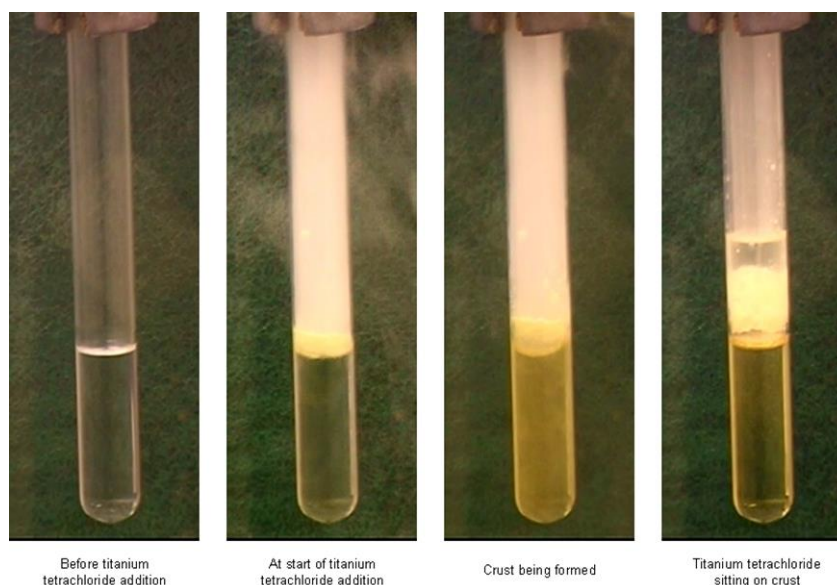
It had previously been observed [Buston, 2011; Cruse, 2011] that if  $\text{TiCl}_4$  reacts with water, when there is more  $\text{TiCl}_4$  present than water, a yellow foam/crust is generally formed. Experiments were performed to investigate whether similar semi-solid foam or crust formation was observed when adding  $\text{TiCl}_4$  to aqueous hydrochloric acid. Experiments were performed from test tube (*ca.* 1 cm diameter) up to 1 litre reactor scale.  $\text{TiCl}_4$  addition was carried out either as a continuous trickle, or as a larger single portion or portions (‘slugs’). In all the experiments performed, a crust/sponge like foam was formed by addition of  $\text{TiCl}_4$  to the aqueous hydrochloric acid. In most, but not all, experiments this was a contiguous layer over the whole surface of the reaction vessel, allowing the subsequent build-up/accumulation of a layer of liquid  $\text{TiCl}_4$  above this crust (Figure 1).

Figure 1. Representative example showing formation of crust when adding  $\text{TiCl}_4$  to aqueous hydrochloric acid

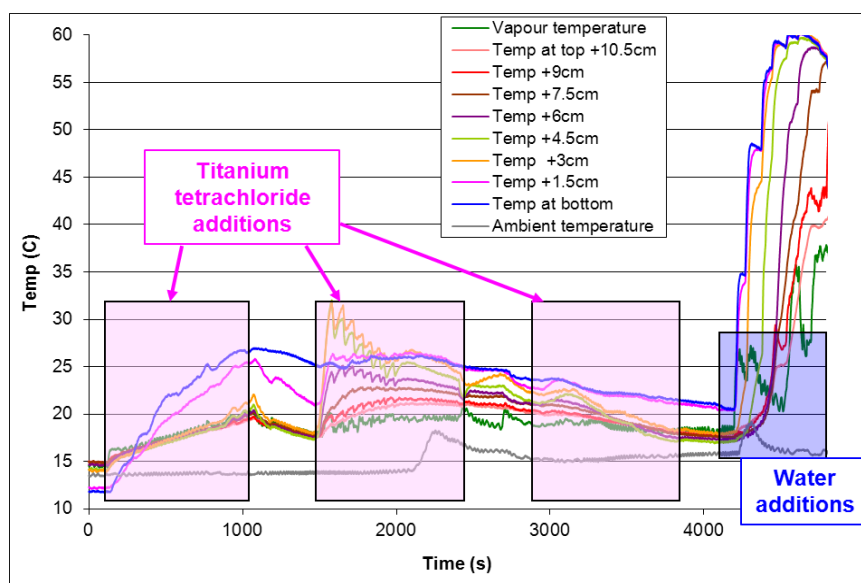
Subsequent addition of water to the reaction mixture containing the described foam/crust led to an extremely violent reaction, characterised by very rapid temperature rises and the evolution of large quantities of smoke/gas (Figure 2).

Figure 2. Representative example showing temperature changes when adding  $\text{TiCl}_4$  to aqueous hydrochloric acid and subsequent addition of water

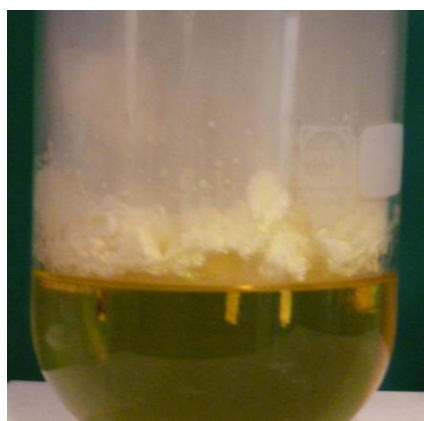
In experiments where portions of  $\text{TiCl}_4$  were added rapidly onto an aqueous phase of hydrochloric acid previously treated with  $\text{TiCl}_4$ , substantial foams were formed. Subsequent addition of water through a spray nozzle onto these foams once again resulted in vigorous reactions, with substantial and rapid temperature rises being observed. An example of the foam formation is shown (Figure 3).

Figure 3. Foam formation in 1 litre vessel –  $\text{TiCl}_4$  added in portions to aqueous hydrochloric acid previously treated with  $\text{TiCl}_4$

Given that, under normal conditions, a controlled reaction between water/aqueous hydrochloric acid and  $\text{TiCl}_4$  was regularly taking place within D650, and that  $\text{TiCl}_4$ , aqueous hydrochloric acid and the products from the reaction between them are the only constituents that could reasonably be expected to be present within the vessel D650, two likely scenarios that could produce the massive forces that would lead to a catastrophic rupture of the vessel were proposed:

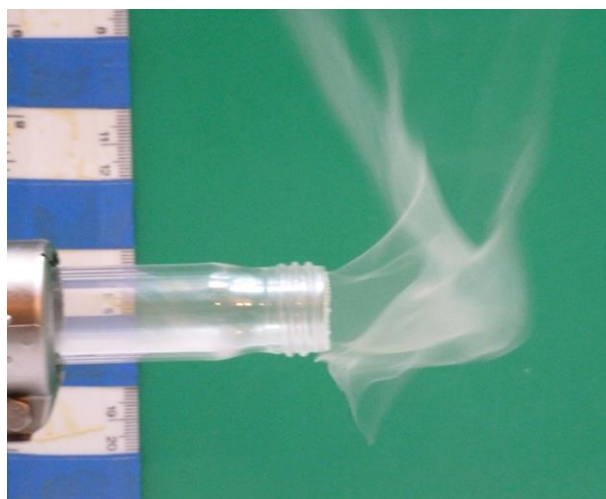
A key feature of the incident was the generation of a large dense white cloud. In an effort to replicate the condition of the plant post-incident, an experiment was performed to demonstrate the effect of venting to atmosphere a process gas stream which had passed through pipework containing  $\text{TiCl}_4$ . A length of glass pipework was assembled, the initial horizontal section of which was filled with  $\text{TiCl}_4$ . When a dry, non-reactive, gas (nitrogen) was passed over the liquid, white fumes were observed at the end of the pipework due to gaseous  $\text{TiCl}_4$  becoming entrained in the gas stream and reacting atmospheric moisture (Figure 5).

Figure 5. Fumes leaving pipework

When the pipework feeding into unit 600 was dismantled post-incident, a significant quantity (up to 7,000 kg) of  $\text{TiCl}_4$  was found to be present. With the process gas flow running, a quantity of  $\text{TiCl}_4$  would have been entrained within, and been transported by the flow. Therefore, it would seem likely that a substantial quantity of liquid  $\text{TiCl}_4$  may have been pushed through the pipework and into vessel D650. Any  $\text{TiCl}_4$  entrained in the gas stream would contribute to the temperature rises and the continuing thickening of the scrubber solution observed within vessel D650 in the run up to the incident. In addition, once vessel D650 had ruptured, this entrained titanium tetrachloride contained in the process and purge gases would have reacted with atmospheric moisture to create a smoke cloud that would have continued to grow (as well as being moved and dissipated by the wind) for as long as there was any gas flow. This would have contributed to the smoke cloud observed by witnesses to the incident.

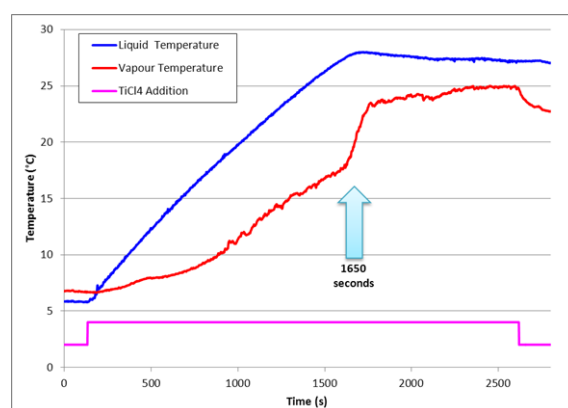
This data shows that the reaction of  $\text{TiCl}_4$  with water generates more heat than the analogous reaction with aqueous hydrochloric acid. It can reasonably be expected that the reaction with {hydrochloric acid previously reacted with  $\text{TiCl}_4$  would be similar to, or less heat producing than that with aqueous hydrochloric acid. A similar experiment was performed in which a much larger quantity of  $\text{TiCl}_4$  was added, at the same rate and in the same system, to aqueous hydrochloric acid. A graph of the temperatures seen in this experiment is shown (Figure 8).

Figure 8. Temperature rises in Dewar experiment adding  $\text{TiCl}_4$  to aqueous hydrochloric acid

These temperature traces show that there comes a point in this experiment (after approximately 1650 seconds) where continued addition of  $\text{TiCl}_4$  does not predominantly result in heat being generated and the liquid warming up. However, a stream of white fume from the vent pipe was seen, commencing at about the same time, which increased in intensity as the experiment continued. If the reaction maintains the same pathway, i.e. the  $\text{TiCl}_4$  is reacting with the water within the aqueous hydrochloric acid to form similar products, then one would expect the same energy to be released from the chemical bonds involved in this reaction, whether the water originates from aqueous hydrochloric acid or pure water. As a result, we would expect that the energy released from these changes in chemical bonds is being dissipated by a means other than heating up the reaction mixture and its immediate surroundings. The most obvious means for consuming this energy is by the vapourisation of hydrogen chloride from solution to gas (energy is consumed in this process). This would imply that more hydrogen chloride gas is generated at this stage in the process. This appears to be a reasonable assumption since there is a maximum amount of a gas that can be dissolved in any given solvent (with this generally diminishing as the temperature is increased). Thus, hydrogen chloride produced in the reaction of  $\text{TiCl}_4$  with hydrochloric acid will not be able to be dissolved in the reaction medium as readily as in the corresponding reaction of  $\text{TiCl}_4$  with water. In addition, the reaction of  $\text{TiCl}_4$  with aqueous hydrochloric acid will consume some of the water within the aqueous hydrochloric acid, thus making it more concentrated and even less able to dissolve further hydrogen chloride gas.

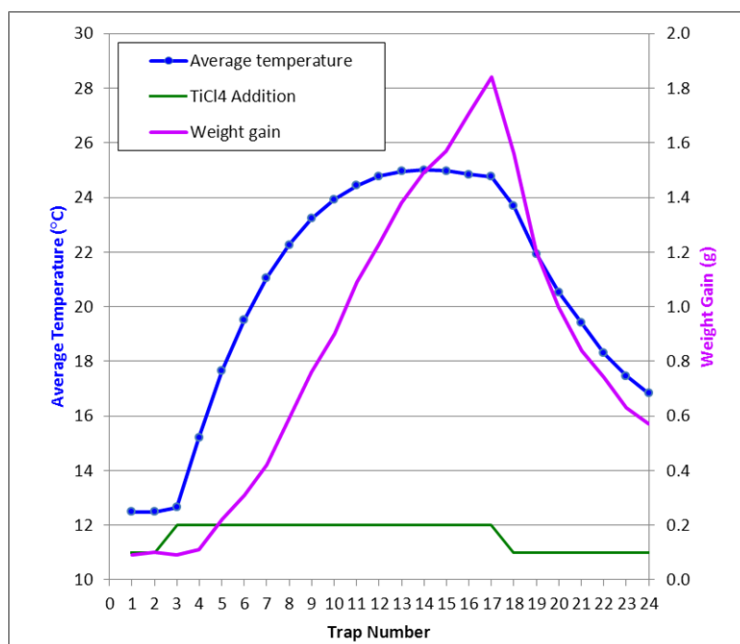
However, when titanium tetrachloride was similarly added to a large excess of aqueous hydrochloric acid, a smaller temperature rise (to  $25^\circ\text{C}$ ) was observed. In contrast, appreciable quantities of acidic gas were trapped. Indeed, temperature rise was observed to plateau, after which the quantity of acidic gas evolved continued to increase (Figure 9).

Figure 9. Temperature rises and gas evolved adding  $\text{TiCl}_4$  to aqueous hydrochloric acid

The smaller temperature rises observed when  $\text{TiCl}_4$  reacts with aqueous hydrochloric acid compared to when  $\text{TiCl}_4$  reacts with water can be explained by the correspondingly greater gas evolution. Thus, the energy released by the reaction is being used to liberate a larger quantity of hydrogen chloride gas. Accordingly, it is the case that addition of  $\text{TiCl}_4$  to aqueous hydrochloric acid will produce less temperature rise, but generate more acidic hydrogen chloride gas than addition of  $\text{TiCl}_4$  to water.

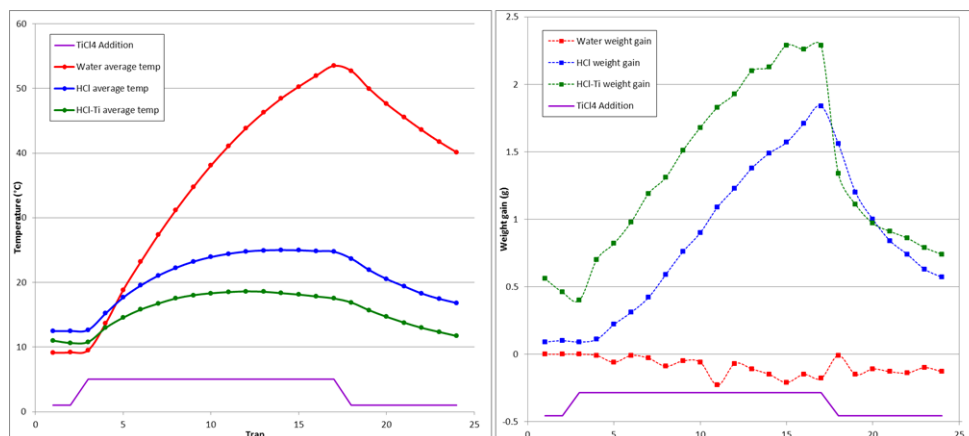
In a similar manner, titanium tetrachloride was reacted with titanium oxychloride solution (the product from allowing  $\text{TiCl}_4$  to react with hydrochloric acid). Continuing the trend observed above, lower temperature rises ( $8^\circ\text{C}$ ), and higher evolved gas quantities were seen. A direct comparison of these three experiments is shown in Figure 10. This clearly shows the related trends of smaller temperature rises and greater hydrogen chloride gas evolution when  $\text{TiCl}_4$  is added to aqueous hydrochloric acid and {aqueous hydrochloric acid previously reacted with  $\text{TiCl}_4$ }, as compared to when it is reacted with water.

Figure 10. Comparison of temperature rises and gas evolution

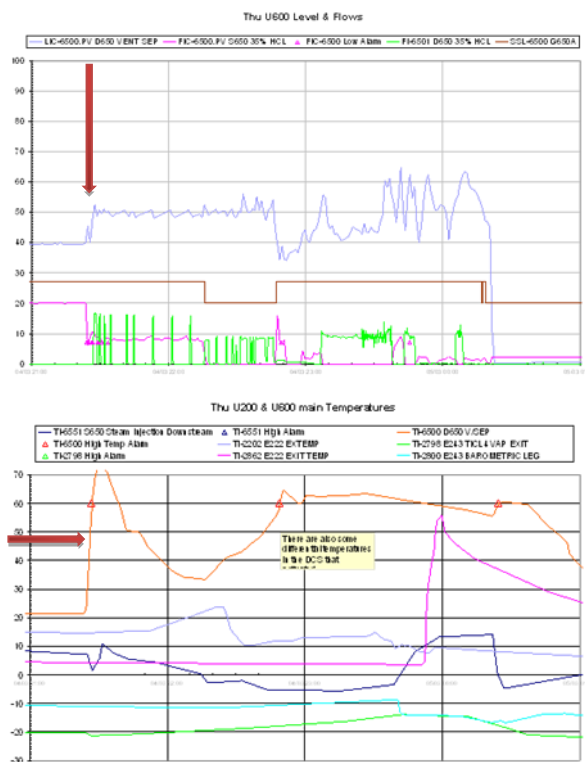
Taking one of the observed temperature spikes from the site process instrumentation, a 50°C temperature rise observed at 21:25 on 4th March 2010 (Figure 11), it was calculated that in the order of 1 tonne of  $TiCl_4$  would need to be added to vessel D650 to produce the observed temperature rise.

Figure 11. Excerpts from process instrumentation to Vessel D650 showing level increase (top) and 50°C temperature rise (bottom)

During the incident investigation, it was noted that, in the 48 h. leading to the rupture of vessel D650, a number of notable temperature 'spikes' occurred within vessel D650. The most likely cause of these are slugs of liquid  $\text{TiCl}_4$  passing through into the vessel from the pipework leading up to D650 and reacting with aqueous hydrochloric acid, producing both heat and hydrogen chloride gas. It has already been shown that it is highly likely that substantial quantities of liquid titanium tetrachloride were present in the pipework.

The experimental results reported above, most notably in Table 1, were used to provide an approximate calculation indicative of the quantity of  $\text{TiCl}_4$  that would need to pass into vessel D650 to produce the observed temperature spikes.

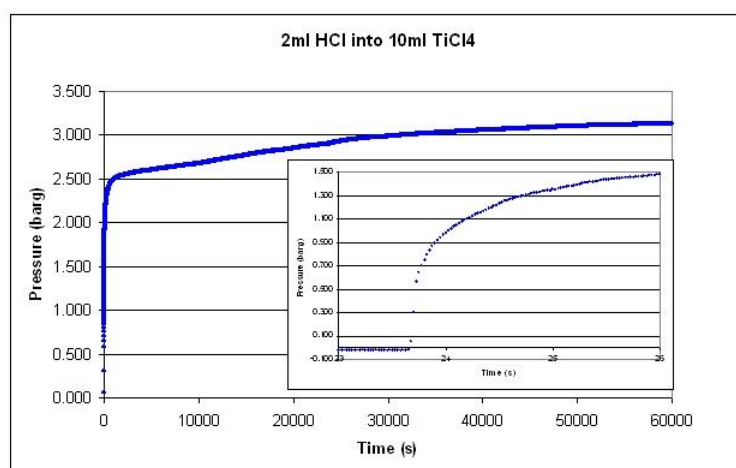
A number of experiments were performed to investigate both the magnitude and rate of the pressure rise when  $TiCl_4$  and an aqueous system were mixed. A closed system was used equipped with a pressure transducer. Each experiment was performed by placing a measured quantity (2-40 ml) of  $TiCl_4$  into the glass vessel. The aqueous reagent, either tap water or 36% aqueous hydrochloric acid solution, was placed into the pipe reservoir above the valve and the system sealed. Once data collection had commenced, the valve was opened and a rapid, pressure generating reaction occurred, forcing all of the aqueous added reagent down into the glass vessel. A typical trace of pressure against time is shown (Figure 13).

Figure 13. Typical Pressure-time trace

From this it can be seen that there is a very rapid initial pressure rise (for this example, about 0.4 s. to increase by 1 bar). After the initial pressure rise, the pressure continued to climb slowly for some hours. This is most probably related to a combination of: firstly an equalisation of pressure across all the pores of the foam and the reaction vessel, and secondly the release of reagents held up within the pores of the foam for further reaction. Several repeat experiments were run for each

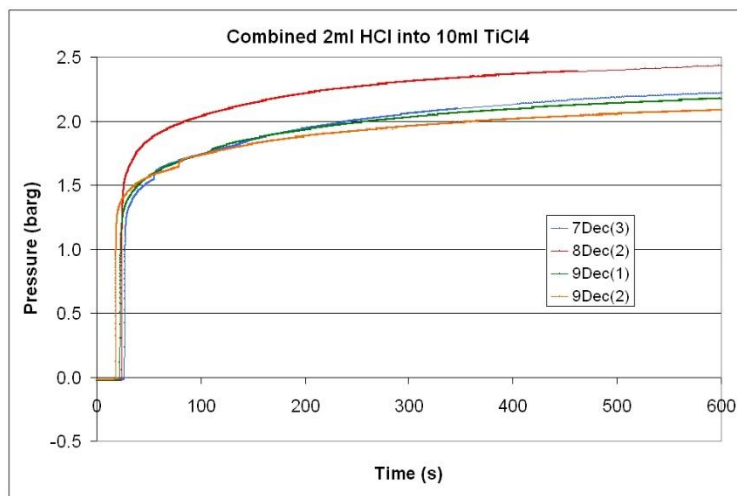
ratio of reagents (eg. 2 ml HCl with 10 ml  $\text{TiCl}_4$ ) investigated. Some variation within each set of results was observed (Figure 15), arising from the non-homogeneous nature of the reaction mixture. However, all consistently demonstrated a very rapid pressure rise, followed by a more protracted pressure increase at a much lower rate.

Figure 15. Variability in rates of pressure change

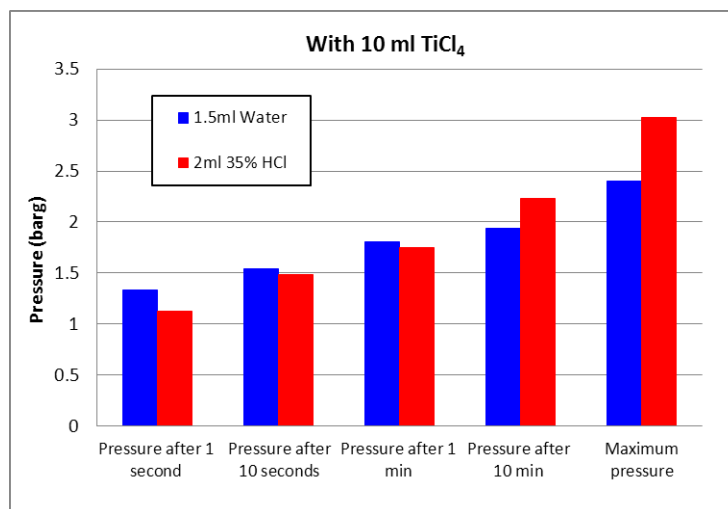
There are two possible sources of gas generation in this reaction; hydrogen chloride will be generated from the reaction between  $\text{TiCl}_4$  and water (the aqueous hydrochloric acid contains about 65% by weight of water). In addition, the water that was consumed by this reaction is no longer present to dissolve the hydrogen chloride from the hydrochloric acid. This can therefore be liberated as a gas and further contribute to the pressure rise. In order to examine the contributions of these two effects, further experiments were performed adding water (rather than hydrochloric acid) to  $\text{TiCl}_4$ . 1.5 ml of water was used. This is approximately the amount of water present in 2 ml of 35% aqueous hydrochloric acid. A comparison of the pressure change seen with adding 1.5 ml water (against the average from adding 2 ml hydrochloric acid) can be seen (Figure 17).

Figure 17. Comparison of pressure gains

It was observed that there was a marginal difference in the initial rates of pressure formation, with the water reacting marginally quicker than the aqueous hydrochloric acid. The final pressure reached is approximately 0.6 bar greater when hydrochloric acid is used. This demonstrates that, for this ratio of reagents, the hydrogen chloride gas dissolved in the hydrochloric acid contributes to the final pressure (and therefore the amount of toxic gas released).

A rapid and pressure generating reaction occurs between  $\text{TiCl}_4$  and aqueous hydrochloric acid, even at room temperature, forming a sticky/foamy solid material. This is followed by a second phase of pressure increase related to the breakdown of the foam and equalisation of the internal pressure across the vessel, which takes place over a time period of several hours. The pressure rises measured in this work can be regarded as occurring at approximately constant temperature since the mass of the reaction vessel (approximately 800 g without lid) and therefore heat capacity of the vessel is very much greater than that of the contents. When considering these results scaled up to vessel D650, the heat loss to the vessel fabric or surroundings (within the timescale of the incident) would be almost negligible (a near adiabatic system). As a result, the gas generated would be at a higher temperature. The key point being made is that the experimental-scale pressure rises observed in this work most likely underestimate any pressures increases that would be observed within a larger reactor vessel.

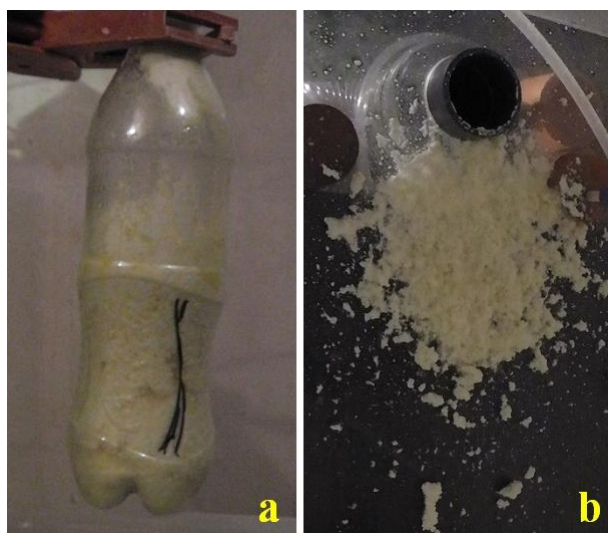
In order to understand more clearly the effect of the reaction between  $\text{TiCl}_4$  and an aqueous system in a vessel with a limited venting capacity, a number of experiments have been carried out using 500 ml plastic drinks bottles. These bottles were chosen since they were transparent and had approximately the same ratio of cross-sectional area to aperture area as vessel D650. In the first experiment, the bottle was prepared for reaction by introducing  $\text{TiCl}_4$  (89 ml, 154 g). Water was then added through the top, although only about 45 ml was added before the addition pipe was ejected by force of the reaction. Two thermocouples measured the temperature inside the bottle; one within the liquid saw a rapid temperature rise from  $15^\circ\text{C}$  to  $32^\circ\text{C}$  within 2 s., the other, located approximately 5 cm above the surface of the liquid rose from  $15^\circ\text{C}$  to  $56^\circ\text{C}$  in the same timescale, and peaked at  $60^\circ\text{C}$ . During the course of this reaction, a sticky yellow material filled the bottle (Figure 18a), a significant quantity of which was ejected and impacted on the roof of the glove box some 50 cm above the bottle opening (Figure 18b).

Figure 18. Result of adding water to  $\text{TiCl}_4$  in a bottle

All of the 'bottle' experiments performed demonstrate the extreme reactivity of  $\text{TiCl}_4$  with water. This reactivity rapidly generates heat and hot gases and forms a non-homogeneous solid which can act to separate portions of the reaction mass from each other. Sticky solid materials have been observed to be ejected vigorously from the bottle; this would have the potential to reduce the bore, or in extreme cases, completely close the normal outlet flow route of a vessel. Accordingly, the experiment results presented here suggest that some degree of obstruction of the vessel outlet is likely.

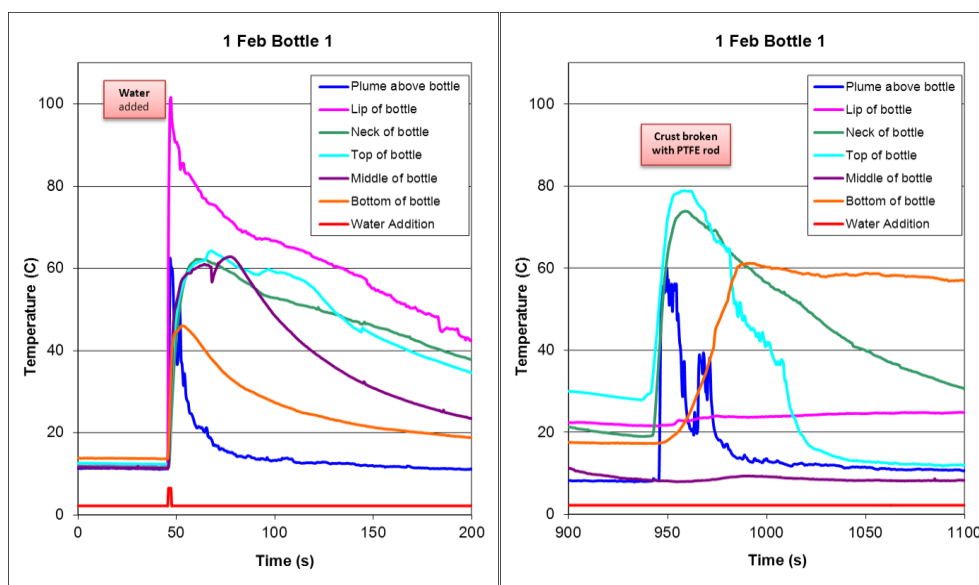
Additional tests of this nature were performed, each of which produced similar results, with temperatures up to  $100^\circ\text{C}$  observed at the lip of the bottle. It was found that considerable effort was required to break up the initially formed crust. On breaking through the crust, further reaction was observed (Figure XX).

Figure 19. Temperatures seen in experiment adding water to  $\text{TiCl}_4$  in bottle
