# Loss Prevention Bulletin

## Revisiting the Tacoma Power Plant boiler

Issue 290, April 2023

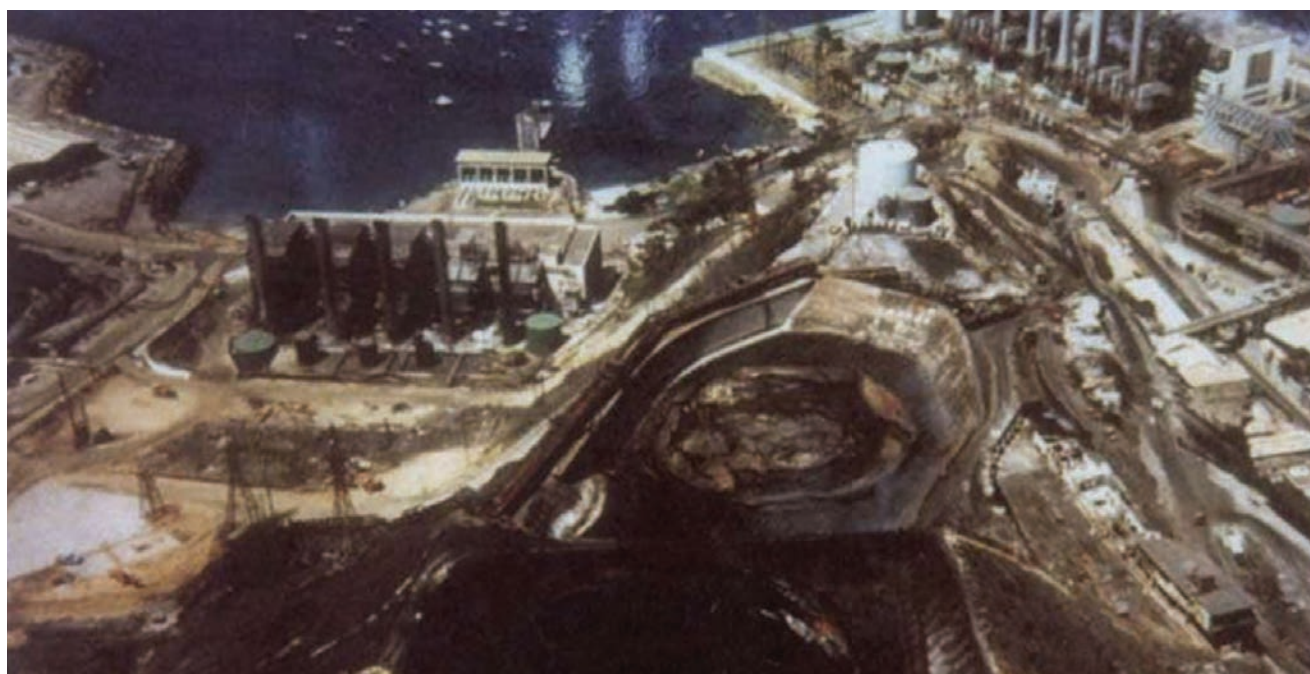
Figure 5 – Image extracted from "Incidents that Define Process Safety" shows the aftermath. Both tank 8 (foreground) and tank 9 (background) appear blackened and crumpled. Notice the steep drop-off of the dike walls and settlements underneath.

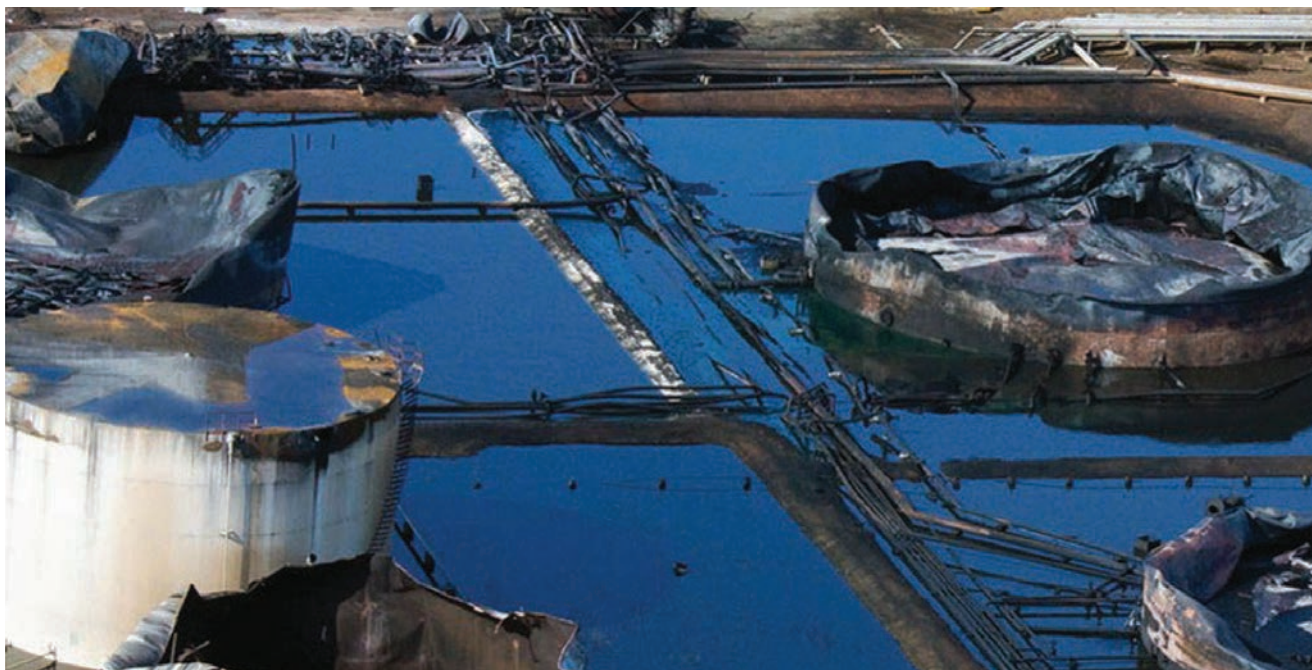
Figure 1– Firewater flooding at site

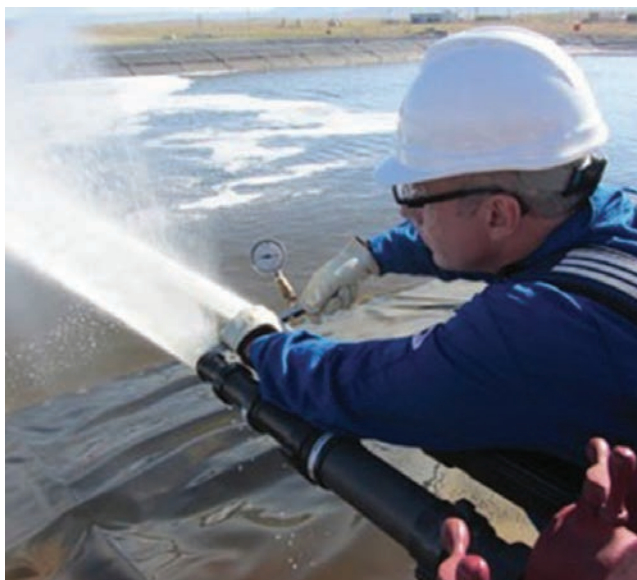
Figure 2 – Firewater flow measurement

Fire pump operational and performance testing also rely on the availability of accurate and up-to-date documentation. Performance testing relies on knowing a fire pump's design ratings for flow and pressure, since that is used as the benchmark to determine if a pump is performing as intended. The records of previous tests are very important to establish trends over time and to note any changes to the system that may explain or help diagnose problems if they arise during testing.
