Incident

The great explosion of 1916

Phillip Carson

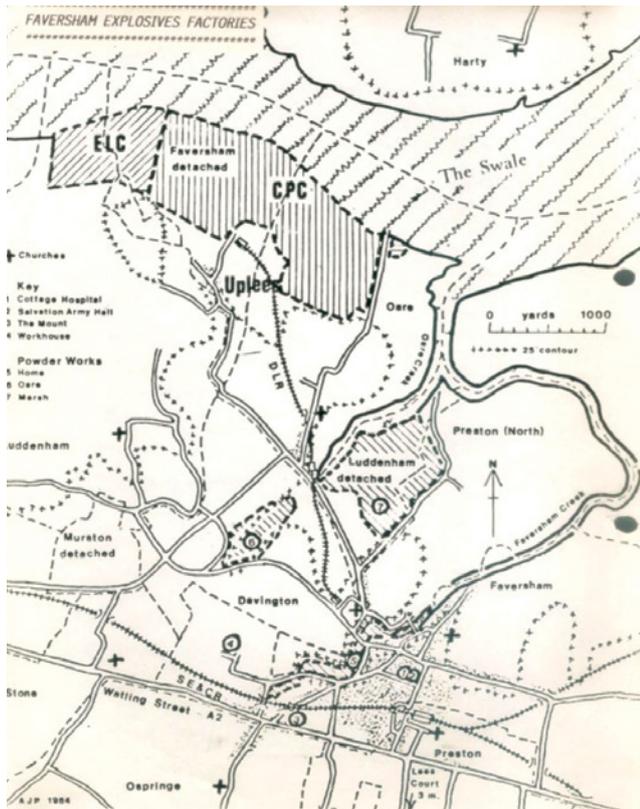
Figure 1 – Faversham explosives factories

ELC=Explosives Loading Company
CPC=Cotton Powder Company

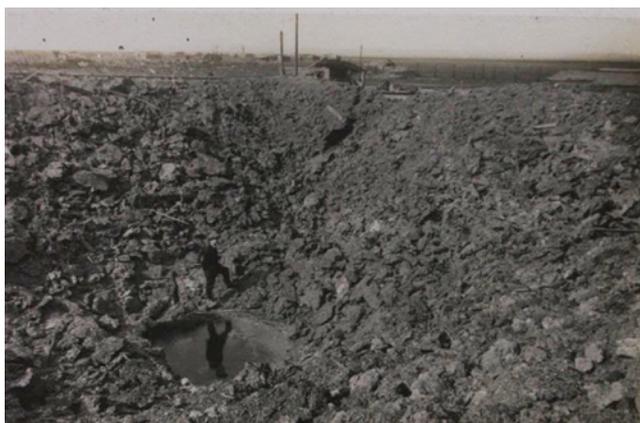
Figure 2 – Crater created by explosion of building 217 (note man in centre)

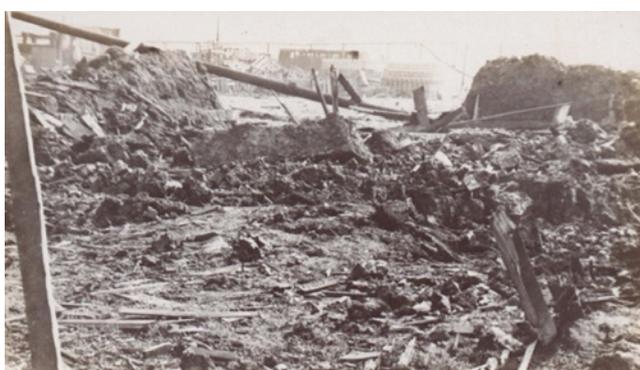
Figure 3 – Remains of building 844
