UPDATE ON THE SPANISH CAMPSITE DISASTER

by
Ian Hymes
Safety & Reliability Directorate, UKAEA, Culcheth

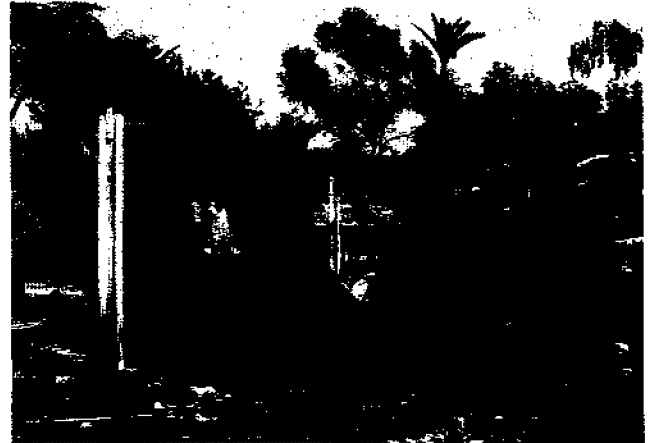
Figure 2.4(c) Mid section of tanker, rectangular sample taken for analysis.

the tank shot sideways into the site probably demolishing part of the boundary wall. The nose cap of the tanker still fastened to the cab by the 'fifth' wheel flew down the SSW axis of the road. The tractor unit became detached en route and came to rest at 60 m whilst the endcap carried on for another 100 m shedding the 'fifth' wheel and an antisurge baffle on the way. Photographs showing missiles from the tanker are shown in Figure 2.4(a) to 2.4(e). The ejected vapour/aerosol produced a fireball.

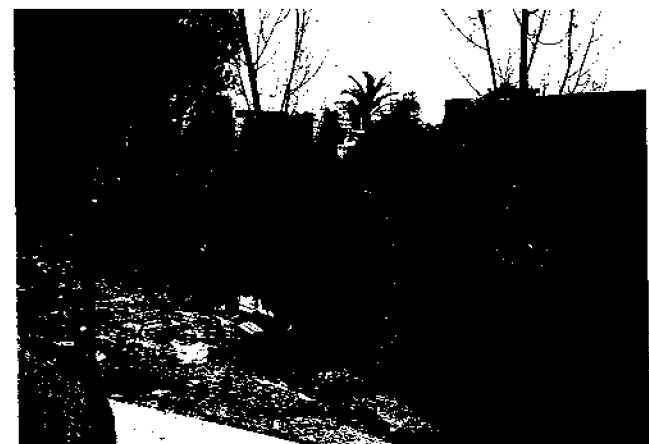
Figure 2.4(e) Set of rear wheels embedded in wall of campsite.
