Lessons learned from the coastal flooding of process industry sites on Teesside and Humberside by the storm surge on 5-6 December 2013

Abstract: On 5-6 December 2013 there was a storm surge in the North Sea that caused flooding along the east coast of England. 2,800 homes were flooded, but there were no fatalities. The effect on the process industry was significant, with sites flooded on Teesside and Humberside. Coastal water levels were the highest recorded since January 1953 and the highest tide ever was recorded on the Humber.

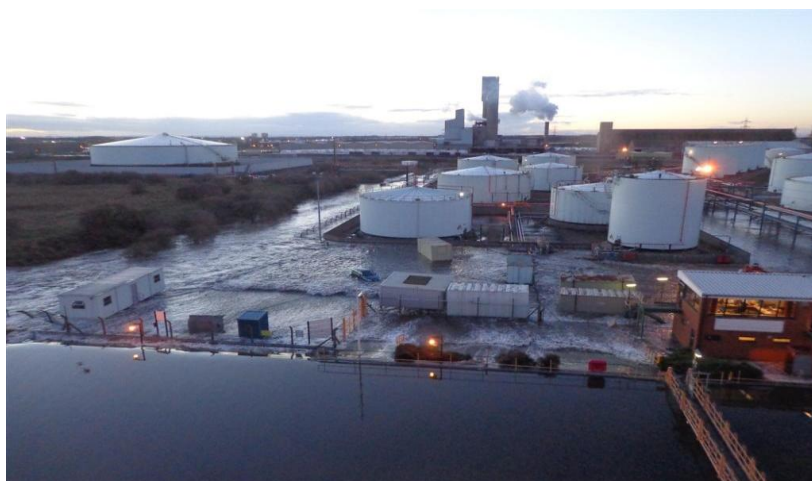
Figure 1. Inter Terminals, Riverside Terminal. Water overtopping the flood defences – as seen from a ship at the terminal.

The surge caused a rise in the river level to 4.3 MAOD which over topped the defences along the river frontage and Billingham Beck and erosion of the bank created 2 short breaches, lowering the effective protection level. The huge volume of water entering the site from the river and the beck flooded the whole site to a depth of 1.8m

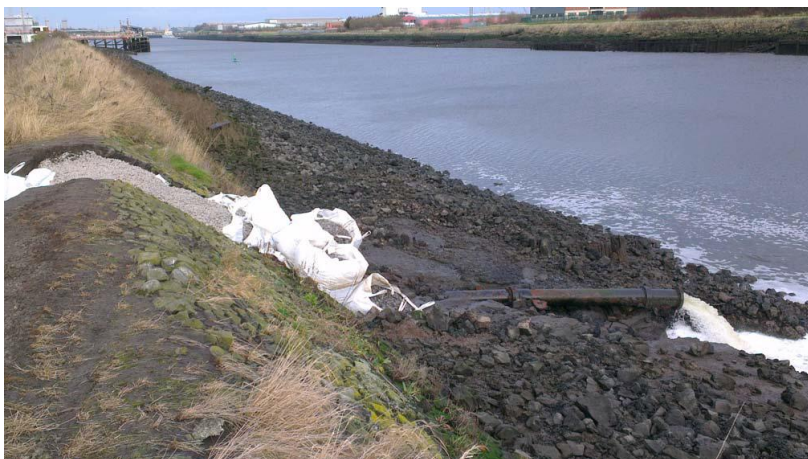
Figure 2. Inter Terminals, Riverside Terminal. Damaged flood defence embankment showing the temporary repair.

The river defence embankment is being raised to 4.85 MAOD and work to protect the rest of the site boundary to the same level is also planned. The final protection of the site will be 1 in 1000 (0.1 %) annual chance of flooding in any year.

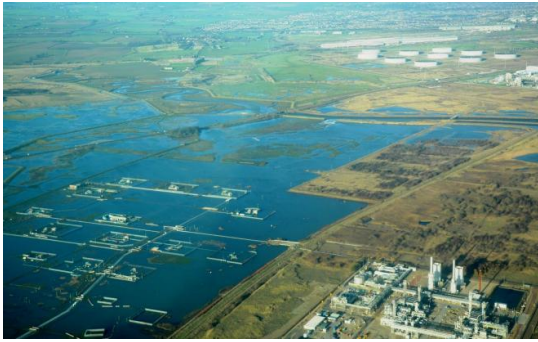
Figure 3. SABIC Brinefields and Cavities storage area showing the flood defence breach.

On Teesside, the flood defences at Port Clarence had been overtopped causing flooding to 30 properties but the defences remained intact. The flood defences at Inter Terminals Riverside Terminal had also been overtopped and damaged with 2 short breaches. Inter terminals was responsible for the maintenance of these defences and they successfully completed the repairs within a couple of days, with some assistance from the Port Authority. At the SABIC Brinefields storage area a 50m length of the flood defence embankment had been completely washed away so flood water was flowing into and out of the site with every tide, widening the breach as it did so. The Environment Agency made the repair of this breach their top priority on Teesside because of the potential safety and environmental consequences if there was a loss of containment and the importance of the site to the operations of SABIC and the wider Teesside chemical industry. The repair work, which took 16 days and cost about £1.5M, included:

At approximately 8pm whilst undertaking a routine tour of the Brinefields and Cavities area a process technician heard a large crashing sound and observed a "tsunami like" wall of water coming from Greatham Creek into the area which stores hydrocarbons in underground salt cavities. Fortunately the technician was in a safe location away from the incoming water.

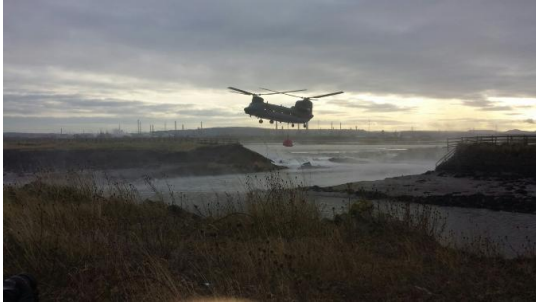
Figure 4. SABIC - Chinook helicopter dropping big bags into the breach.

- Calling in a military Chinook helicopter for 3 days to drop big bags containing rocks into the breach. It soon became clear that this was insufficient to close the breach but it did protect the ends of the embankment and prevent the breach from growing with each tide.
- Closing the A178 to through traffic so that it could be used solely to provide access to the breach.
- Using a remote controlled survey boat to measure the depth of the scour hole at the breach so the amount of material need to close the breach could be calculated.
- Employing contractors to build a 150m temporary access road along the back of the embankment then close the breach using rocks topped with clay.

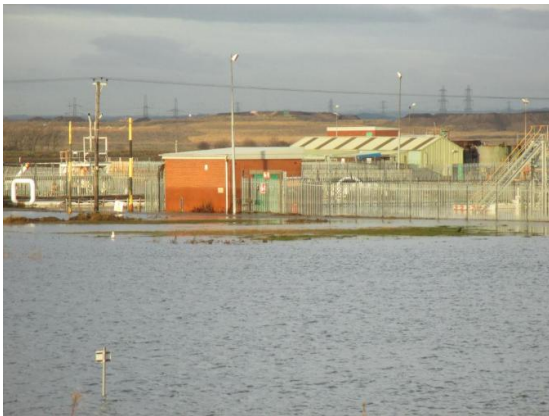
Figure 5. SABIC – note flood level mark half way up the control room wall.

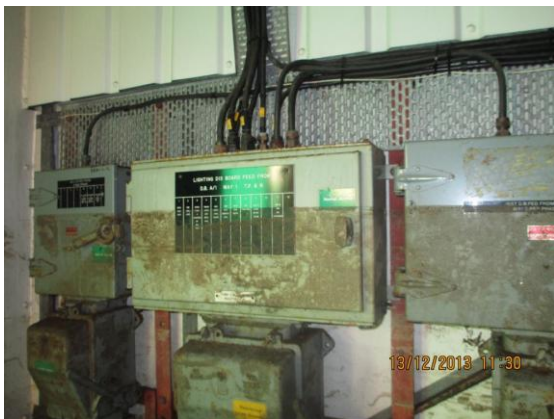
Figure 6. SABIC - flood damage to electrical equipment.

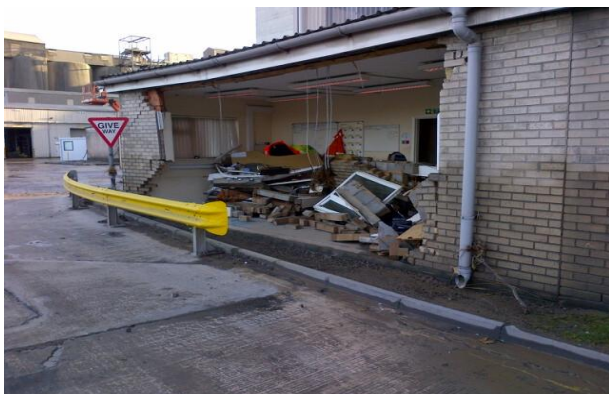
Figure 11. CEMEX – wall collapsed due to pressure of floodwater.

The flood water and silt caused catastrophic and irreparable damage to control systems, the power supply network, compressed air systems, buildings and the cement kiln which was still operational due to insufficient cooling time. High and low voltage systems were destroyed by water tracking into the terminated ends of the cables and all production ceased. Damage could have been worse had it not been for decisive action taken by the Plant Director, that minimised impact to both plant and equipment and ensured the welfare of employees.

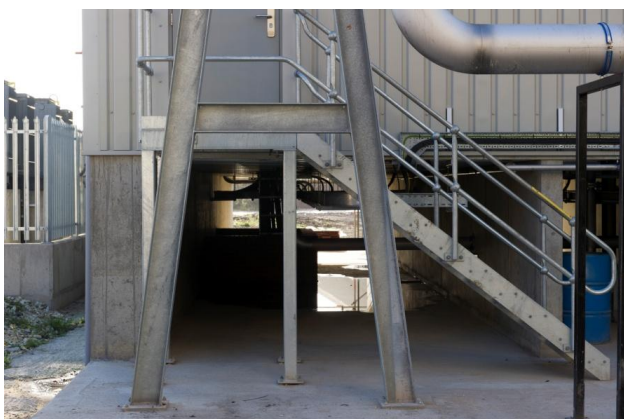
Figure 12. CEMEX – a new compressor building raised on 2m concrete plinths.

Repairs involved significant time and investment with up to 400 contractors on site at any one time. The work included the installation of new primary sub-stations, a new compressor building, a new control room, 6.4 km of new high voltage cables, (with none of the original high voltage system being reusable), along with low voltage and control cabling and 22 metres of new kiln shells. 86 skips of electrical equipment alone were removed from site. Wherever possible, new cables and plant have been elevated to 2 metres above ground level.
