## CONTROLLING THE FIRE RISKS FROM COMPOSITE IBCS

G. Atkinson<sup>1</sup> and N. Riley<sup>2</sup>

<sup>1</sup>Health and Safety Laboratory, Harpur Hill, Buxton SK17 9JN

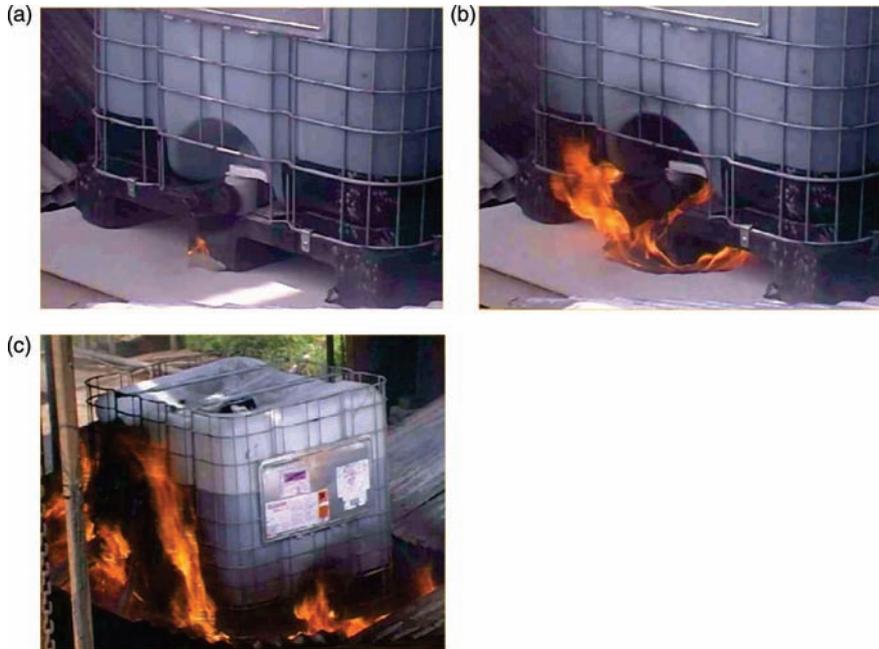
**Figure 3.** Fire in an IBC containing an industrial lubricant (flashpoint 75°C)

- a. Ignition of plastic pallet.
- b. The initial leak of lubricant is immediately ignited by plastic fire.
- c. Rapid leakage (>10 kg/s) occurs as the fire develops.

Two distinct types of fire development were observed. The first type of fire is illustrated by the sequence of photographs in Figure 3. Ignition of plastic components produces a plastic fire that is sufficiently large to ignite the material that leaks out of the IBC. Fire then develops rapidly as the IBC loses its contents in a few tens of seconds.

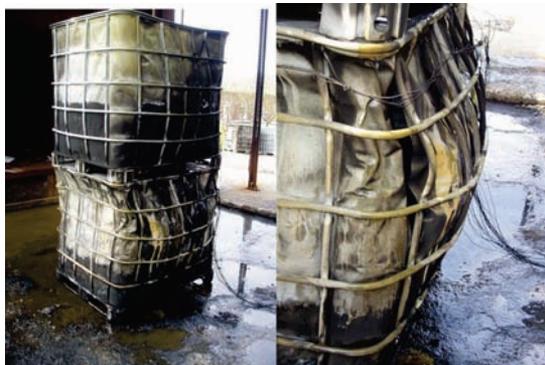
**Figure 6.** Damage to a stack of metal clad water filled IBCs during fire engulfment. Separation of metal cladding sheets is visible in lower (closeup) view

An example of the final level of damage is shown in Figure 6.

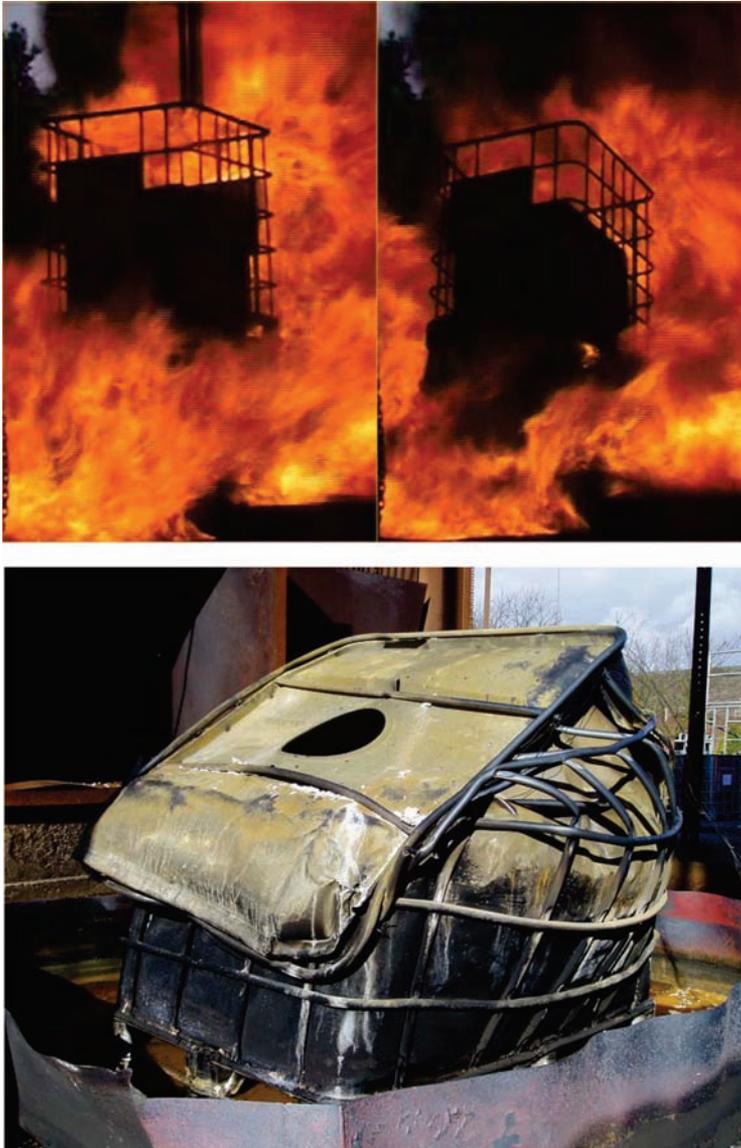
**Figure 7.** Crushing of lower (water filled) IBC by an upper IBC loaded with bricks (970 kg) during fire engulfment Above – extent of initial (arrested) yielding. Below – extent of damage following final uncontrolled collapse

In one test the liquid load in the top IBC was replaced by an equivalent mass of bricks. In this case the initial buckling was arrested by liquid release from the lower IBC. However, in this case, when the rapid flow from the lower IBC slackened there was no compensating flow from leakage of the top IBC. After roughly 40 seconds yielding resumed and the lower IBC failed completely (Figure 7).

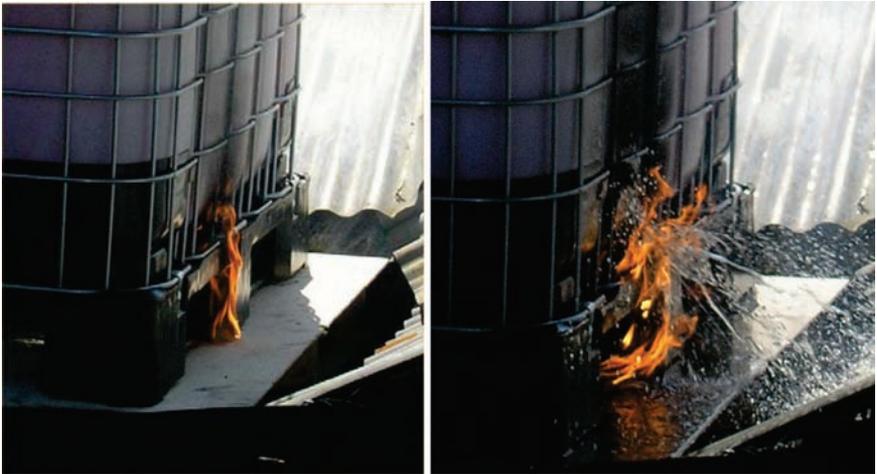
**Figure 8.** Small fire at the edge of the pallet of an IBC containing a mineral oil lubricant. Early failure occurs where flames impinge on the inner receptacle

1. Small fires near the edge of the pallet that impinged on an exposed inner receptacle caused failure of the receptacle wall in a few minutes if the IBC contained an aggressive liquid – Figure 8. This type of failure is clearly not strongly dependent on the pallet type.

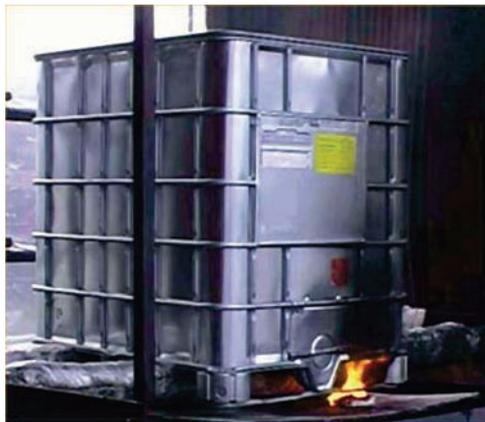
**Figure 9.** A small fire under of the pallet of a metal clad IBC containing a mineral oil lubricant. Failure of the base of the inner receptacle occurs even though this is protected by the folded metal sheet forming the top of the pallet

2. All of the plastic pallets tested were rapidly ignited by small fires.
3. Surprisingly even IBCs which had metal pallets and metal clad sides (such as the Schutz SX-EX) proved vulnerable to ignition by very small fires beneath the pallet – Figure 9. The metal sheet that supports the base of the IBC in most metal pallets is pressed into folds during manufacture to increase its stiffness – Figure 10. The mechanism of failure during exposure to a small fire under the pallet appears to involve yielding of areas of the base of the IBC inner receptacle above folds in the IBC base. A possible failure mechanism is illustrated in Figure 11.

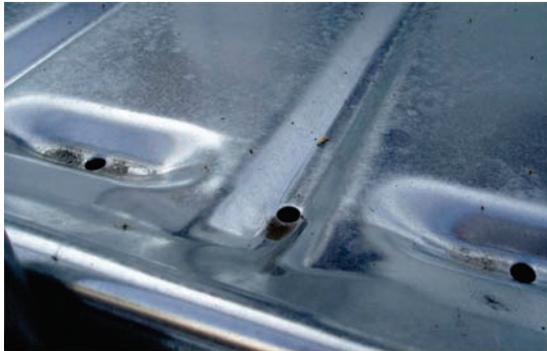
**Figure 10.** The top of a metal pallet – formed into folds to increase stiffness
