**PUBLIC REPORT OF
THE FIRE AND EXPLOSION AT
THE CONOCOPHILLIPS
HUMBER REFINERY
ON 16 APRIL 2001**

Prepared by the Health and Safety Executive

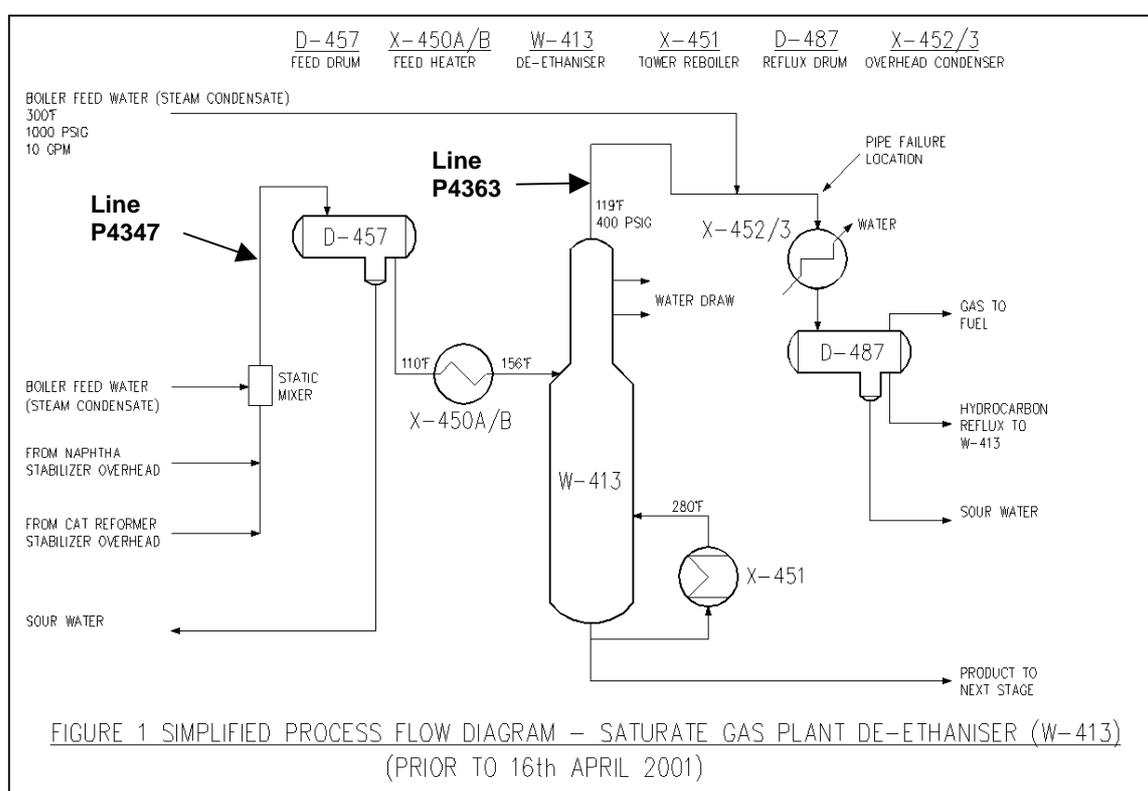
Figure 1 - Diagram of the SGP

The Refinery can be subdivided into a number of operational units; one of these units is the Saturate Gas Plant where hydrocarbon products are separated. It was on this Unit that the incident of 16 April 2001 occurred. The SGP contained three distillation columns, the first distillation column was the de-ethaniser W413 where mainly methane, ethane and propane were removed from the liquid and vapour transferred to the condensers X452 and X453. These materials were extremely flammable. The vapour was then cooled so that some condensed, mainly into propane. The uncondensed vapour was passed to the refinery fuel gas system. Pipe 4363, shown in Figure 1, connected the top of the De-ethaniser column to the condensers.
