IMPERIAL CHEMICAL INDUSTRIES LIMITED
PETROCHEMICALS DIVISION

SAFETY NEWSLETTER No.74

74/1 MORE ABOUT BELLOWS

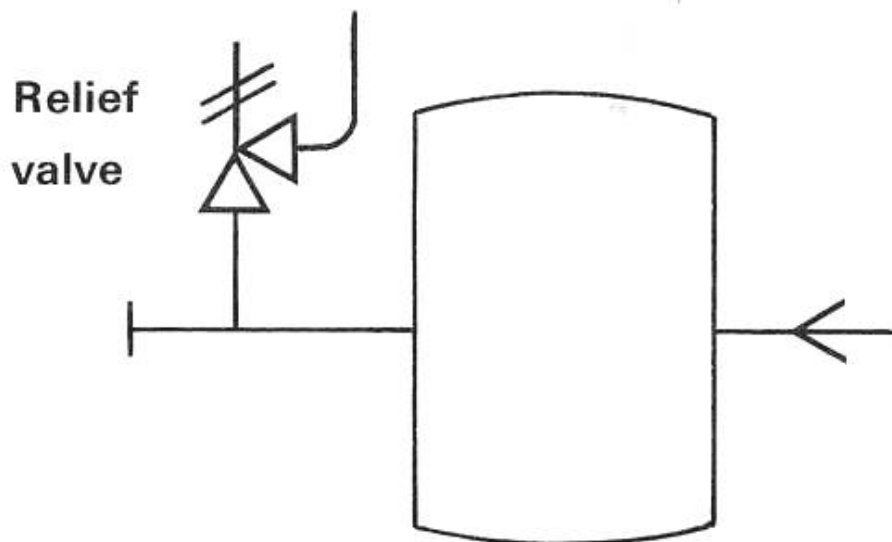
1. Why is a leak of petrol at 120°C and 100 psig more dangerous than a leak of cold petrol? (70/3).
2. We want to start up a piece of equipment on which maintenance has just been completed. It is evening. The top copy of the clearance certificate (permit-to-work) is in the maintenance supervisor's office which is locked. What should be done? (71/1).
3. What are the two sorts of compressed air mask and when should they be used? (67/2).
4. When should we use spirally-wound gaskets and when should we use CAF gaskets? (72/4).
5. What special precautions are necessary before carrying out maintenance on air cooler fans? (7 1/4).
6. What could make an underground tank rise out of the ground? (71/10).
7. Which is the best sort of cupboard for solvents, steel or wood? (70/7 (b)).
8. What is wrong with this arrangement? (70/1).
