Lessons learnt from some accidents which resulted in discharges to regulated waters

Chris Dickinson, FIChemE, Regulatory Officer, The Environment Agency, Deanery Road, Bristol, BS1 5AH

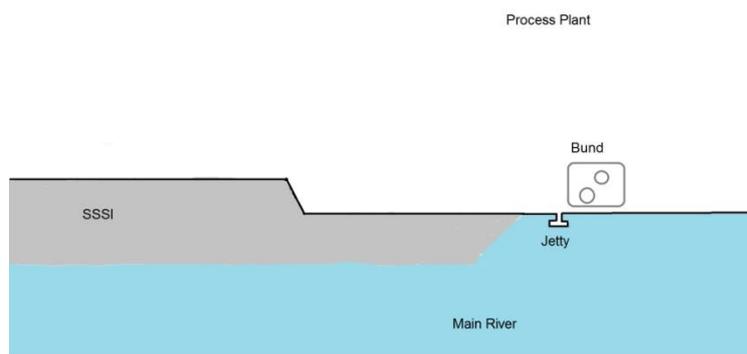
Figure 2 - Sketch of the Location of the Incident

The initial concern was the location of the release to the River. This was adjacent to an inter-tidal mudflat on the River which is a designated Site of Special Scientific Interest (SSSI) as it is a feeding ground for a number of rare water fowl, as shown in Figure 2

Full ecological assessments of the SSSI was undertaken a month after the event and again four months later. Fortunately, the environmental impact was localised and short term. The investigations demonstrated that there was no impact on the adjacent mudflats.

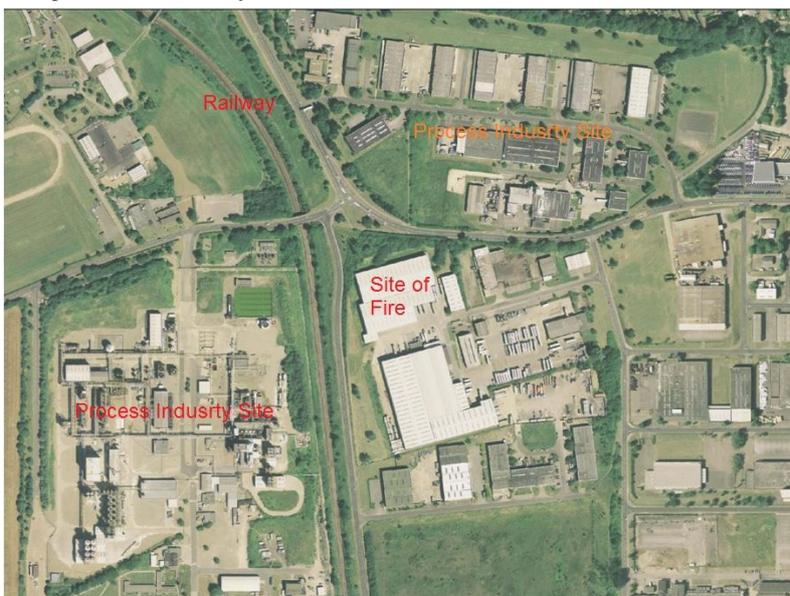
Figure 6 - A picture of the Establishment before the Fire

The establishment is the warehouse complex in the middle of the picture. The top one caught fire. It was Located in the middle of an industrial complex, with one other COMAH
