The explosion at HS041175  
Appleby-Frodingham steelworks  
Scunthorpe, 4 November 1975

A report by HM Factory Inspectorate

# The explosion at the Appleby-Frodingham steelworks, Scunthorpe 4 November 1975

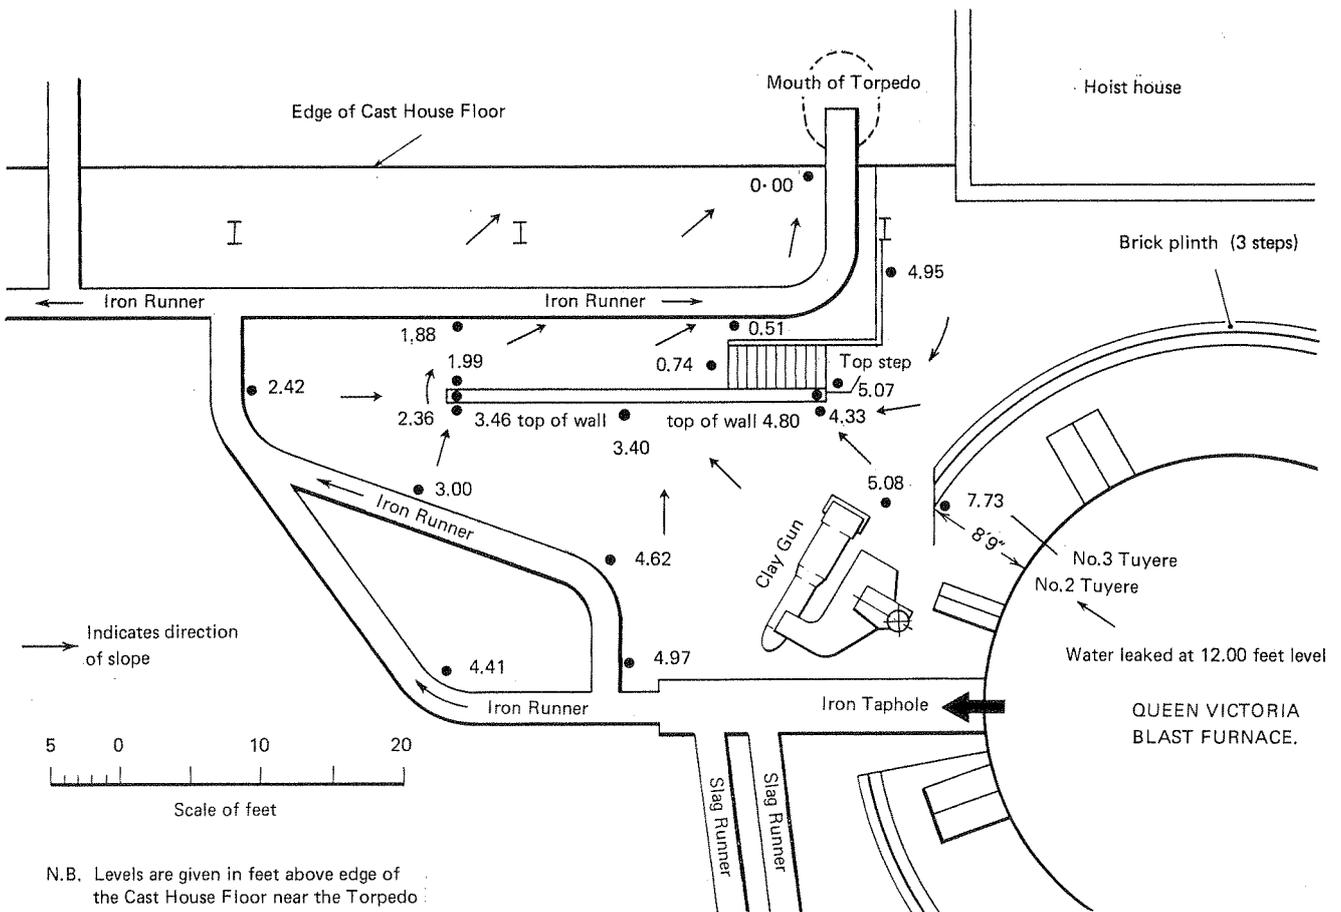
**Fig 5** Survey plan of the cast house floor, setting floor heights in feet above a zero datum located near to the lip of the iron runner concerned

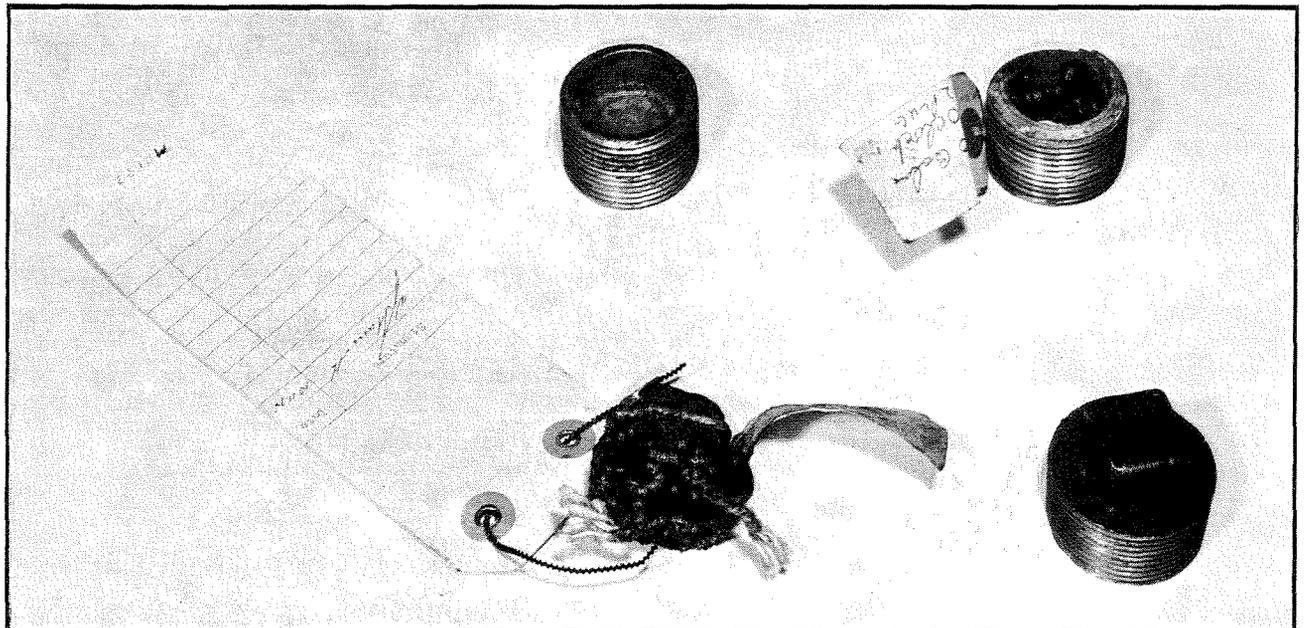
Fig 1 Components received

- (1) A new, ferrous plug, unlabelled (fig 1, bottom right).
- (2) A used, ferrous plug, (fig 1, bottom left), to which were attached two labels. The description "No. 5 cooler, No. 5 position" was written on one side of the smaller label and "No. 0133" on the reverse. The description "Item No. 11, Hearth Cooler Plug from Q Vic furnace, No. 5 cooler, No. 5 position" was written on the larger label. This label was signed, dated 10.11.75, and was secured by a wire passing through a hole drilled in the plug and a lead seal numbered 42.
- (3) A new, non-ferrous plug (fig 1, top left), unlabelled, and
- (4) A used, non-ferrous plug (fig 1, top right), to which was attached a label on which "QV No. 20 cooler 2 o'clock, No.2 plug" was written on one side and "No. 0214" on the reverse side.

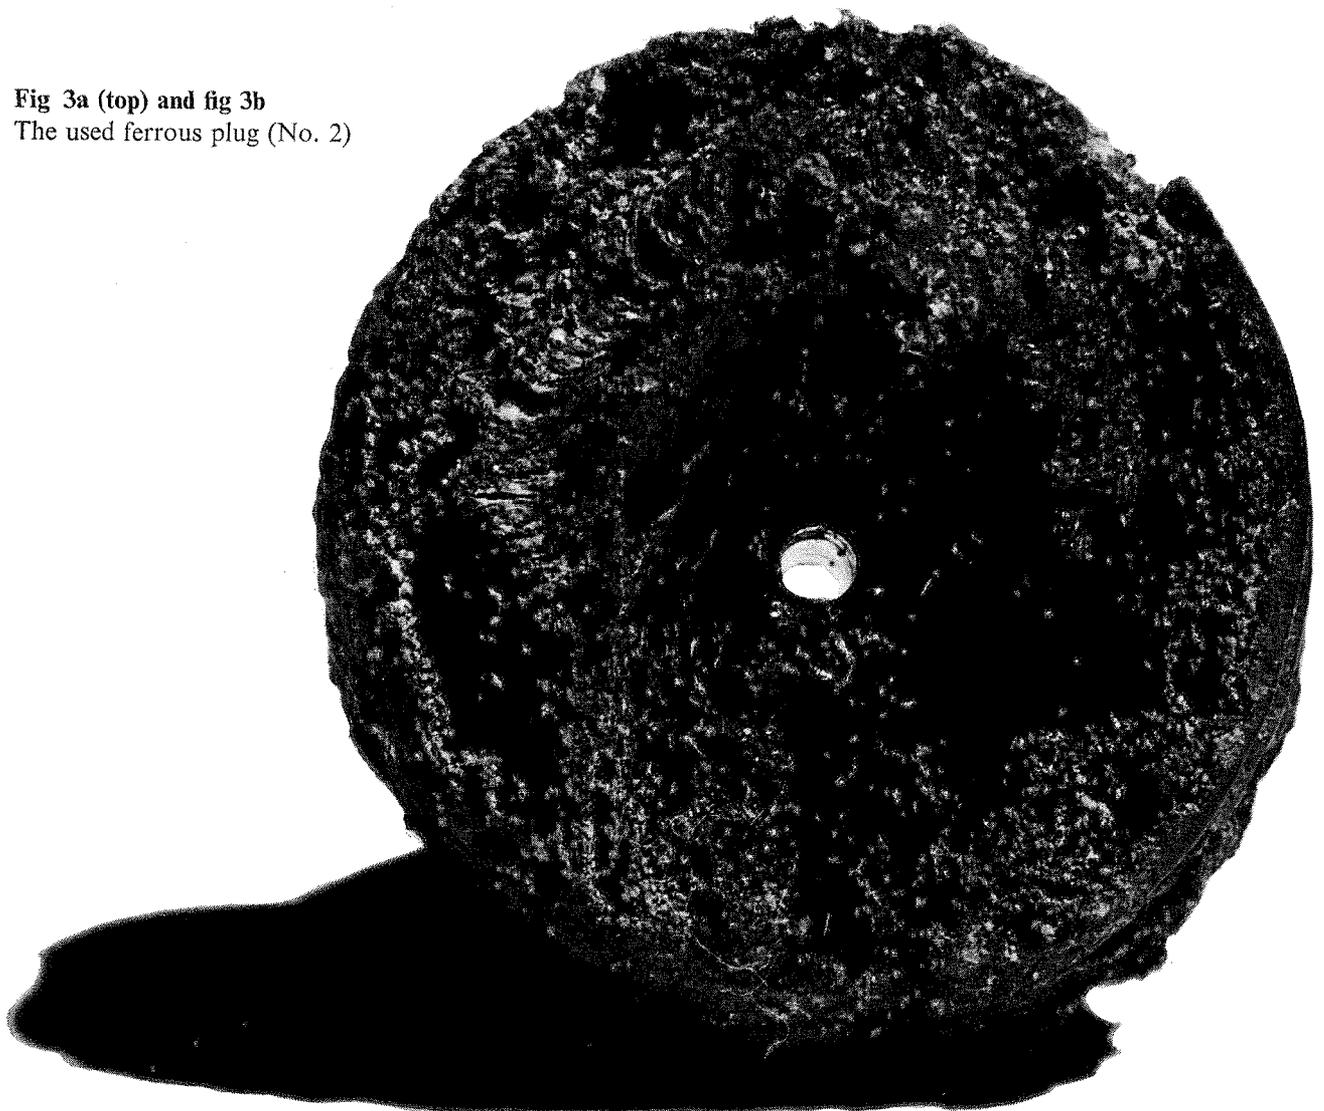
Fig 3a (top) and fig 3b  
The used ferrous plug (No. 2)

3.1.2 The used, ferrous plug (No. 2) is shown in figs 3a and 3b. These photographs clearly show that the component was very severely corroded, especially around the threads and on the back face, ie opposite the square protrusion. Only two threads were clearly defined for about a quarter of the circumference. The rest were so corroded that they were barely discernible in many places. However, the most intense attack had taken place

**4.1** The used, ferrous plug (No. 2) was made from a poor quality wrought iron, which had been hot formed to shape, and the threads had been machine cut after forming. The slag particles were large, and showed little sign of having been broken down during manufacture of the iron. Some particles were large enough to be clearly visible to the naked eye.

**4.2** The used, ferrous plug (No. 2) was heavily corroded, the corrosion product consisting mainly of hydrated ferric oxide and magnetite. The presence of chlorine and other elements was detected. Micro-examination of the sectioned plug showed that this corrosion had preferentially attacked the interface between the slag particles and the matrix. The orientation of the particles was such that deep penetration from the back face had

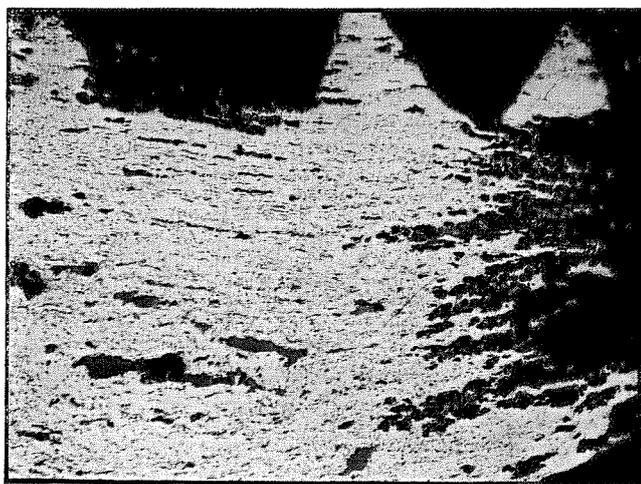
Fig 7 Magnification 10

Preferential corrosion had taken place in the same way along the edges of slag particles which, because of the grain created by hot working, lay across the base of the threads. The effect was thus to weaken the attachment of the threads to the rest of the plug. One part of the thread in the section shown in Fig 7 can be seen to have been completely lost; other parts of the thread are in various stages of degradation.

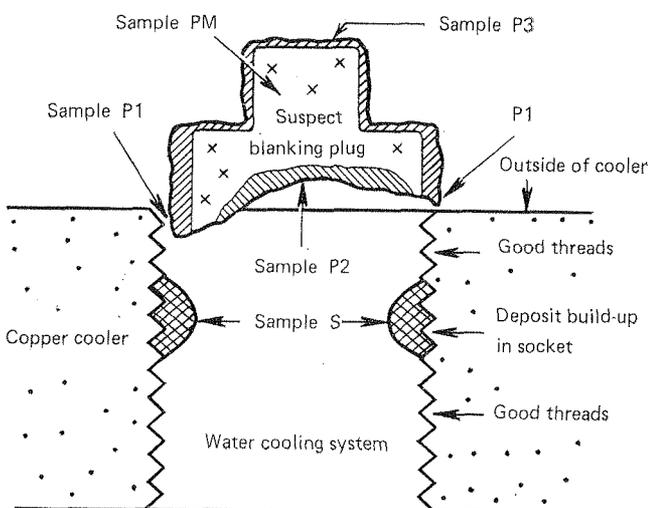
Fig 1 Samples taken from suspect plug and socket. Schematic representation of suspect plug and socket in the copper cooler. The hatched areas indicate predominately non-metallic material

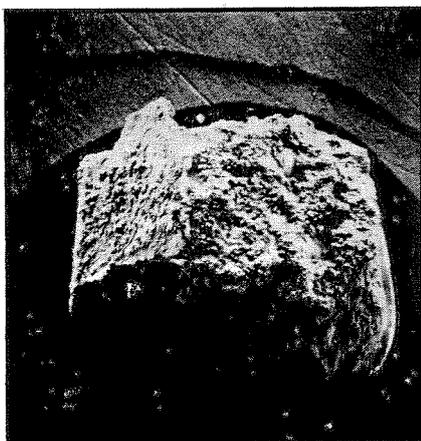
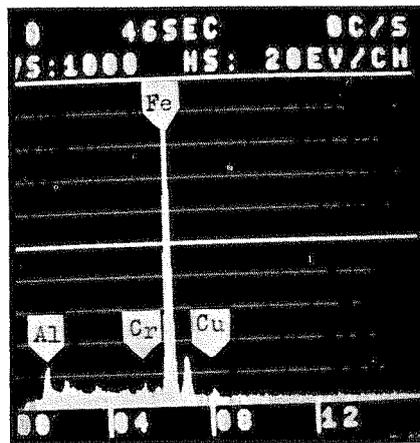
**Fig 2** Debris from socket  
(sample S)

The debris available comprised aggregates of small particles, and several small samples of this material were examined microscopically. A typical piece is shown in fig 2, together with an energy-dispersive x-ray spectrum: as can be seen, strong peaks from iron and aluminium are evident with minor ones from chromium, sulphur, manganese, silicon, copper, titanium, calcium, and nickel. In fact, the peak from aluminium in this spectrum is artificially high, due to stray x-rays from the specimen holder, as was demonstrated later using a brass holder.

Scanning electron micrograph (a) of a typical particle with its non-dispersive x-ray spectrum (b). The latter shows peaks from Fe, Al, S, Cr, Mn, Cu, Ca, K, Cl, Ti (in approximate order of peak height)

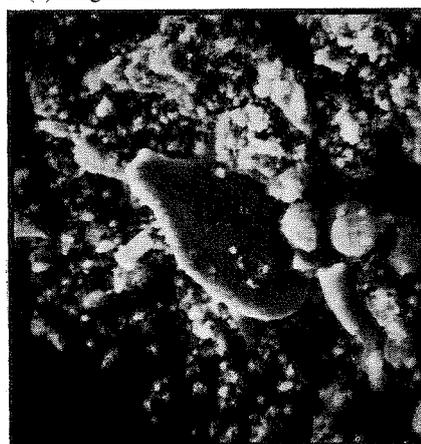
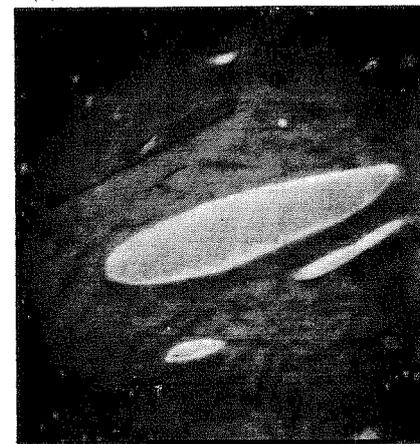
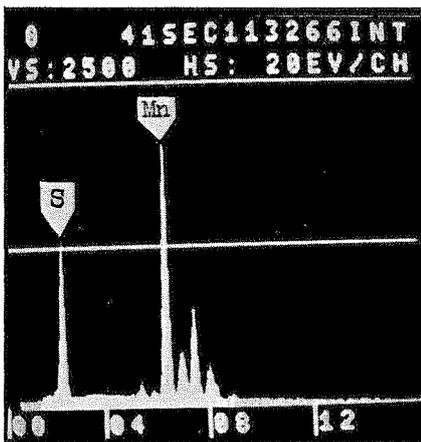
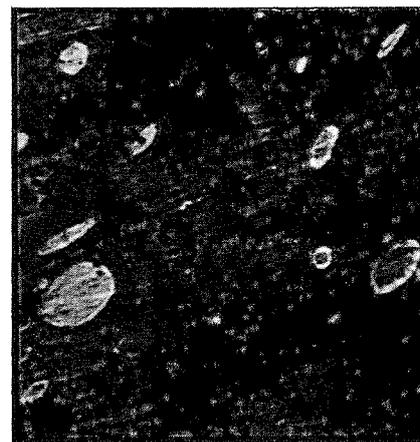
**Fig 3** Manganese sulphide inclusions in debris from socket  
(sample S)

An important observation on samples from this debris is the presence of particles of manganese sulphide type-I non-metallic inclusions, about 15-50  $\mu\text{m}$  long, (fig 3). Although most of the debris was apparently non-metallic, a few small metallic particles were detected in the aggregate, and in a polished section, one of these metallic areas also showed the sulphide inclusions (fig 3).

(c) Non-dispersive x-ray spectrum of the MnS particle in (b) showing strong concentrations of MnS with small quantities of Ni, Cu, Ti, Cr

(d) Optical micrograph of polished metallic fragment in debris, showing dispersion of MnS inclusions

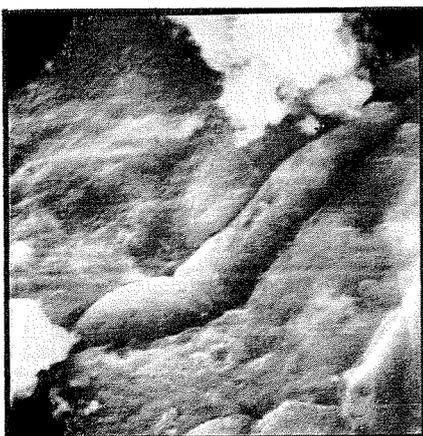
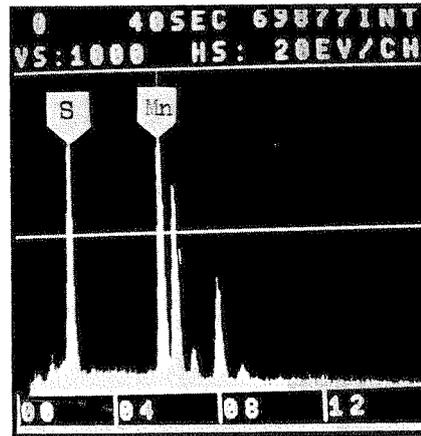
**Fig 4** Debris from the suspect plug  
(sample P 1)

Scanning electron micrograph showing manganese sulphide particle, and (b) non-dispersive x-ray spectrum of the particle showing high concentrations of Mn, S, Fe, Cu, and some Al

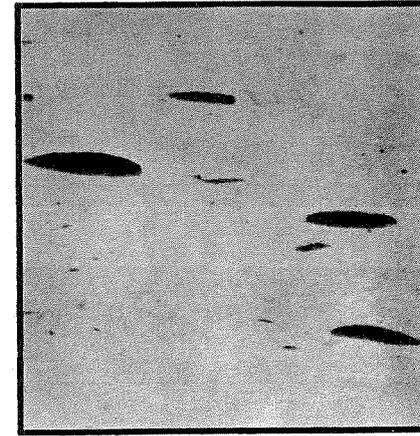
**Fig 5** Metallic part of the suspect plug  
(sample PM)

Optical micrograph (unetched) showing a dispersion of MnS Type-1 inclusions

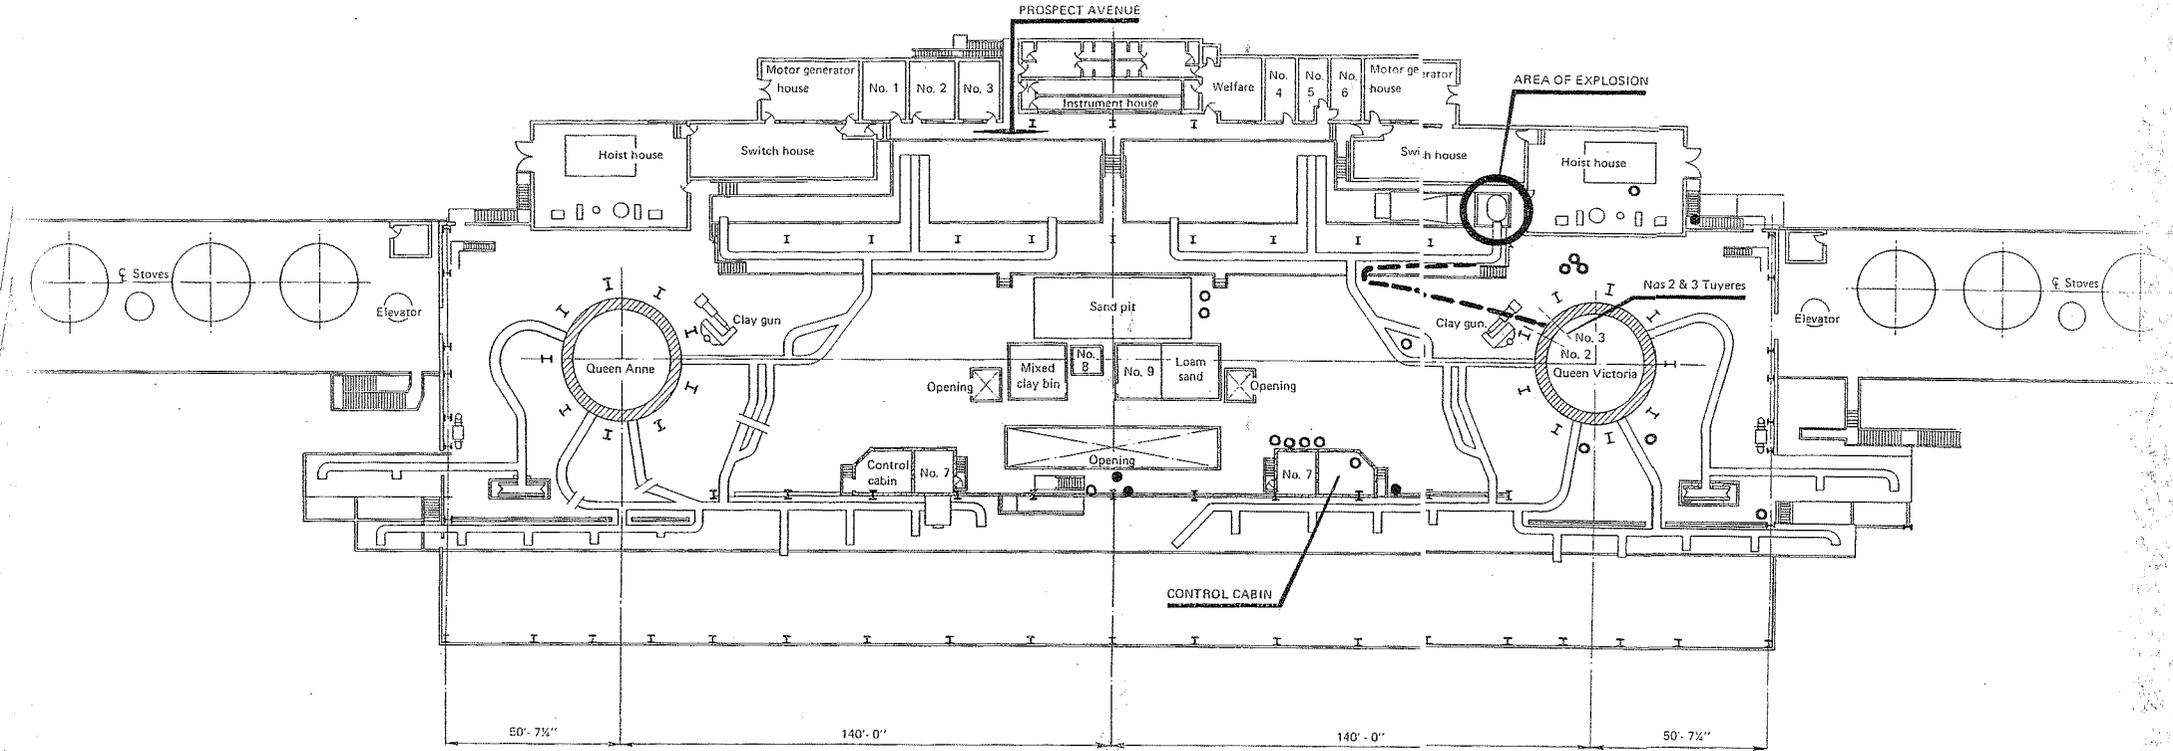
Probable position of workmen at the time or just after the explosion
