The explosion at the Dow chemical factory, King's Lynn 27 June 1976

A report by HM Factory Inspectorate

The explosion at the
Dow chemical factory
King's Lynn
27 June 1976

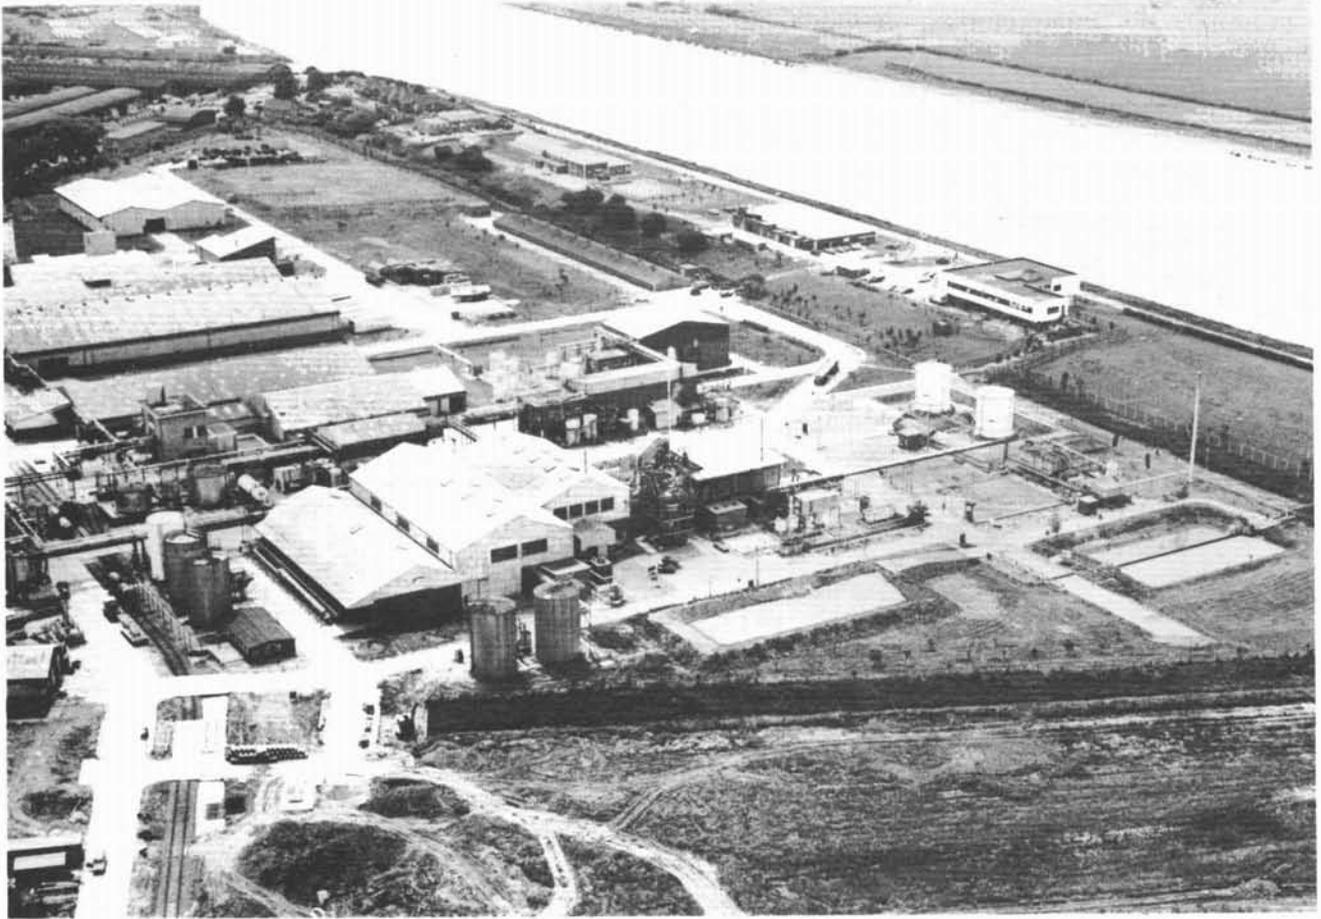
BEFORE An aerial view of the site taken some time before the date of the explosion.

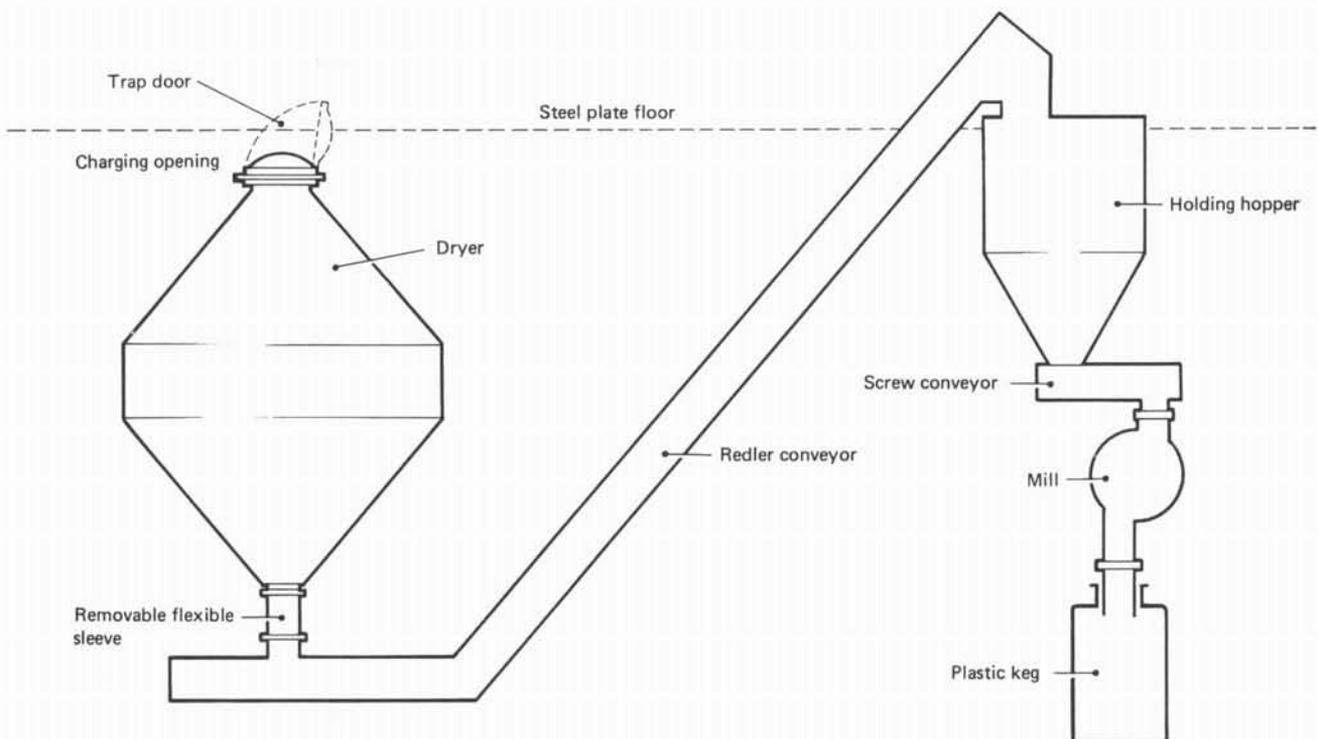
Clopidol drying and packing plant

were, however, as described, and it appears that materials could have been left in the dryer for periods of twenty-four hours or more before transfer to the holding hopper. Although the Clopidol plant had originally been fitted with dust explosion suppression equipment, the adoption of the plant for Zoalene processing had shown an appreciable leakage of dust which necessitated fitting exhaust ventilation to the elevator and hopper.
