The Putney Explosion

A report of the investigation by the Health
and Safety Executive into the explosion on
10 January 1985 at Newnham House,
Manor Fields, Putney

A report by HM Factory Inspectorate

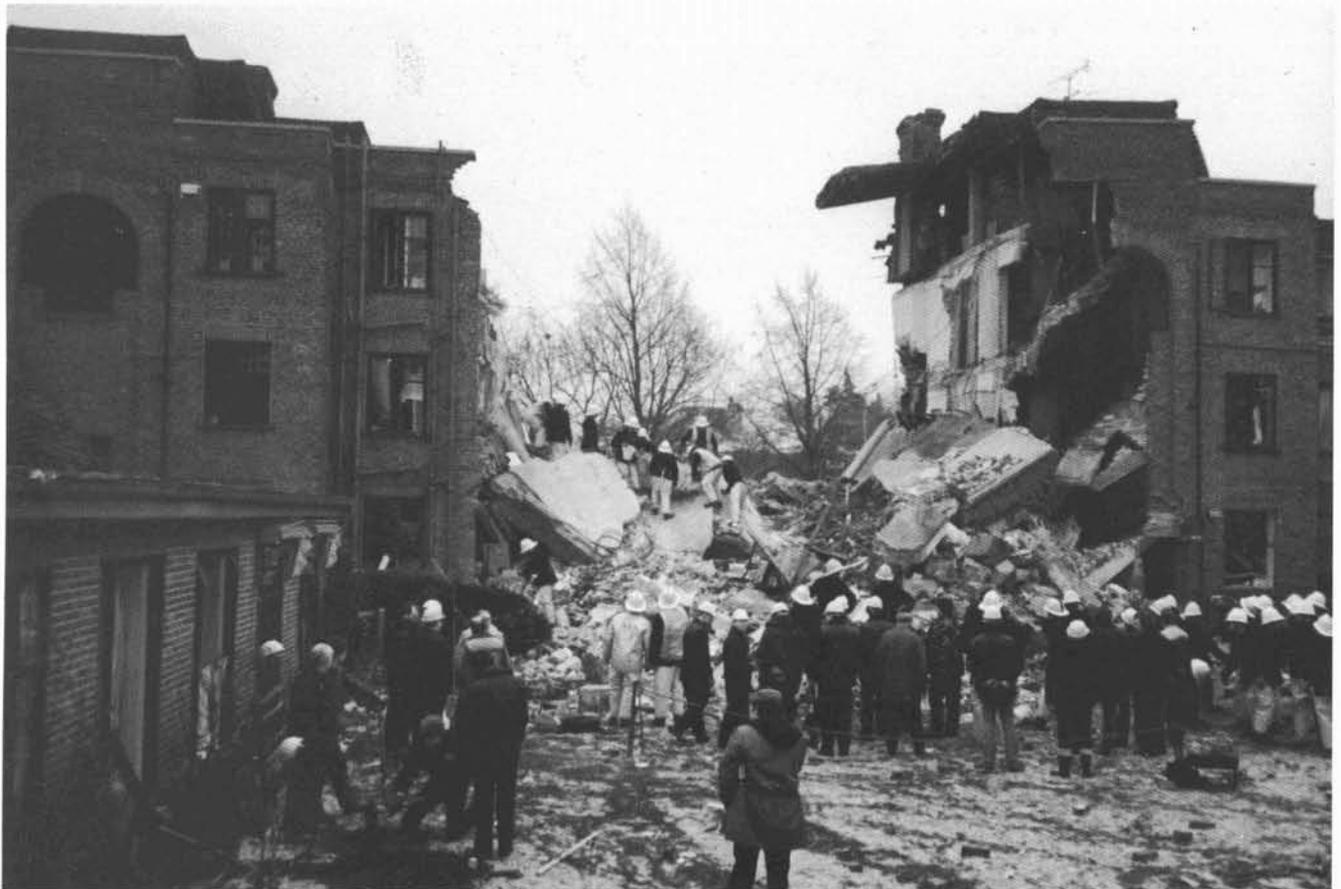
Rescue services search for survivors

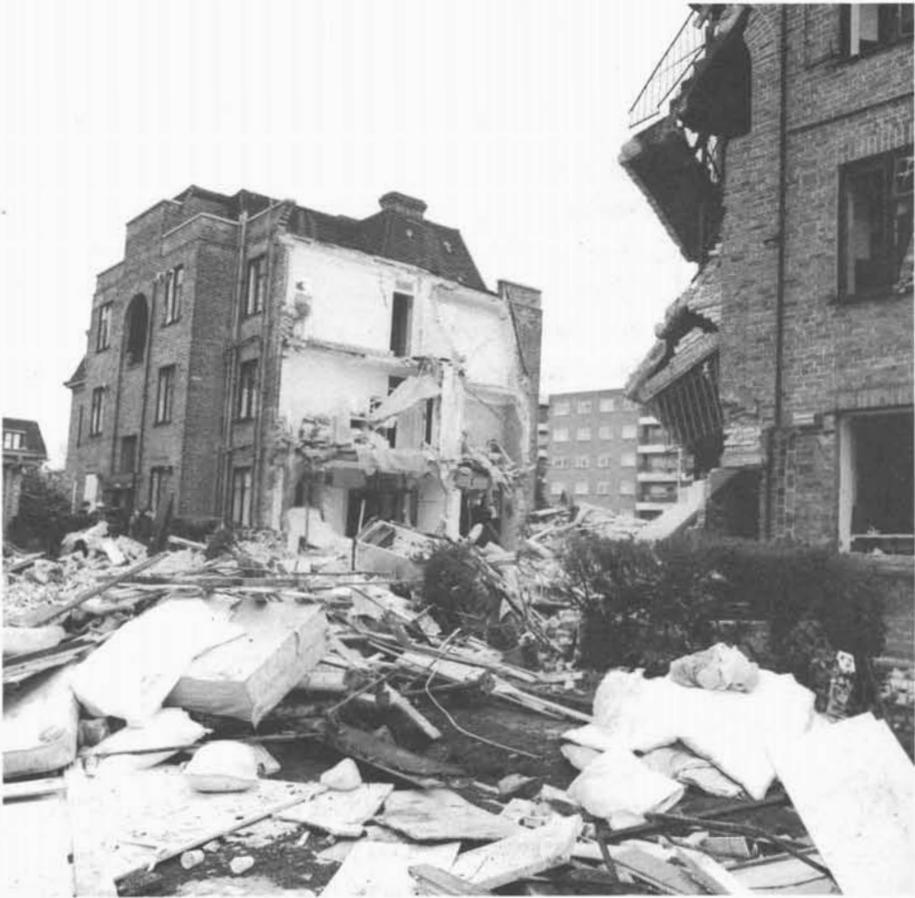
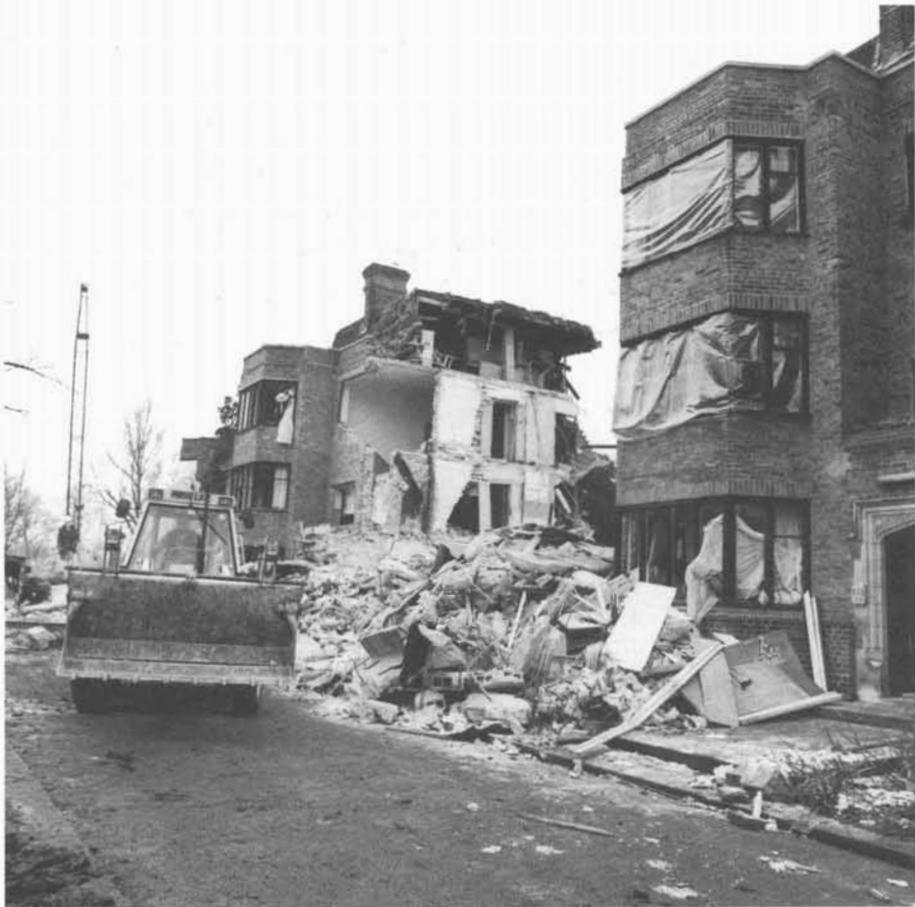
General views of damage

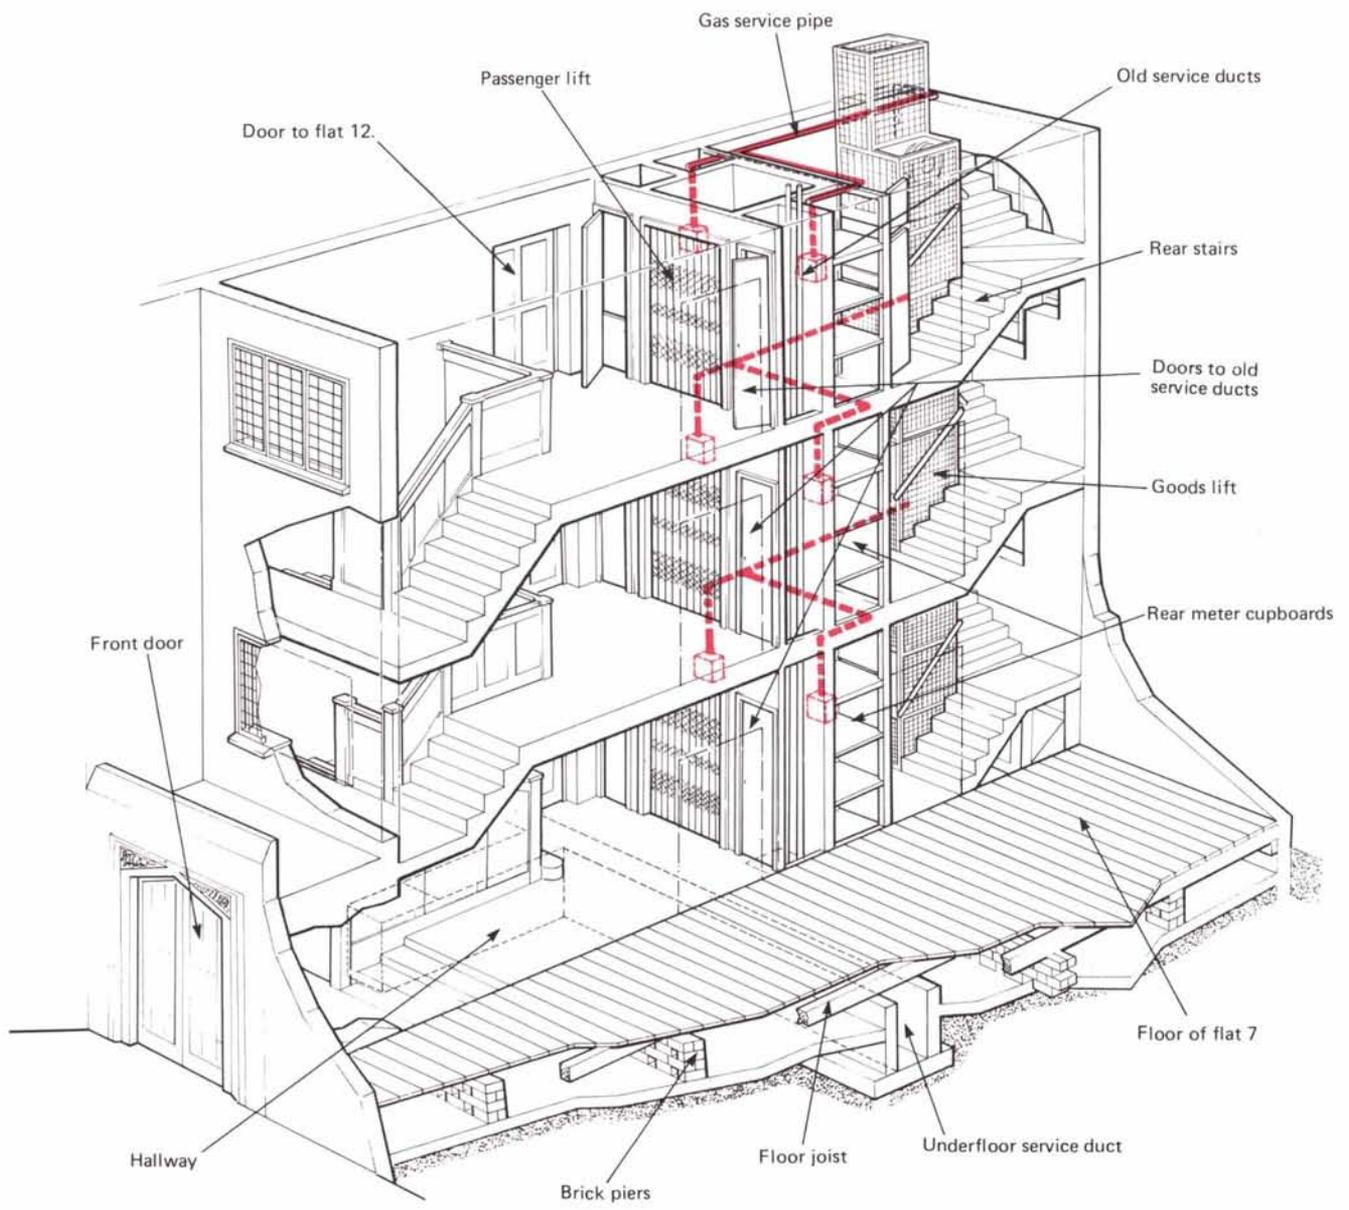
Fig 5 Section of Newnham House through stairway

48 From this point the gas could have followed many routes into the central ducts, and into the flats through gaps around the skirting boards, between floorboards and through carpets. Surviving occupants smelt gas strongly in the front stairway to Flats 7 to 12 immediately before the explosion but, apart from Flat 12, not inside the flats. It is not known whether gas was smelt in the ground floor flats (see Figure 5).

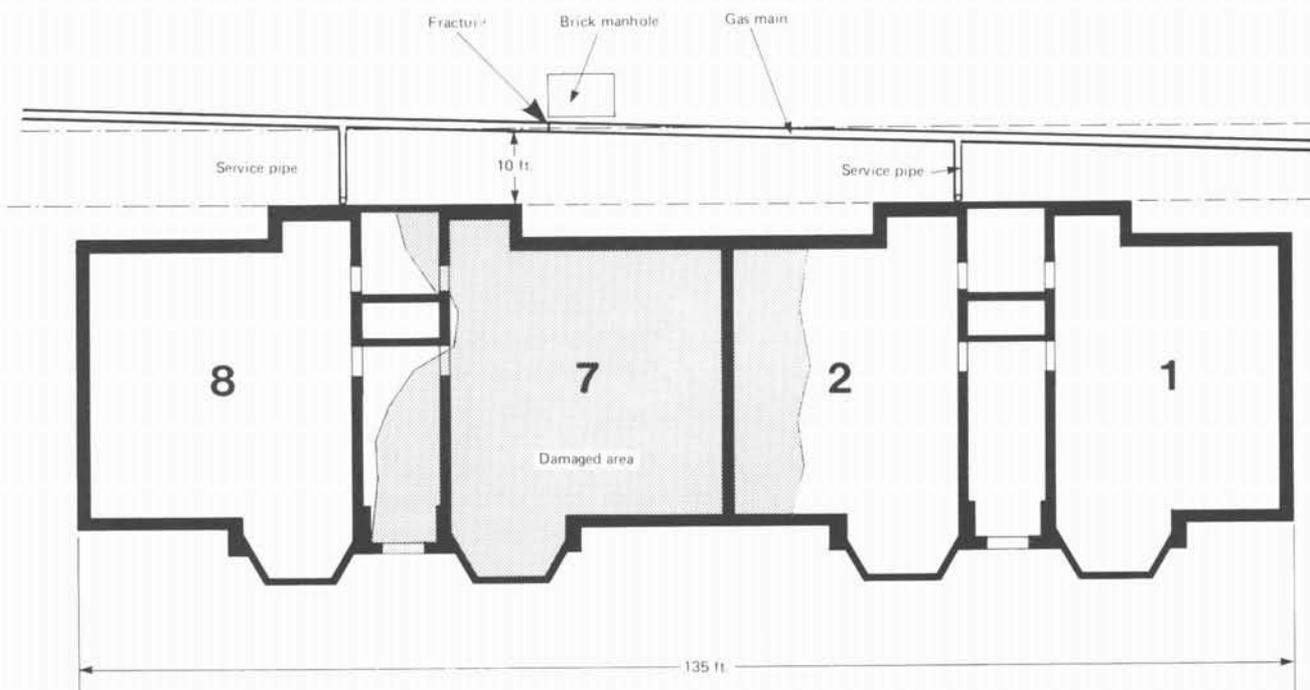
Fig 6 Plan of ground floor of Newnham House

12 The gas main runs parallel to Newnham House under the far edge of the service road, approximately 2.5m to 3.5m from the rear wall (see Figure 6) and approximately 700mm deep. It supplies the block through two 50mm (2") service risers running up the outside of the block to one side of each rear stairwell (Figure 7). These pass through the outside wall at each floor level and are connected to the individual gas meters.

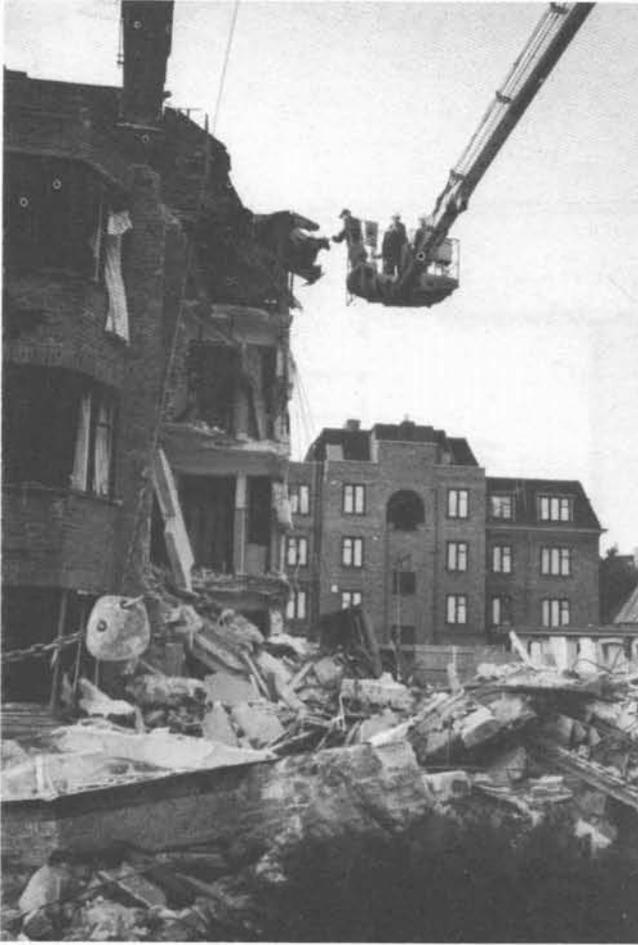
Fig 8 Mobile access platform

14 The explosion left parts of the remaining building in a dangerous condition. Under the direction of HSE improvements in structural safety were effected by use of a mobile access platform and a crane to enable the investigation to proceed (see Figure 8).

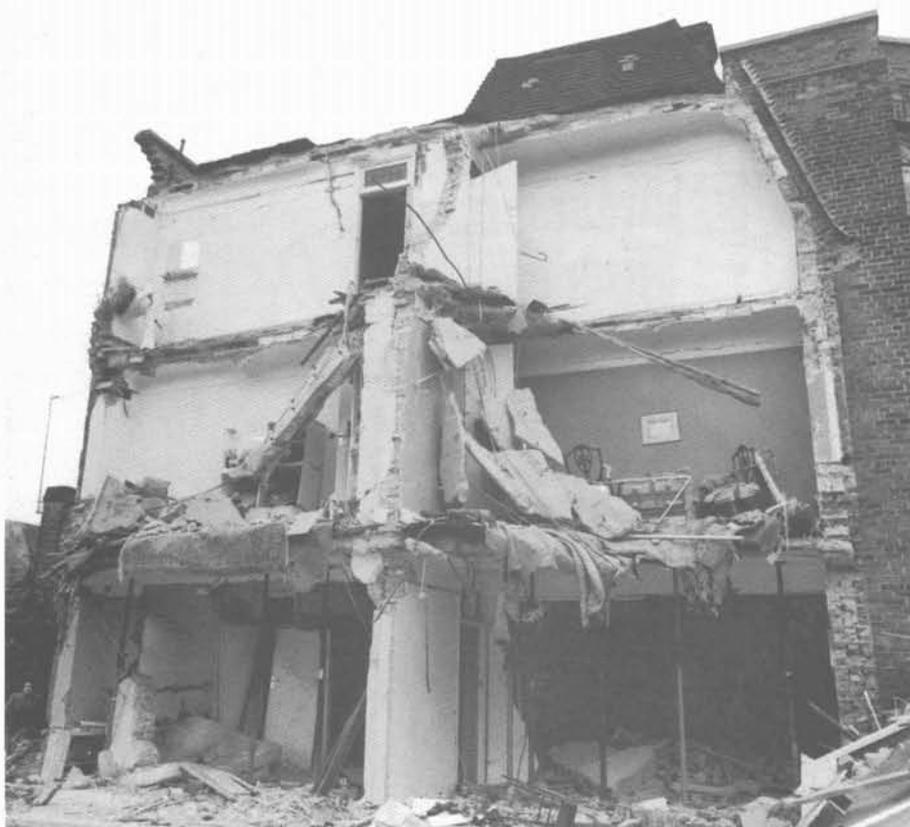
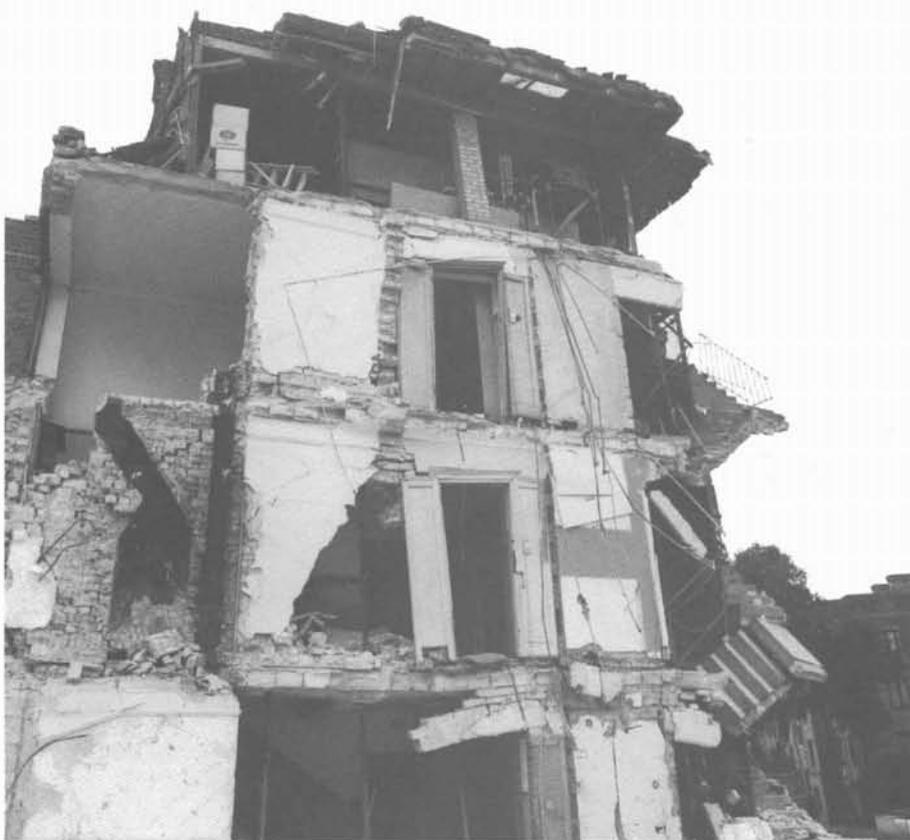
General views of damage
