The chemical release and fire at the ASSOCIATED OCTEL COMPANY LIMITED

A REPORT OF THE INVESTIGATION BY THE HEALTH AND SAFETY EXECUTIVE INTO THE CHEMICAL RELEASE AND FIRE AT THE ASSOCIATED OCTEL COMPANY, ELLESMERE PORT ON 1 AND 2 FEBRUARY 1994

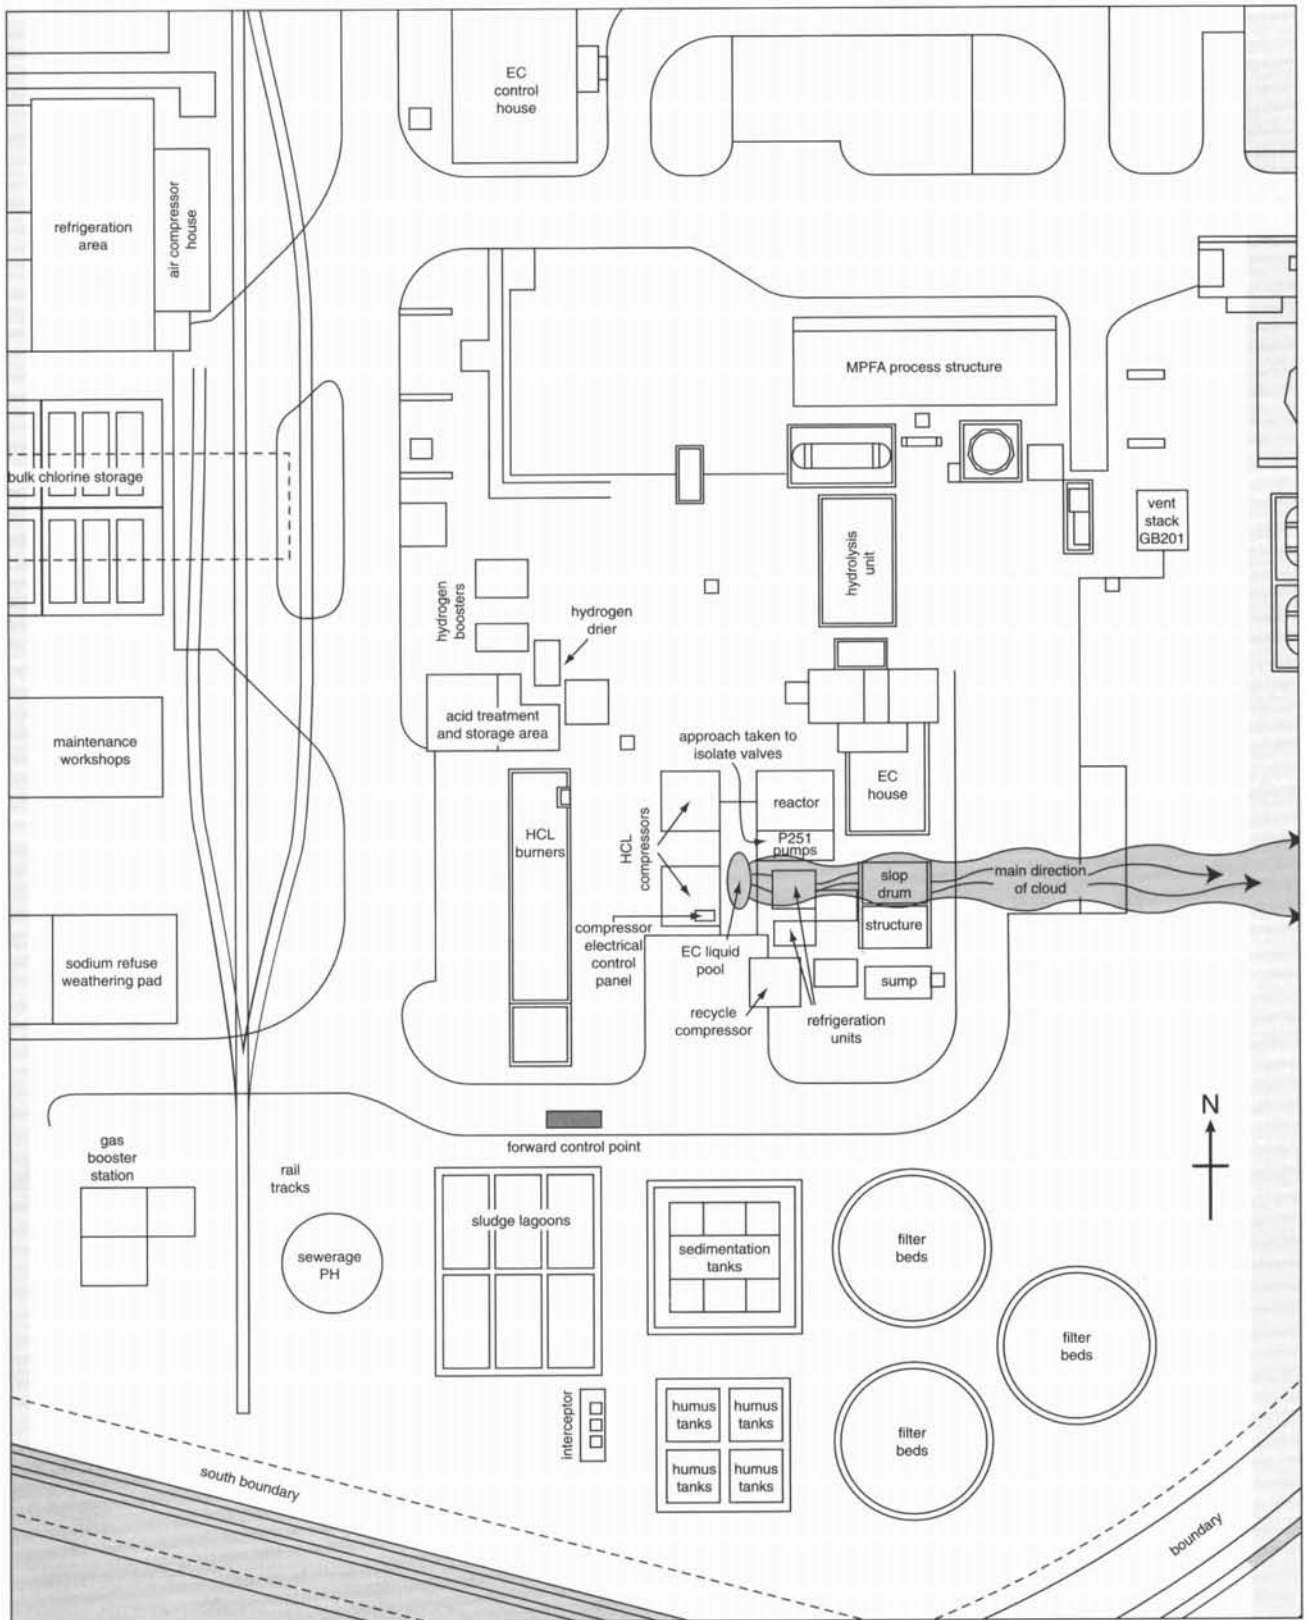
Figure 1: Plan of area around EC Plant

- 72 The compressor was inoperative as its piston had been removed, nevertheless electrical supply was available at the panel at the time of the incident. This panel was at the location marked in Figure 1. On the control panel, there were a number of items of electrical equipment, each of which were designed to an appropriate explosion proof standard.

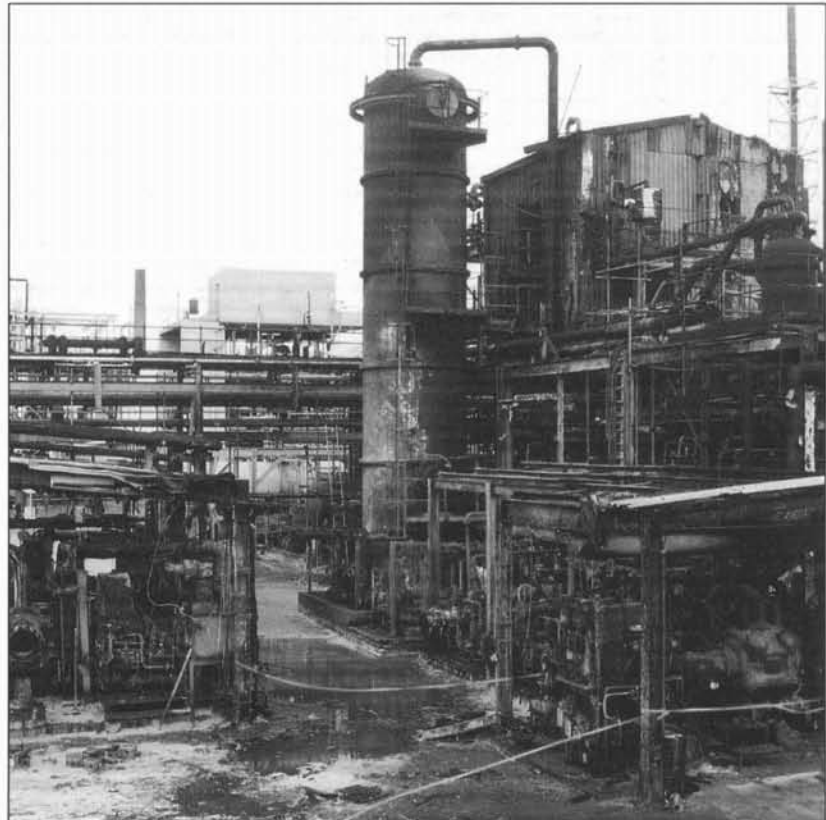
Figure 2
*Photograph of
general view of EC
production plant*

- 15 The EC plant was constructed in 1972. It occupied a relatively small area of the site, about half the size of a football pitch. A general view of the plant is shown at Figure 2. The reactor stood in a brick bund designed to contain small spillages and drain them via a pipe and gully to a soakaway and evaporation area approximately 10 metres away. The area on which the plant stood was tiled and gradually sloped towards the evaporation area. Since mid-1992 the reactor and two further large process vessels, V255, known as the slops drum, and V256, the stabiliser feed drum, had been clad with an intumescent fire protection coating. This type of coating expands in a fire to form successive layers of insulating protection and was designed to provide a minimum of two hours

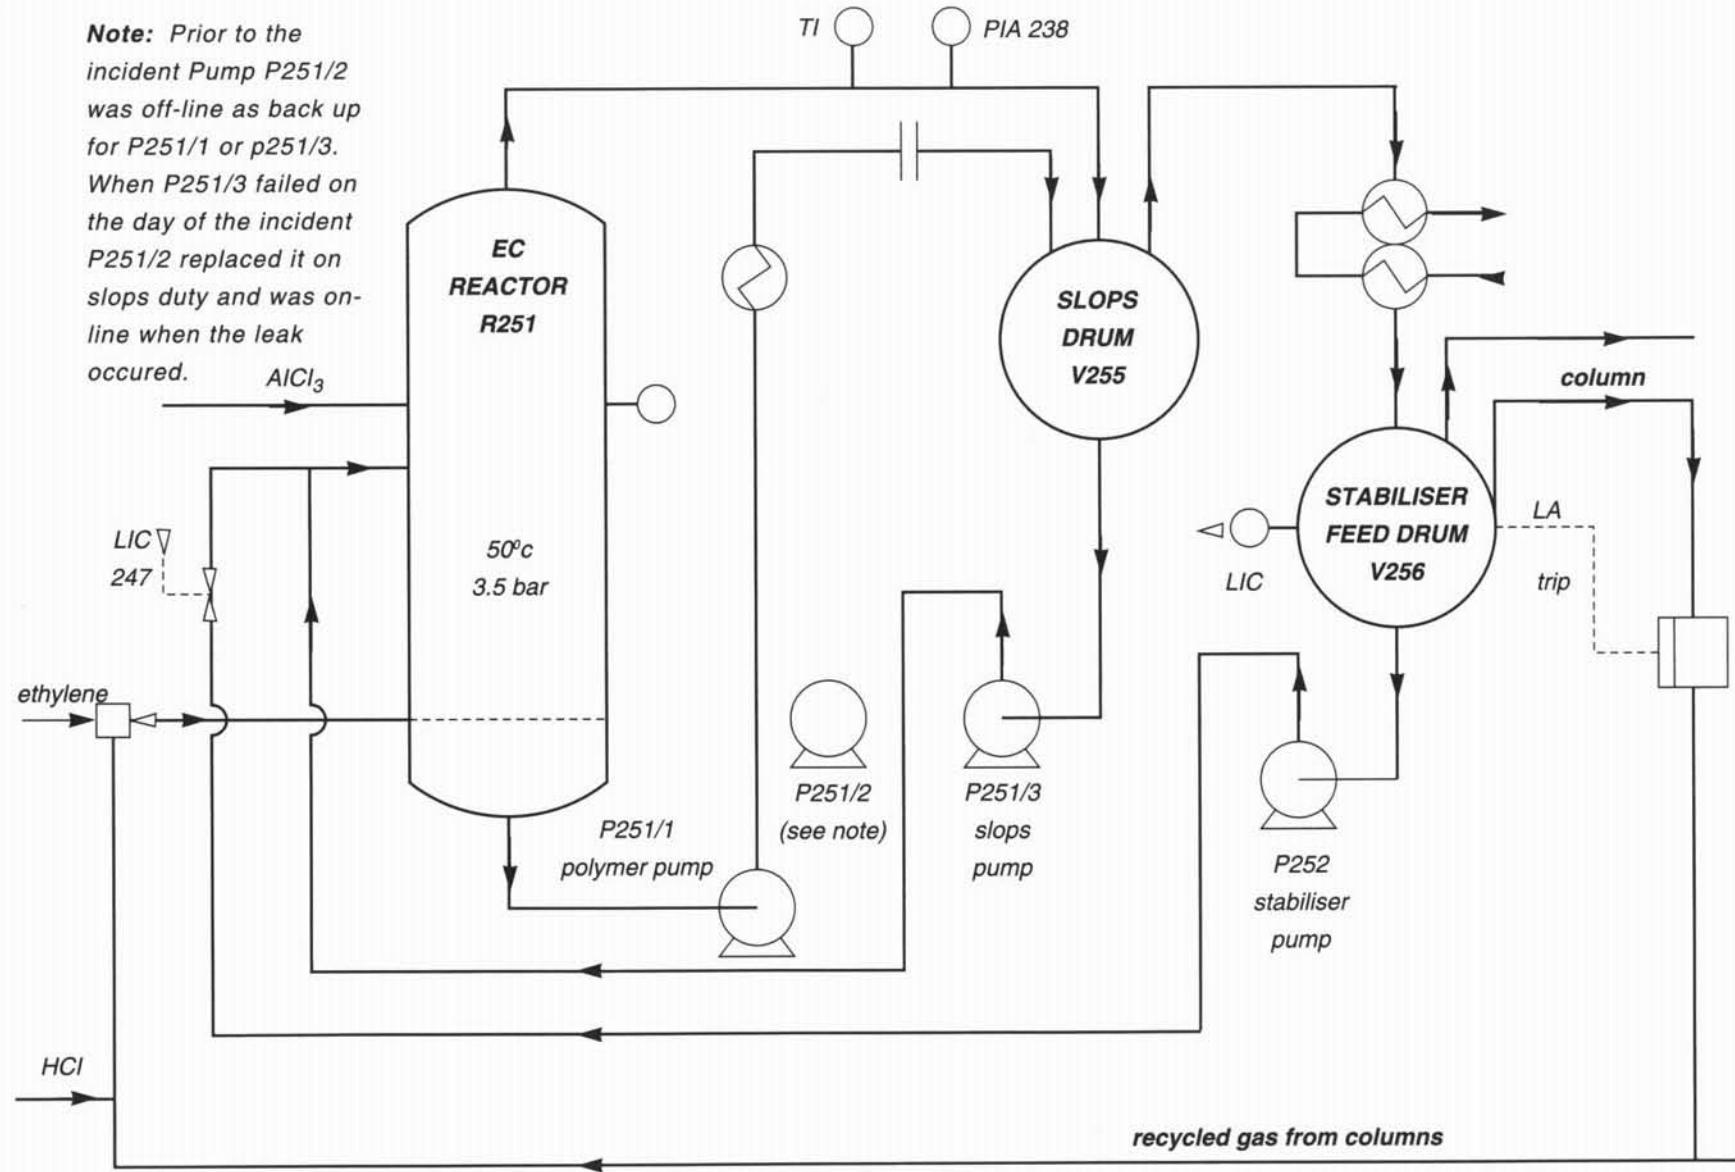
Figure 3: Simplified process flow diagram of EC process

Note: Prior to the incident Pump P251/2 was off-line as back up for P251/1 or p251/3. When P251/3 failed on the day of the incident P251/2 replaced it on slops duty and was on-line when the leak occurred.

- 16 Ethyl chloride was manufactured by the liquid phase reaction between ethylene and hydrogen chloride (HCl) in the presence of ethyl chloride and catalysed by aluminium chloride. The HCl was produced on a demand basis for the EC production plant by burning hydrogen in chlorine in an adjacent plant. It was filtered and compressed then fed to the EC reactor. A simplified flow diagram of the EC process is shown in Figure 3.

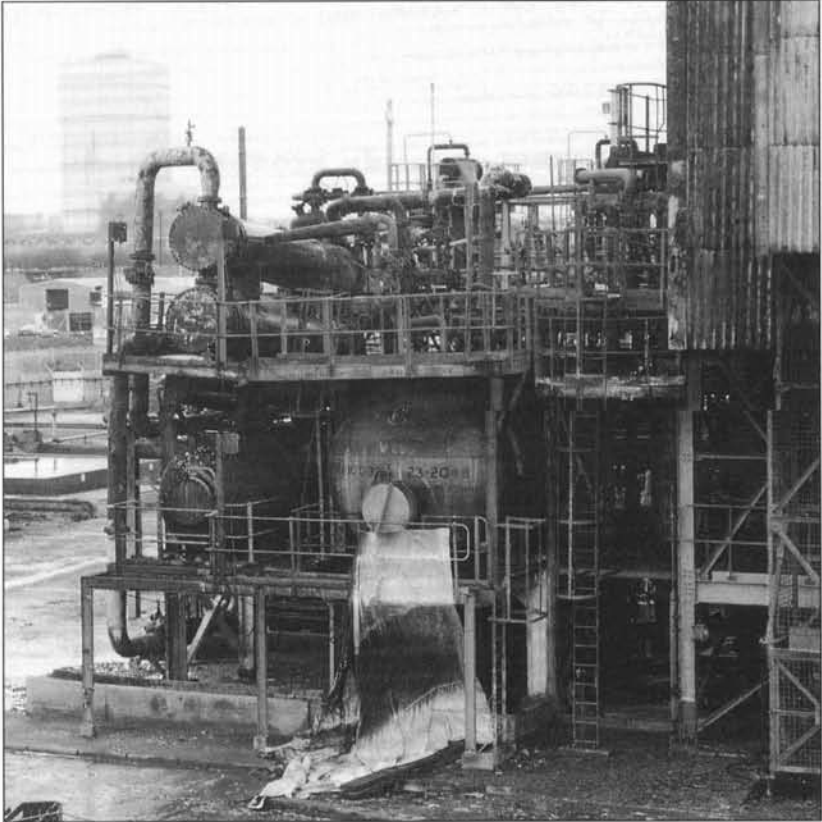
Figure 4 Photograph of slops and stabiliser feed drums (seen from the east)

- 19 The slops and stabiliser feed drums were positioned next to each other on a steel gantry at a height of approximately 3 metres above ground level (Figure 4), about 6 metres from the reactor. Underneath the two vessels was an area enclosed on three sides by a brick wall of height 0.6 metres sloping to the same evaporation area as the reactor. The evaporation area was immediately adjacent to these vessels at ground level. A by-product of the process was a polymer oil made up of heavier hydrocarbon components than ethyl chloride. This was removed as waste from the bottom of the reactor by a third pump, P251/1.
