## Part H

### HISTORIC INCIDENTS THAT ILLUSTRATE THE BREACHES IN DEFENCE IN DEPTH

#### Incident Studies and Illustrated Safety Teaching Examples for ChemEngers

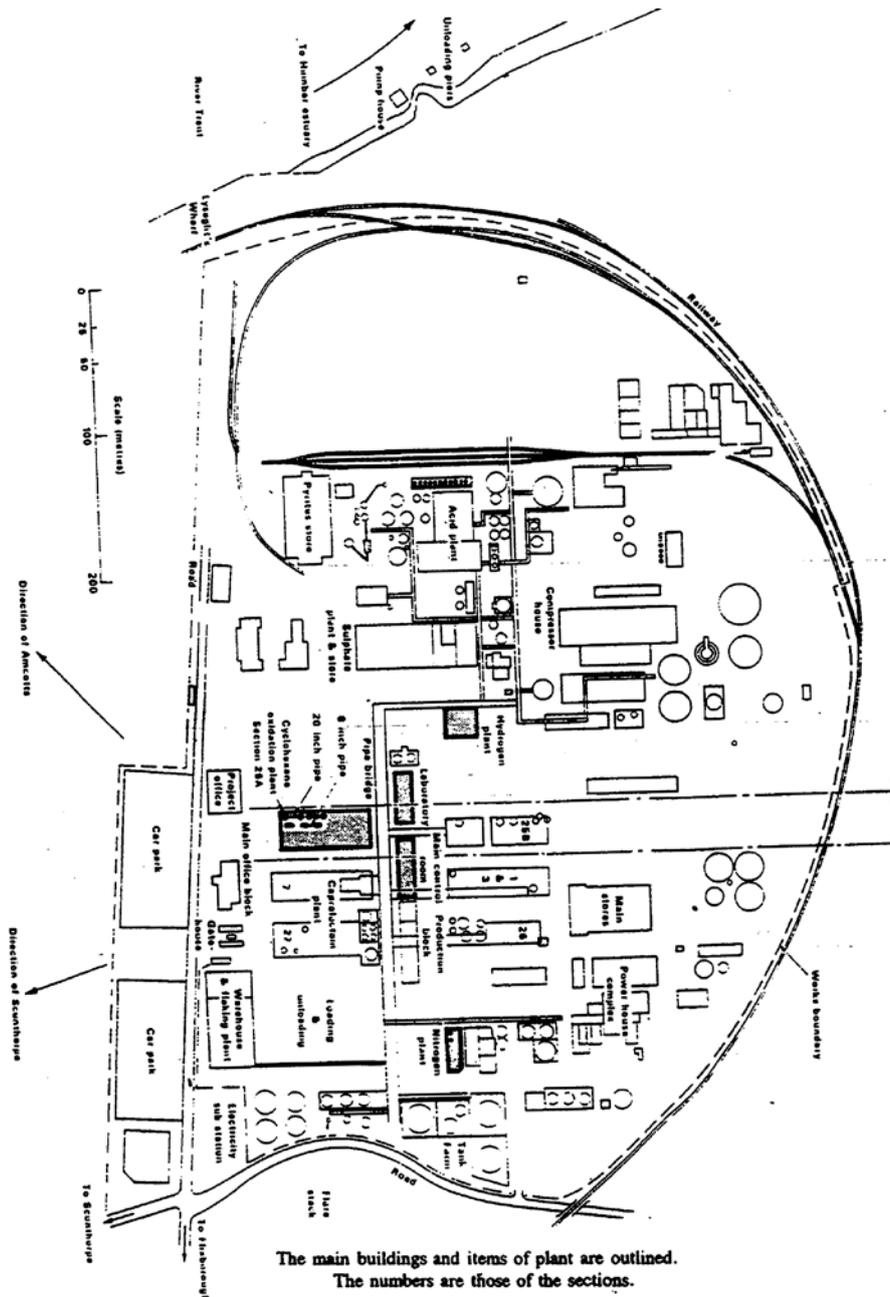
Figure A. Simplified site plan of the works of Nypro (UK) Ltd at Flixborough

The site layout is shown in Fig A before the event and in Fig B as an actual view after the event. The process is shown in Fig C, it will be noted that reactor 5 is bypassed. The area and the site were rural and there was the usual application of fertiliser and nitrate run off into the ground water and river. The nitrate run off was not fully appreciated by the work staff. This is a feature of the ground water which played a major role in the lead up to the final explosion.

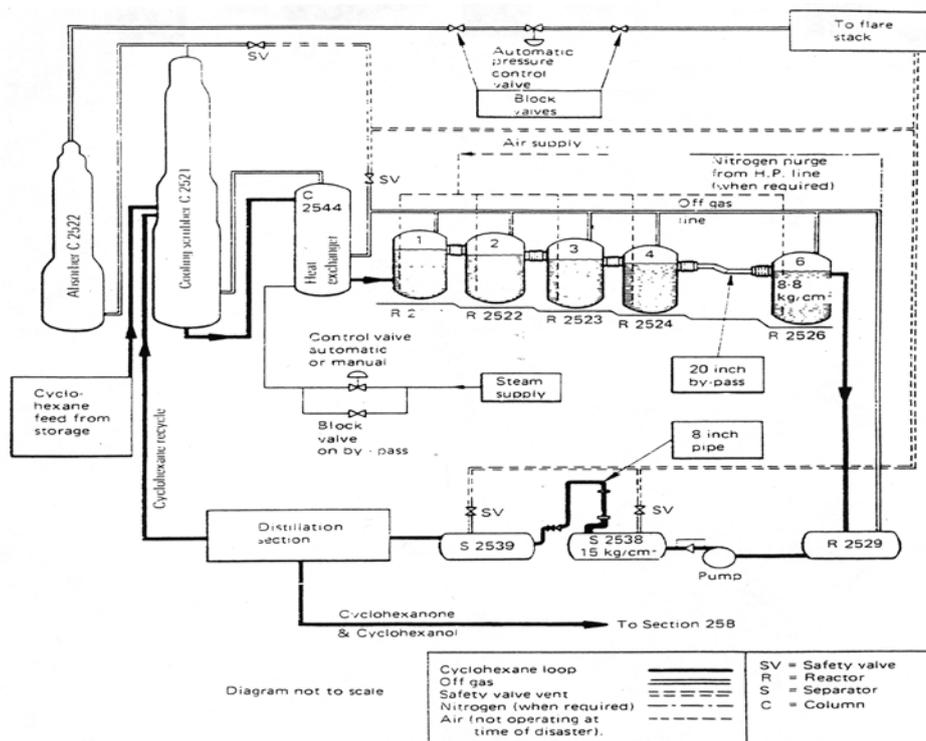
Figure C Simplified flow diagram (not to scale) of the cyclohexane oxidation plant at Flixborough

Following leaks it was normal practice to spray water (water containing nitrates) onto the shell of the reactors this resulted in stress corrosion cracking of the shell. Following inspection reactor 5 was removed as the shell was cracked. The appreciation of the potential for stress corrosion cracking was not understood nor were the implications of cracking appreciated. [Start-up]

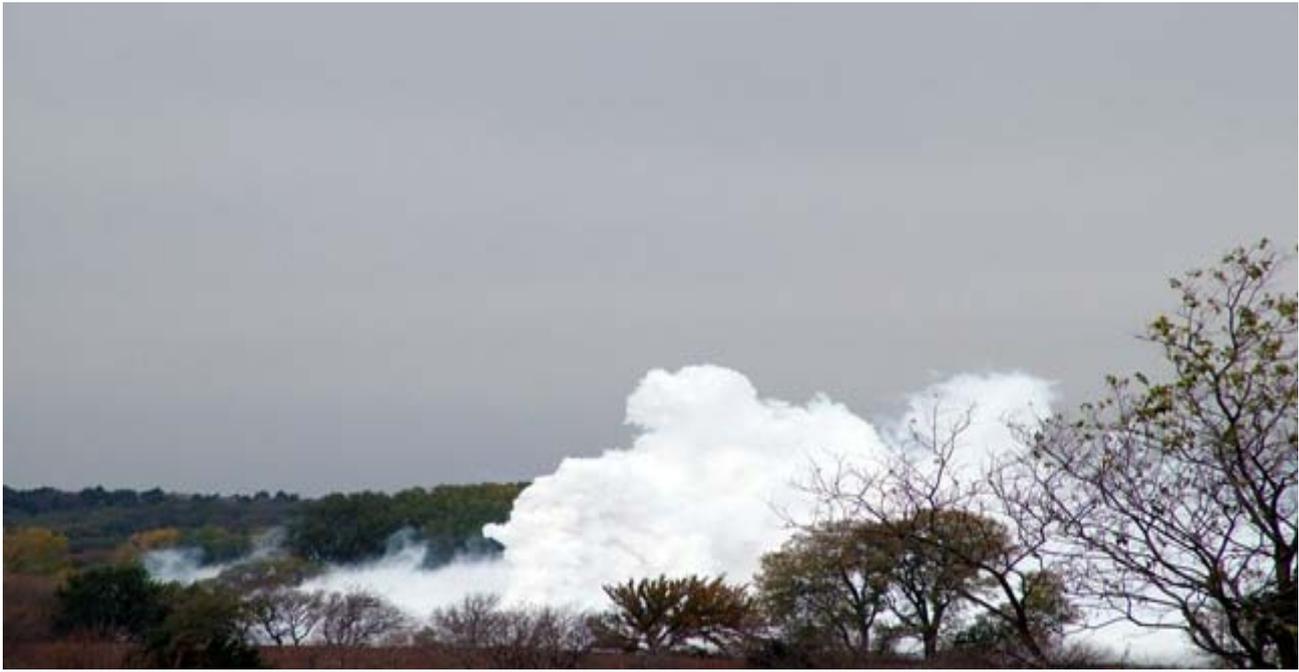
So as to re-enforce the message on learning from history, look at the photo above. It looks like a photo of a rising mist cloud in a valley at dawn. Do not assume anything. It is the photo of a release of liquid ammonia. If you were in this cloud – well to put it simply - you are dead!!!

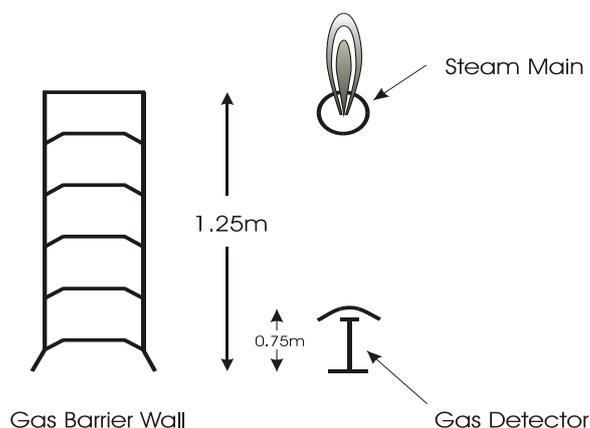
**Figure 3.1 The basis of a “gas barrier wall” in the text**

1. The plant handled cryogenic hydrocarbons.
2. World wide experience showed that cryogenic hydrocarbon leaks had caused a number of serious incidents so a “Gas Barrier Wall” (GBW) was installed – Figure 3.1. This was 5 off 25 cm concrete slabs (1.25m in total). The height was not scientific but was called “*the psychological height of attempt*”, that is, would you climb it in an emergency!? (The author of these studies ran over hurdles which were 1.05 m high). Behind the wall were sections of steam pipe drilled with vertical holes such that the upward momentum of the steam jets would entrain gas and air diluting the gas by “momentum transfer”. In addition an array of Gas Detectors were installed at an elevation of 0.75 m - not good for the knees. (Figure 3.1)

In this case the plant handled cryogenic hydrocarbons and the global incidence of leaks made the management fit a “Gas Barrier Wall” (GBW) around the plant. Inside the wall are hydrocarbon gas detectors as shown in figure 3.1

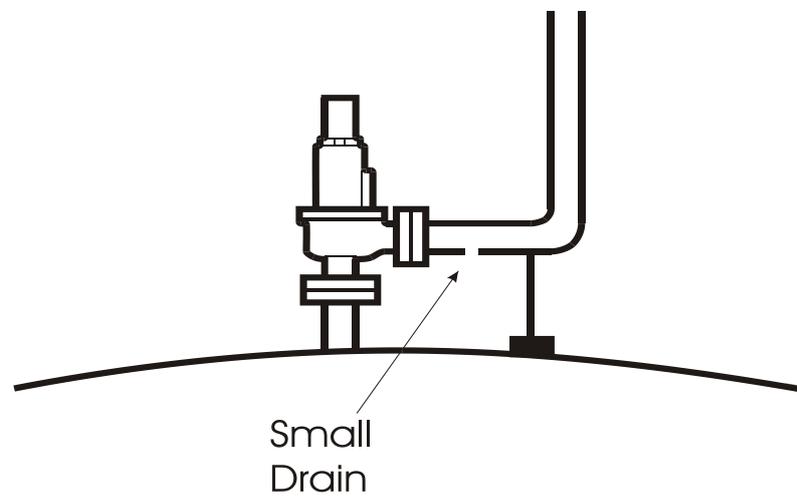
**Figure 3.2.1 Typical steam relief line**

Figure 3.2.1 shows a typical steam pressure relief valve (PRV) arrangement. The PRV has a vertical tail pipe, to avoid any steam burns to bystanders should it lift, which is fitted with a “weep hole” of about 5mm diameter at the bottom. (See fig 3.2.1) The design intent of this hole is to drain any steam which had leaked past the PRV metal seats and condensed on the cold vent pipe (or rain water that may have accumulated in the pipe.) This steam condensate, if not drained, would impose a back pressure on the PRV, increasing the lift pressure, and it would create corrosion of the elements in the PRV causing it to stick shut, hence the drain hole is a **key safety feature**.

One day there was a violent eruption of hot condensed steam from the tail pipe!

1. If the drain hole is choked any slight steam leakage generates condensate which builds up as a column of water, the column is heated by conduction from the PRV internals or the leakage of steam. There must be a balance point of heat gain against suppression of the boiling point of the condensate
2. More importantly the drain hole is actually a safety system – who checks it? In many cases the answer is “no-one”.
3. Figure 3.2.2 (below) shows what happens when the line is not properly supported against jet reaction.

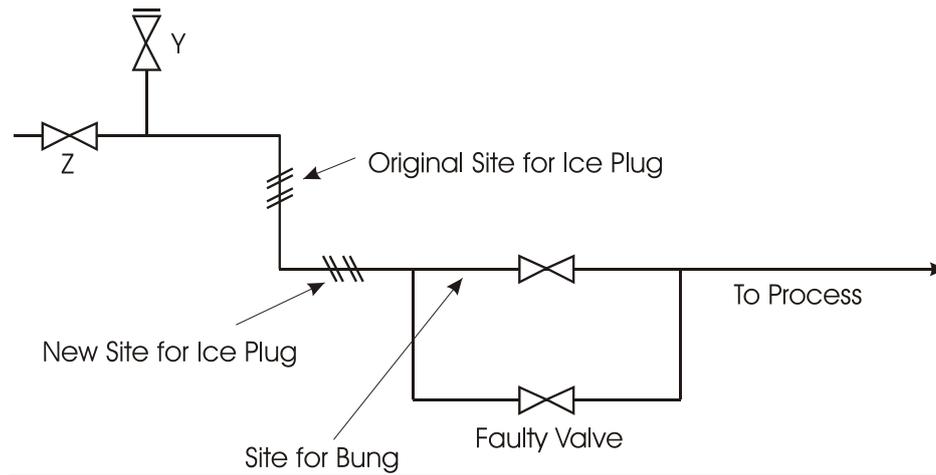
**Figure 3.5.1 Simplified P & ID of work site**

(There is a subtle teaching point that in this specific case the by-pass valve was fitted at the bottom of the line (180°) where fluids might accumulate and cause *interface corrosion*. Ideally the valve should have been fitted horizontally at the 90° position; it can not be fitted at the 0° position due to the master valve fittings.)

The by-pass valve piping was corroded due to interface corrosion and the small section of piping had to be replaced this involved removing one of the double block valves plus the bypass valve. As the upstream valve “Z” was leaking it was decided that an ice plug isolation would be formed in the vertical section of piping, at the hatched section of piping, by water injected through valve “Y”. The combination would be integrity tested by pressurising the interface between the ice plug and an expandable stopper or bung fitted inside the pipe as shown. In effect this was to become a new “*double block and bleed*”. The first isolation was the ice plug and the second was the expandable plug.

For various reasons the bung could not be proven to be pressure tight.
