The Buncefield Incident

11 December 2005

The final report of the
Major Incident Investigation Board

Volume 2

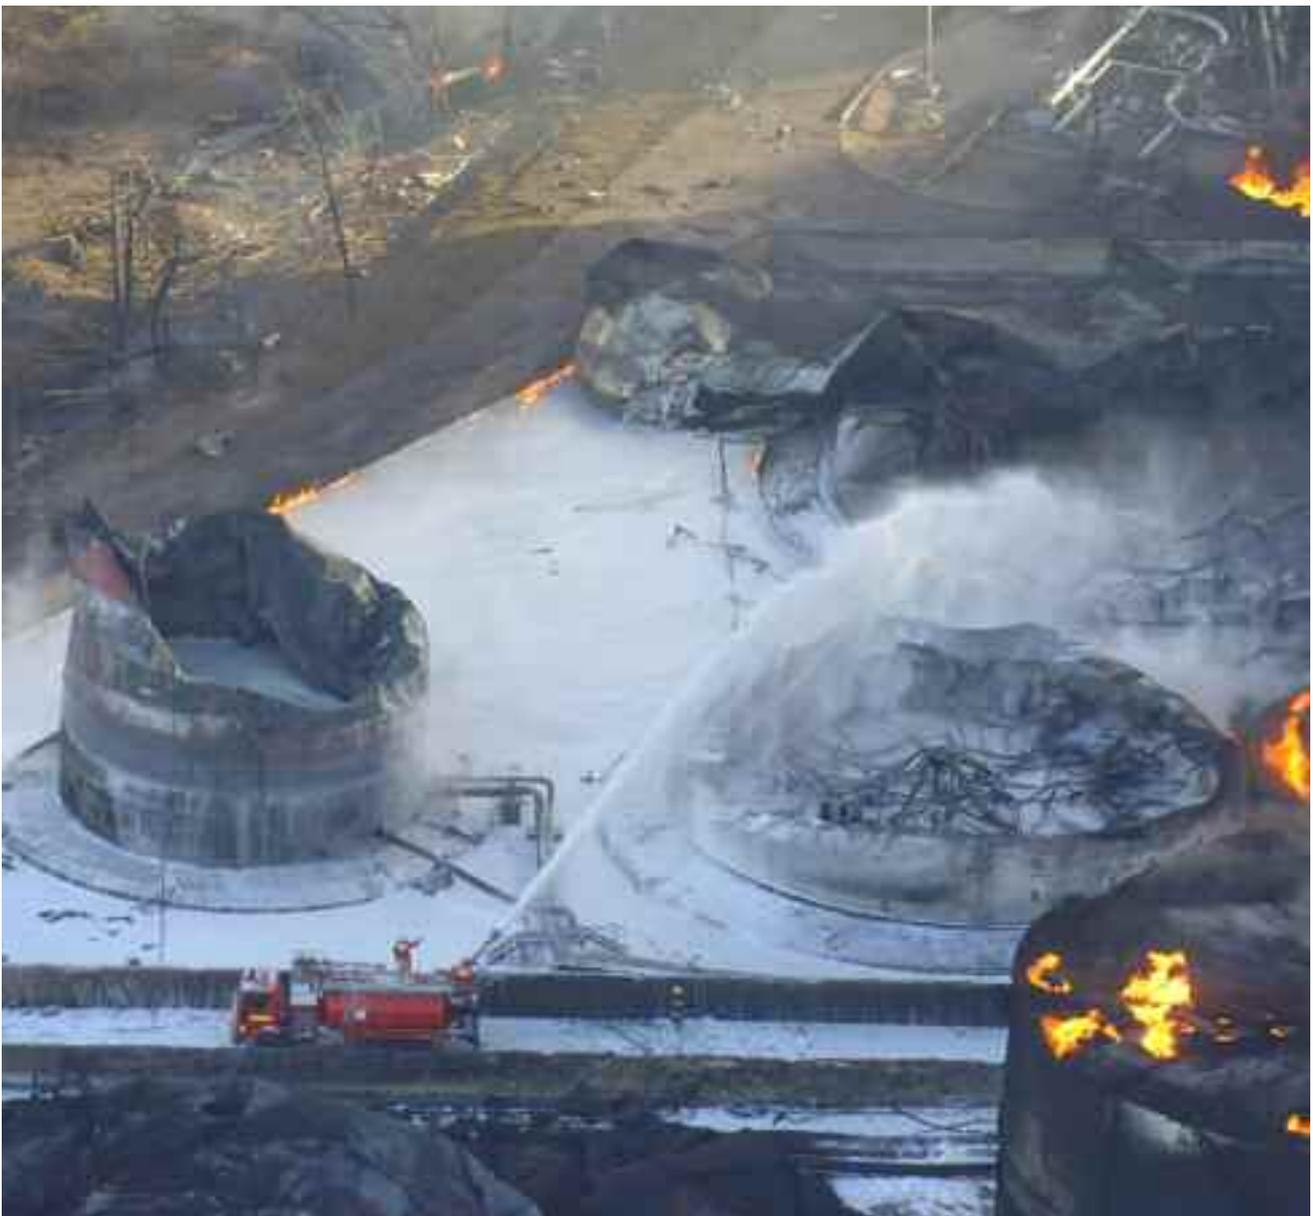
Figure 2 This photograph shows the fire-fighting operation in progress with the appliance in the avenue between bunds 'A' and 'B'

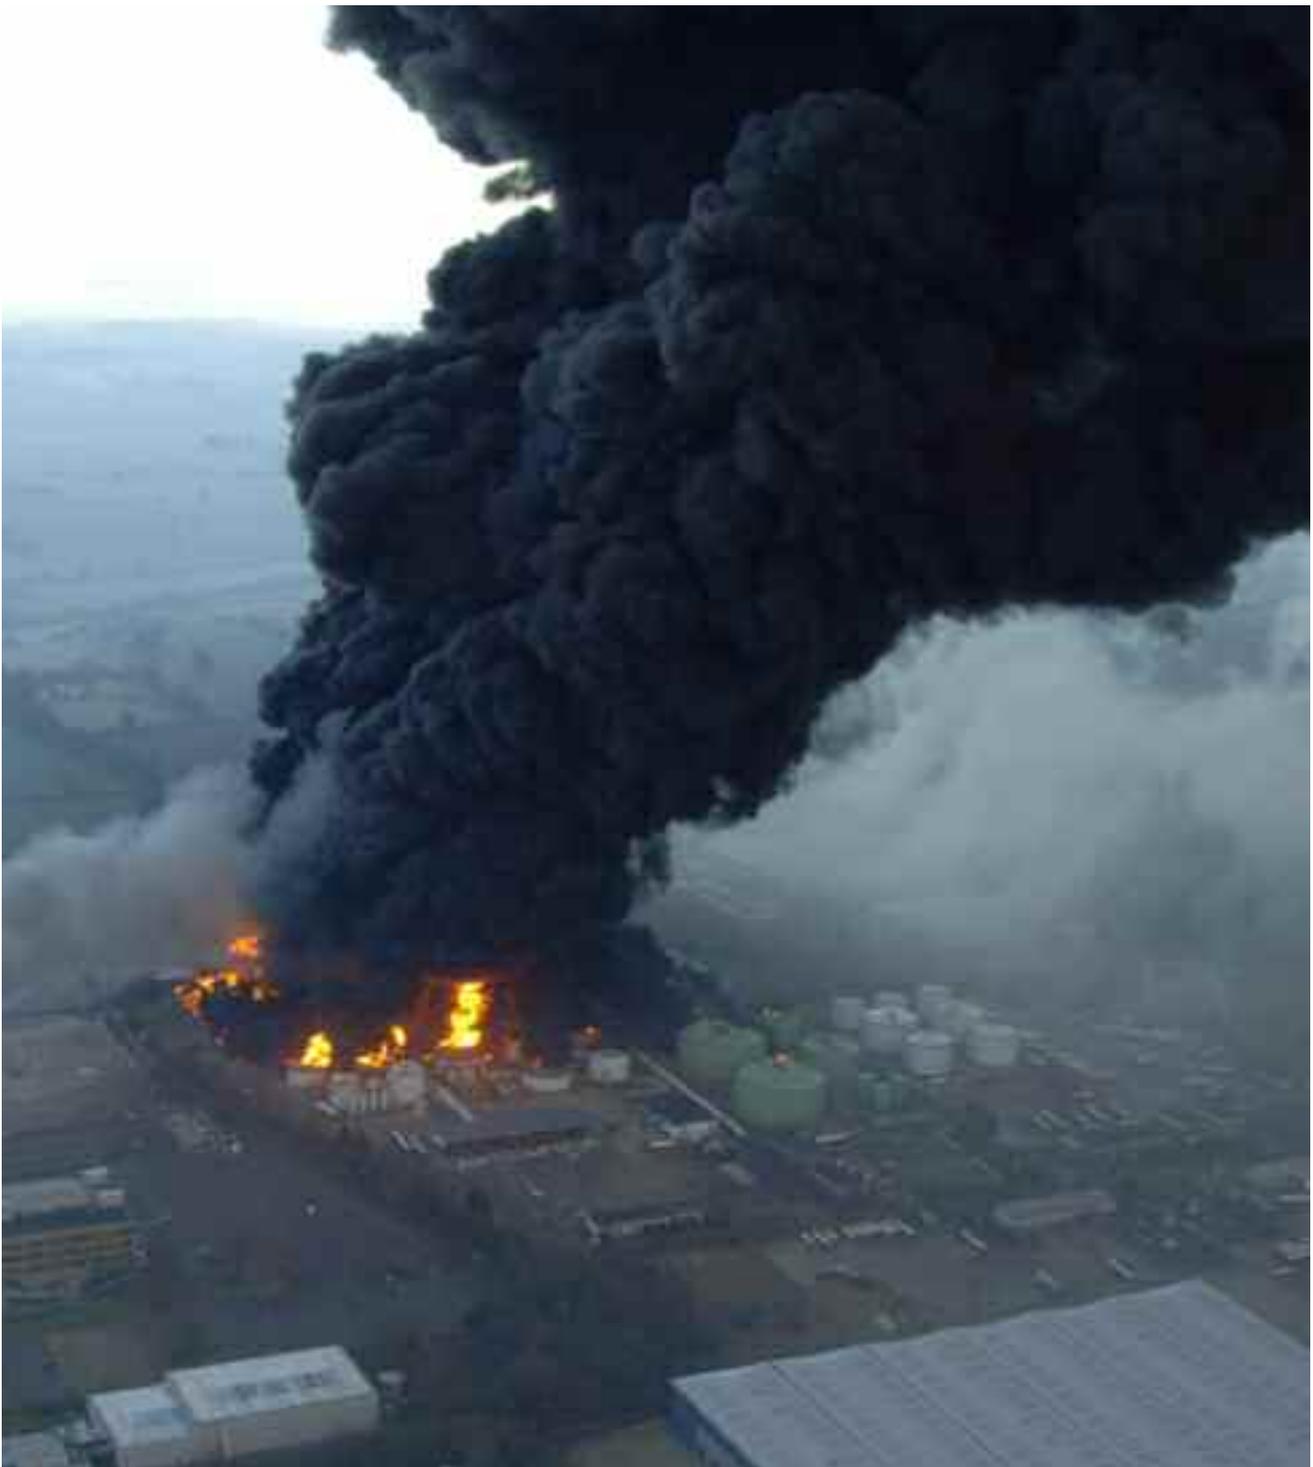
Figure 3 The smoke plume rising and spreading above the Buncefield site.

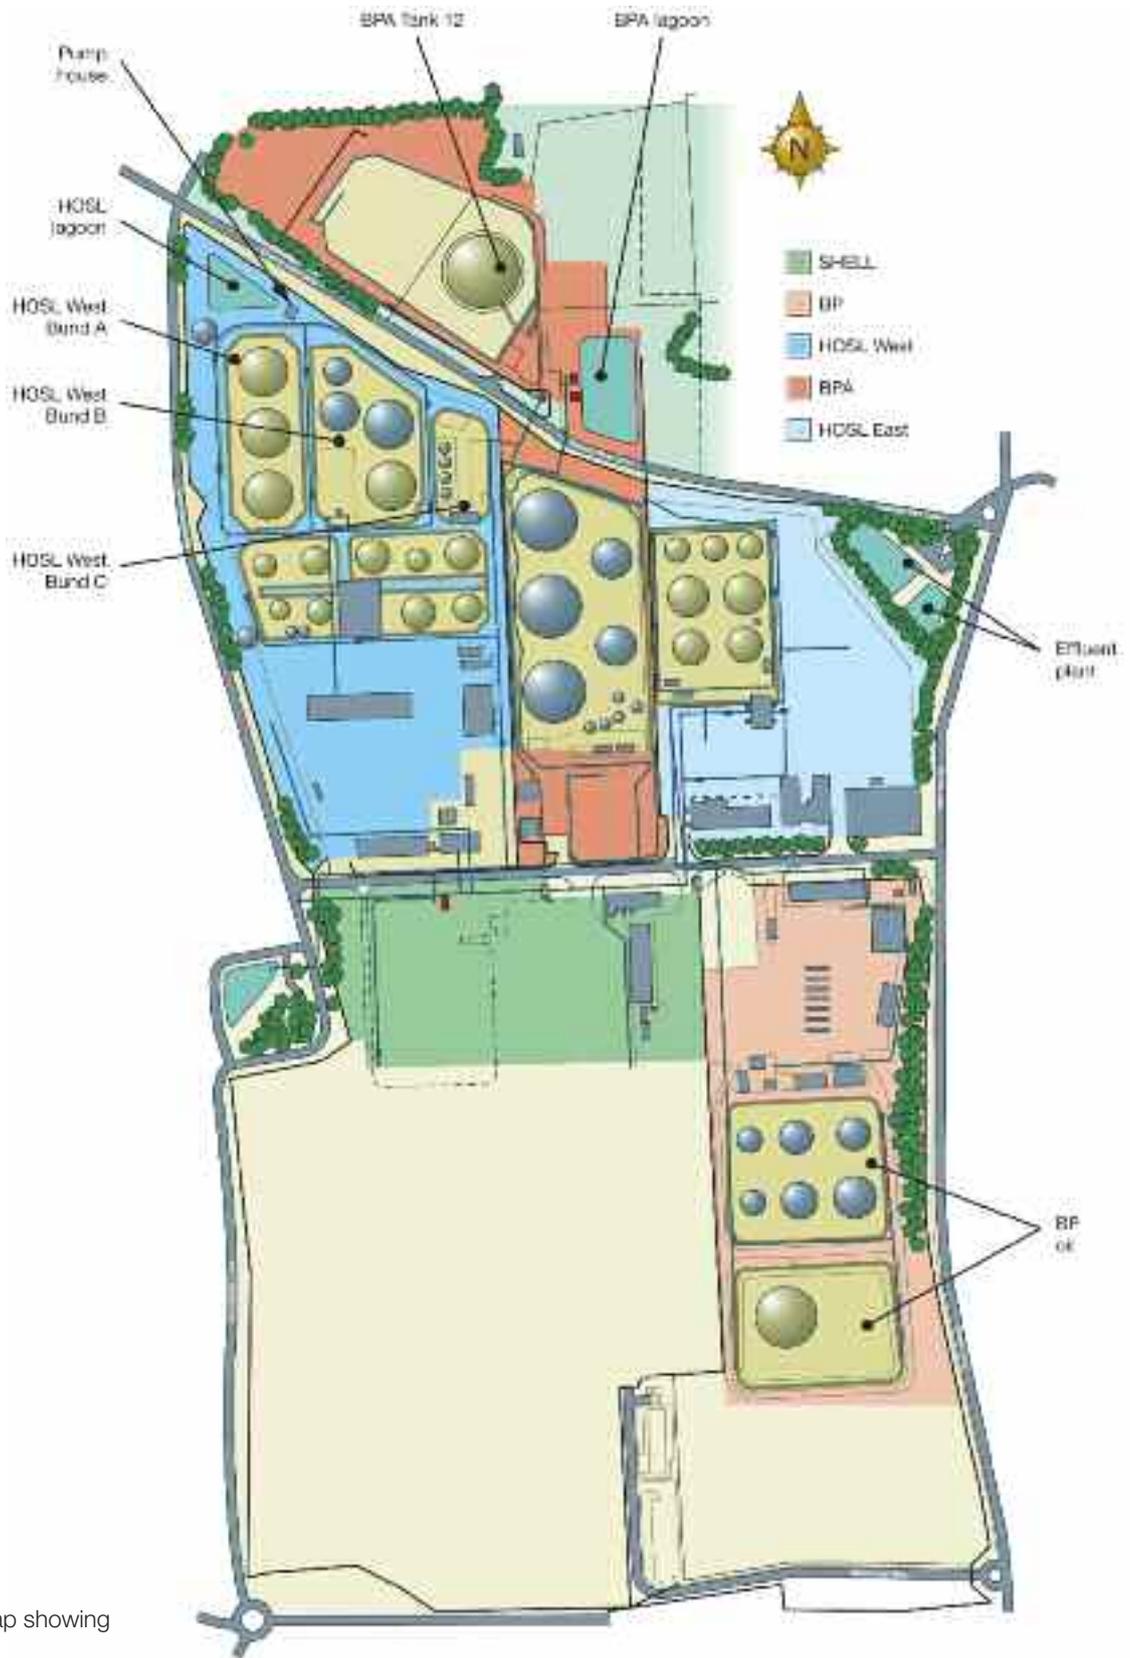
Figure 1 Site map showing bunds

- 8 The first *progress report*¹ noted that the explosions and fires on 11 December 2005 were the result of a massive escape of fuel in the vicinity of bund A on the Hertfordshire Oil Storage Ltd (HOSL) West part of the site. This escaped fuel formed

a flammable mixture with the air. Little was known about how primary containment was lost or how the escaping fuel formed into a flammable mixture. (Figure 1 shows a schematic of the bunds.)

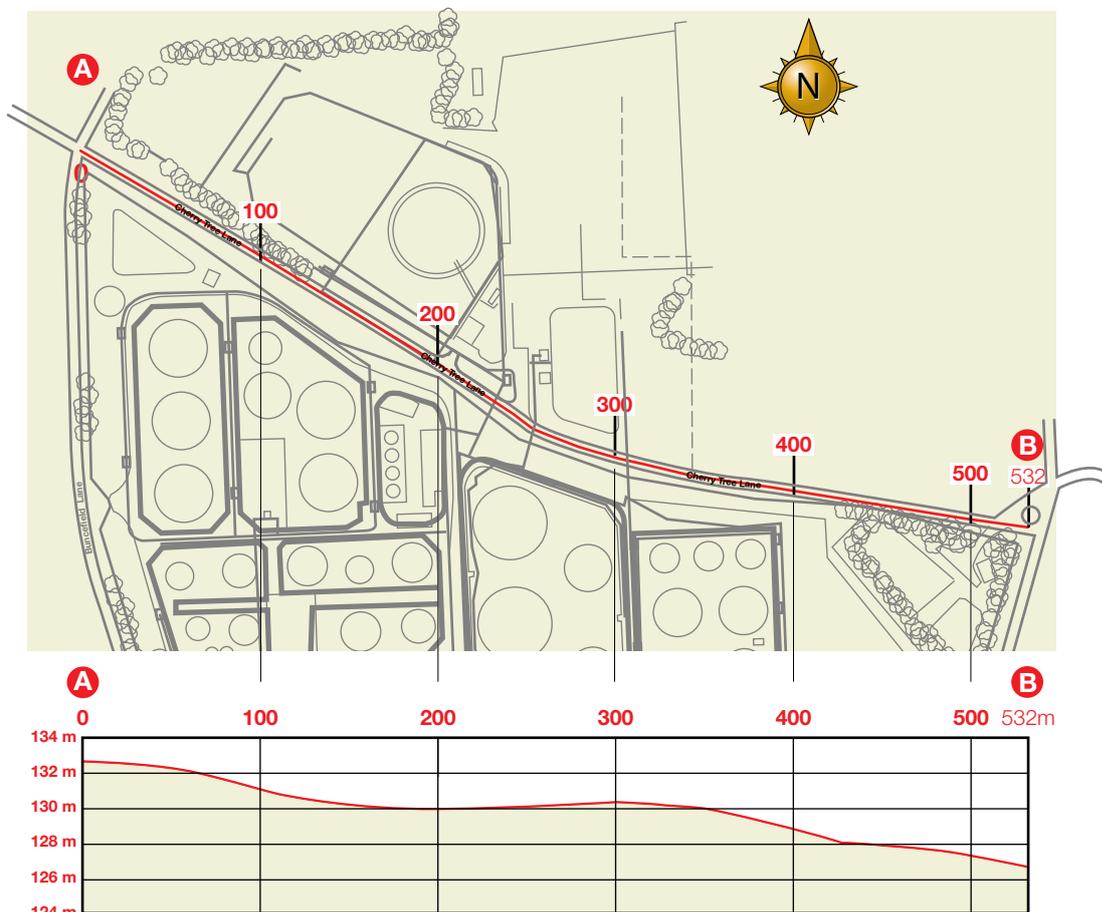
Figure 2 Schematic of topography at Cherry Tree Lane

Ground profile along Cherry Tree Lane (West to East)

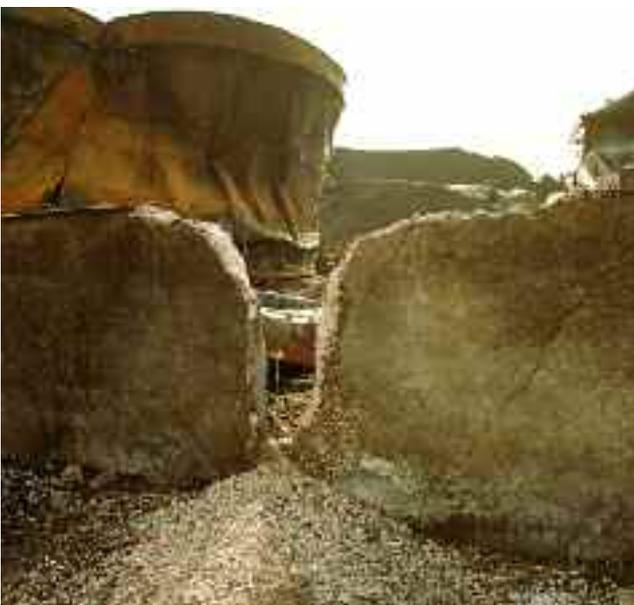
16 While the bunds substantially remained standing throughout the incident, their ability to fully contain the fuel and fire waters was lost as a result of the explosion and subsequent fires. Figure 3 shows the damage caused to bund walls as a consequence of the incident. Pools of fuel were burning in the bunds as a result of loss of fuel from the tanks, along with fires from the tanks themselves. Figures 4 and 5 show a bund, where the concrete panels had been infilled with a joint sealant. This sealant has been lost as a result of the fire and/or hydraulic pressure within the bund.

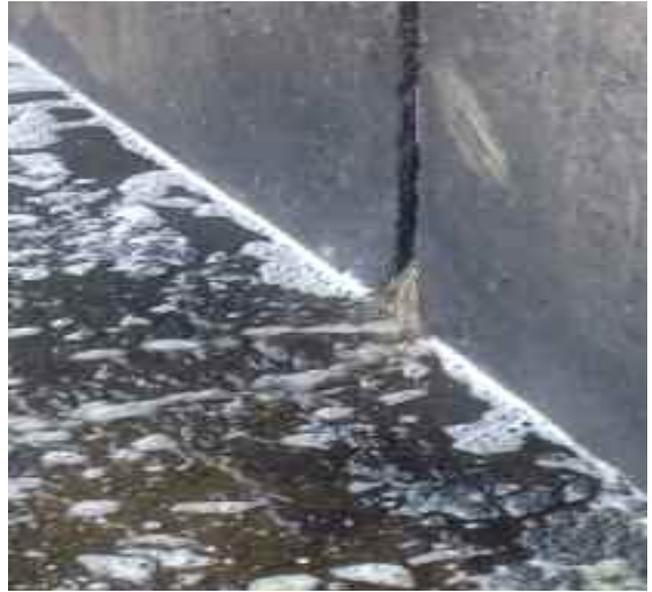
17 Many of the bunds around the site have suffered varying degrees of sealant damage. Figure 6 shows fire water and product leaking from such a joint in the later stages of the incident.

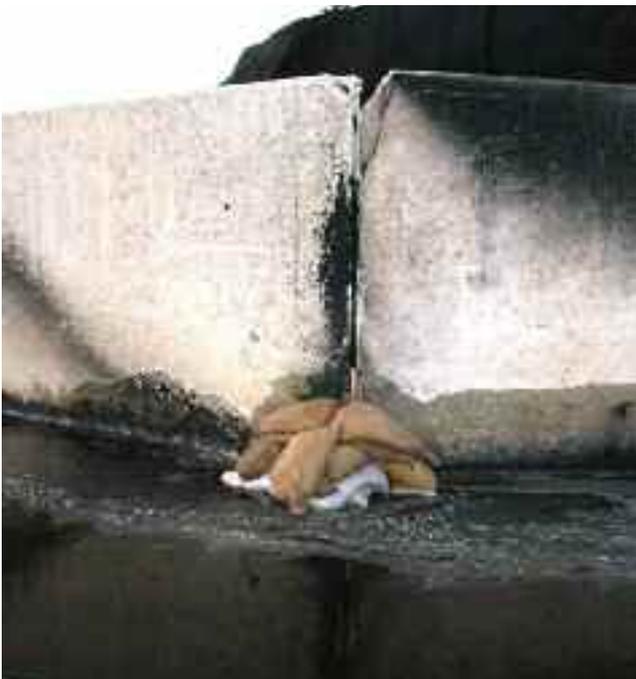
Figure 7

18 Another two leakage mechanisms can be seen in Figure 7. Here a corner joint has opened up, releasing fire water and product. Visible along the lower edge of the bund wall, a 'tide mark' shows where liquids were seen to seep through the concrete itself.

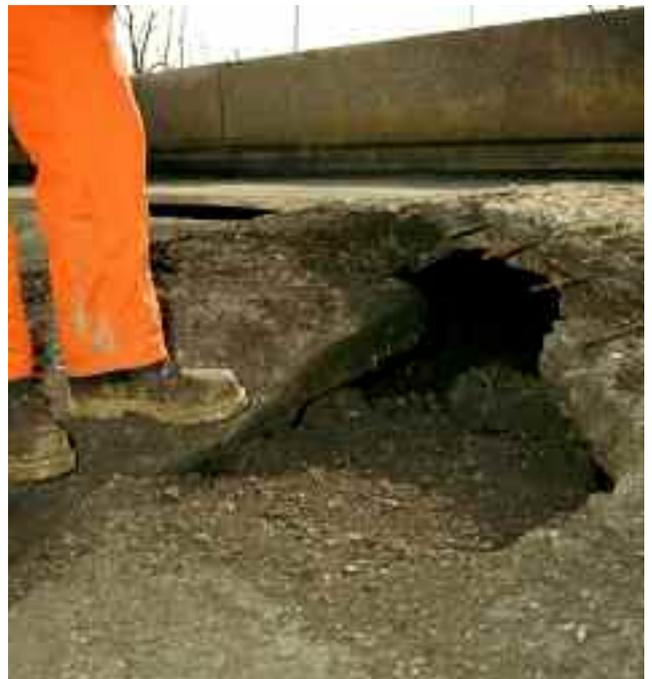
19 Figure 8 shows the base of a bund where the concrete panels have undergone significant 'heave' which has resulted in the escape of product and fire water.

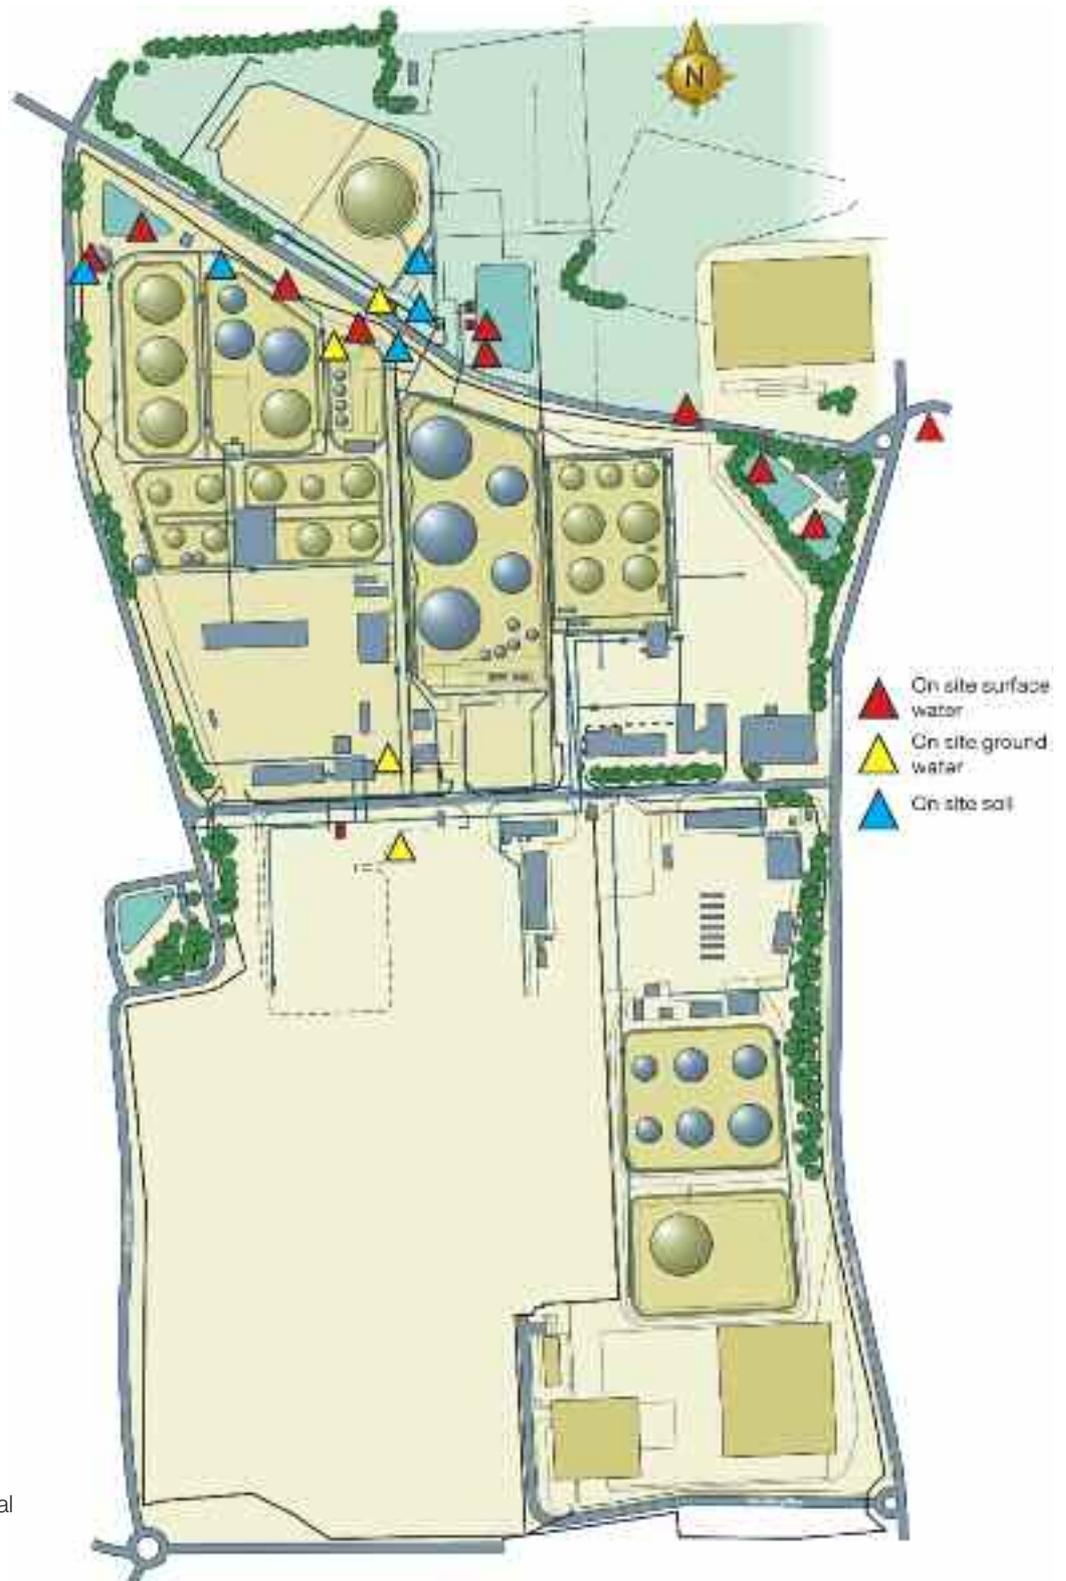
Figure 18 Location of trial pits

53 Investigations to assess the extent of land contamination started in February 2006 along Cherry Tree Lane. Trial pits were excavated at points along the Lane and on site and a number of samples taken for laboratory analysis. The locations of the trial pits are indicated in Figure 18.

54 The initial findings indicate that the surface layer of the soils, the top 30 cm approximately, was contaminated with fuel and fire-fighting products. No visible free product was detected in any of the trial pits at depth. PFOS, hydrocarbons and polycyclic aromatic hydrocarbons have been reported in the laboratory analysis.

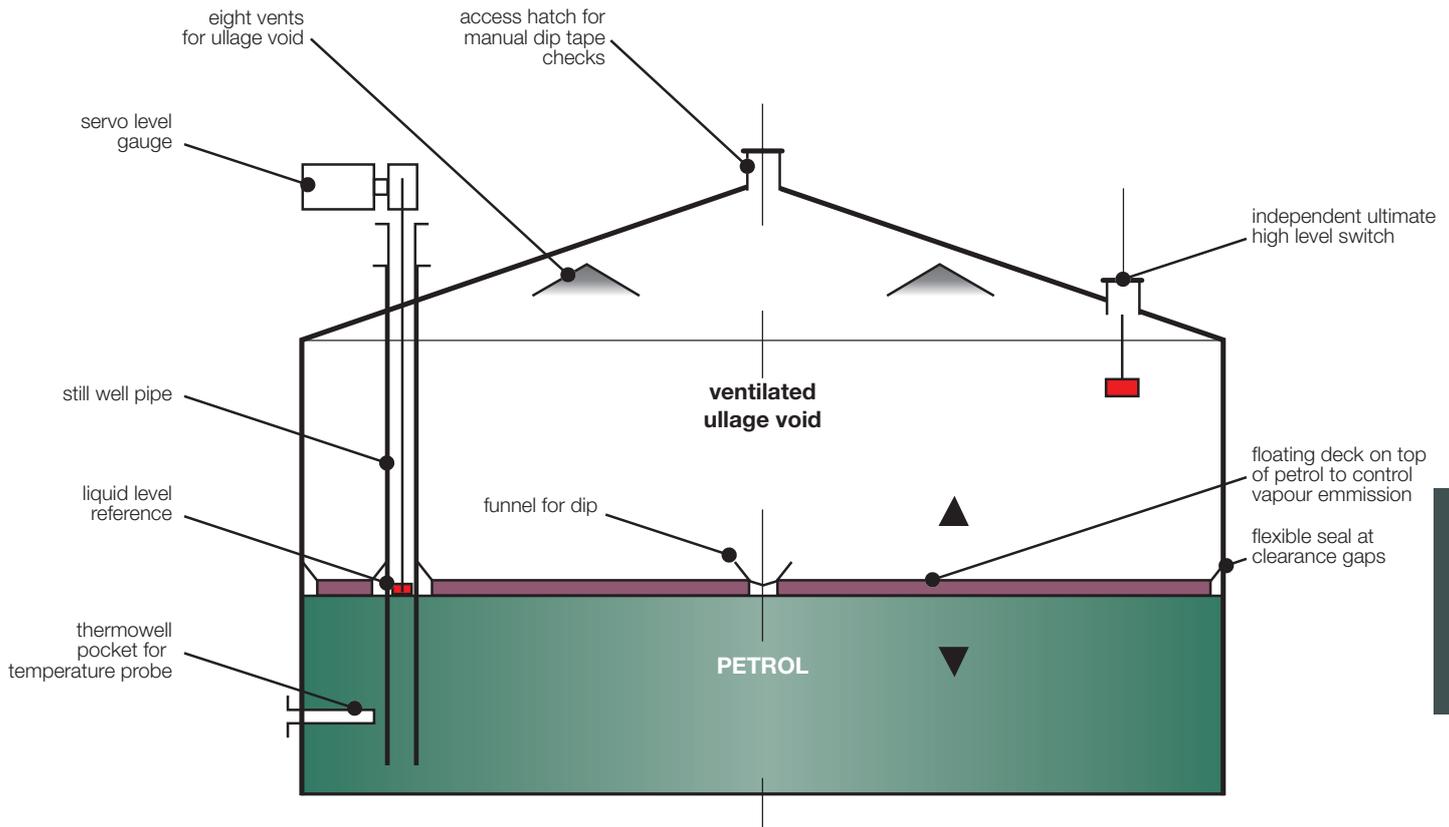
Figure 2 Basic layout of Tank 912

12 Figure 2 depicts the basic layout of Tank 912. This was a floating deck tank whereby in addition to the fixed roof, there is a deck inside the tank which floats on the fuel, thus minimising the emission of vapour from the fuel surface.

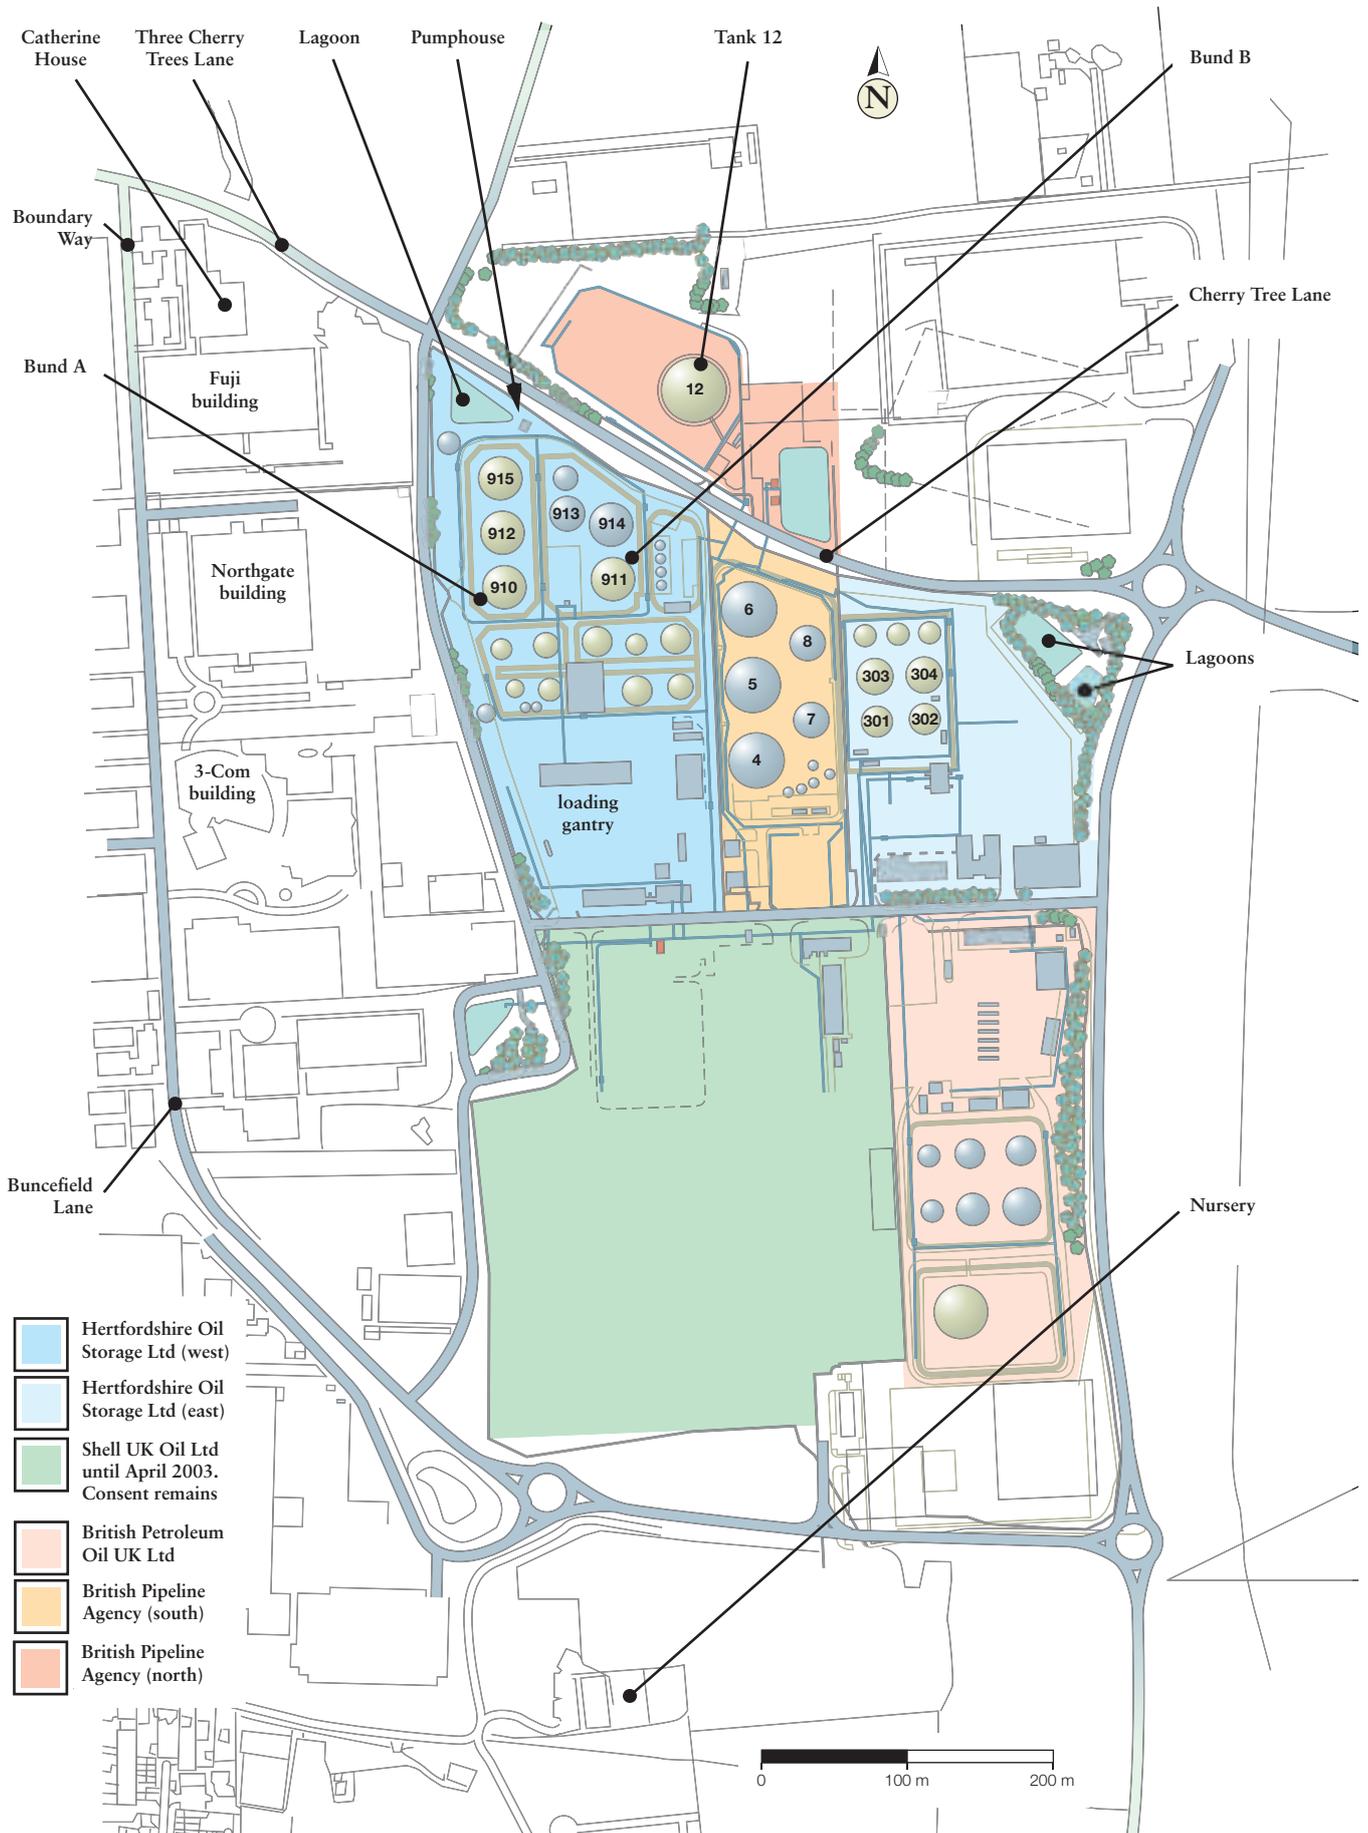
Figure 1 Pre-incident layout of Buncefield depot and immediate surroundings

8 Figure 1 shows the layout of the Buncefield depot and its surroundings. The Buncefield depot forms part of a national petroleum refinery, pipeline and storage system, described in Annex 4. Fuel products were supplied to Buncefield by three pipeline systems:

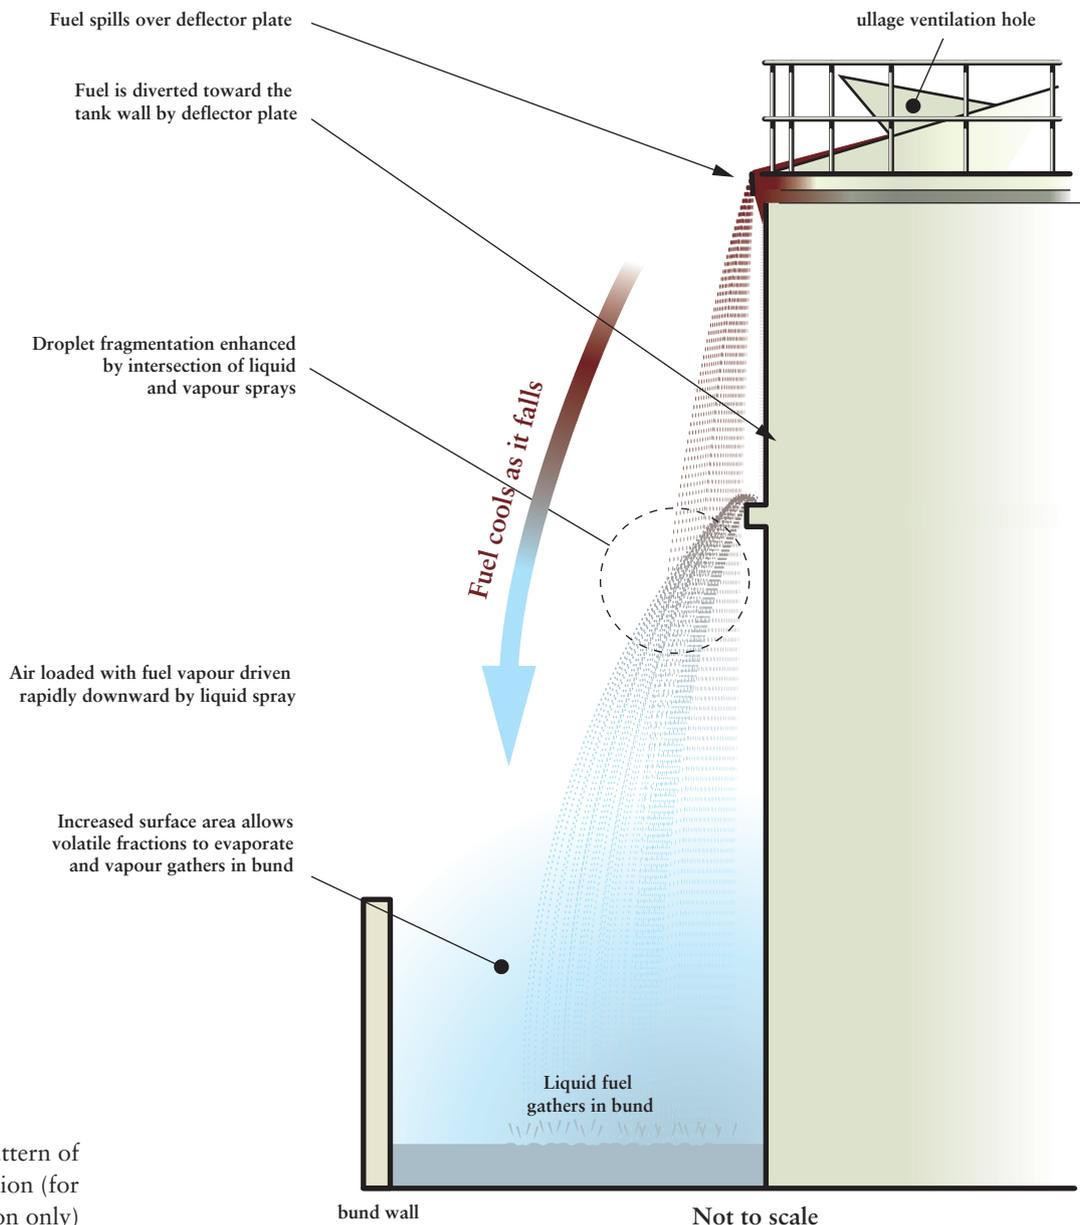
Figure 2 The pattern of fuel dispersion (for illustration only)

25 The Third Progress Report described extensive tests undertaken to model the behaviour of fuel escaping from Tank 912 during overfilling. Tank 912 was fitted with a deflector plate, installed to direct water from sprinklers on the tank’s top to its sides to provide cooling in the event of fire. The tests demonstrated that the deflector plate channelled some of the escaped fuel onto the tank wall, but the rest ran over the top of the plate, fragmenting into droplets that cascaded through the air. Most of the fuel running down the wall hit a wind girder (a structural stiffening ring) and detached from the tank wall, creating a second cascade of droplets.

26 These conditions would promote the evaporation of the lighter components of petrol, eg butanes, pentanes and hexanes. The free-fall of droplets leads to entrainment of air and mixing between the air and fuel vapour, and the formation of a rich fuel/air mixture. Cooling of the surrounding air, already saturated with water vapour by the evaporation, would cause some of the water content to precipitate as an ice mist, which is consistent with the cloud of mist visible on

CCTV. The fuel/air mixture and its accompanying ice mist were heavier than air and so were initially contained within the bund. As the volume of the mixture grew from the continuing overflowing of the tank, it flowed out of the bund, dispersing and flowing off site. Further mixing with the air would have reduced the vapour concentration to the point where significant volumes of the mixture could support an explosion.¹²

27 Since publication of the Third Progress Report, further work to simulate the overflow of liquid from the full height of Tank 912 has confirmed the pattern of fuel dispersal and vaporisation shown in Figure 2.

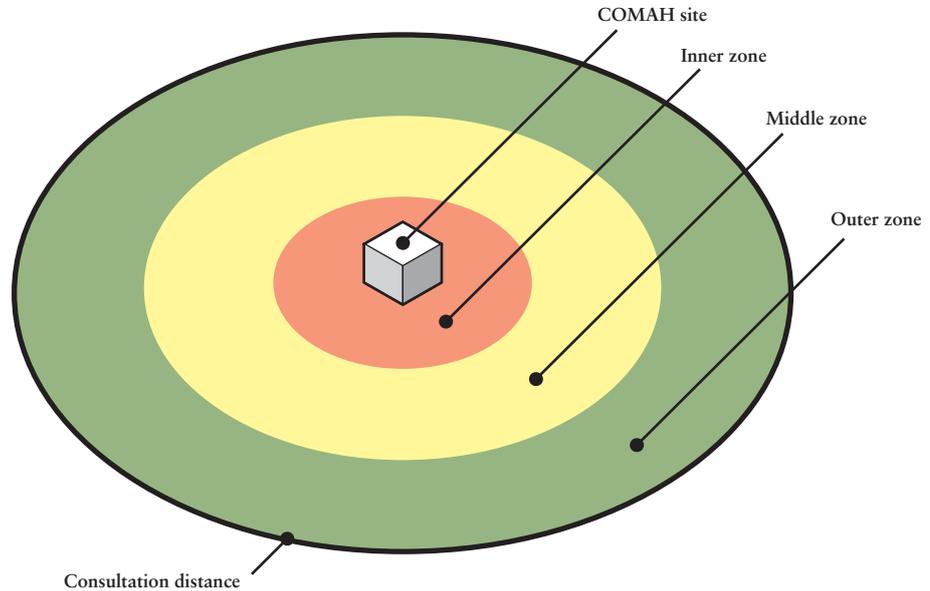
Figure 3 Consultation distance and zones

11 Within the consultation distance, HSE undertakes an assessment of the hazards and risks from the installation and produces a map with three contours representing defined levels of harm or risk which any individual at that contour would be subject to, based on information relating to the hazardous substances consent. The harm or risk to an individual is greater the closer to the installation.

The contours form three zones, with the outer contour defining the consultation distance around major hazard sites. The local authority consults HSE on relevant proposed developments within this consultation distance.

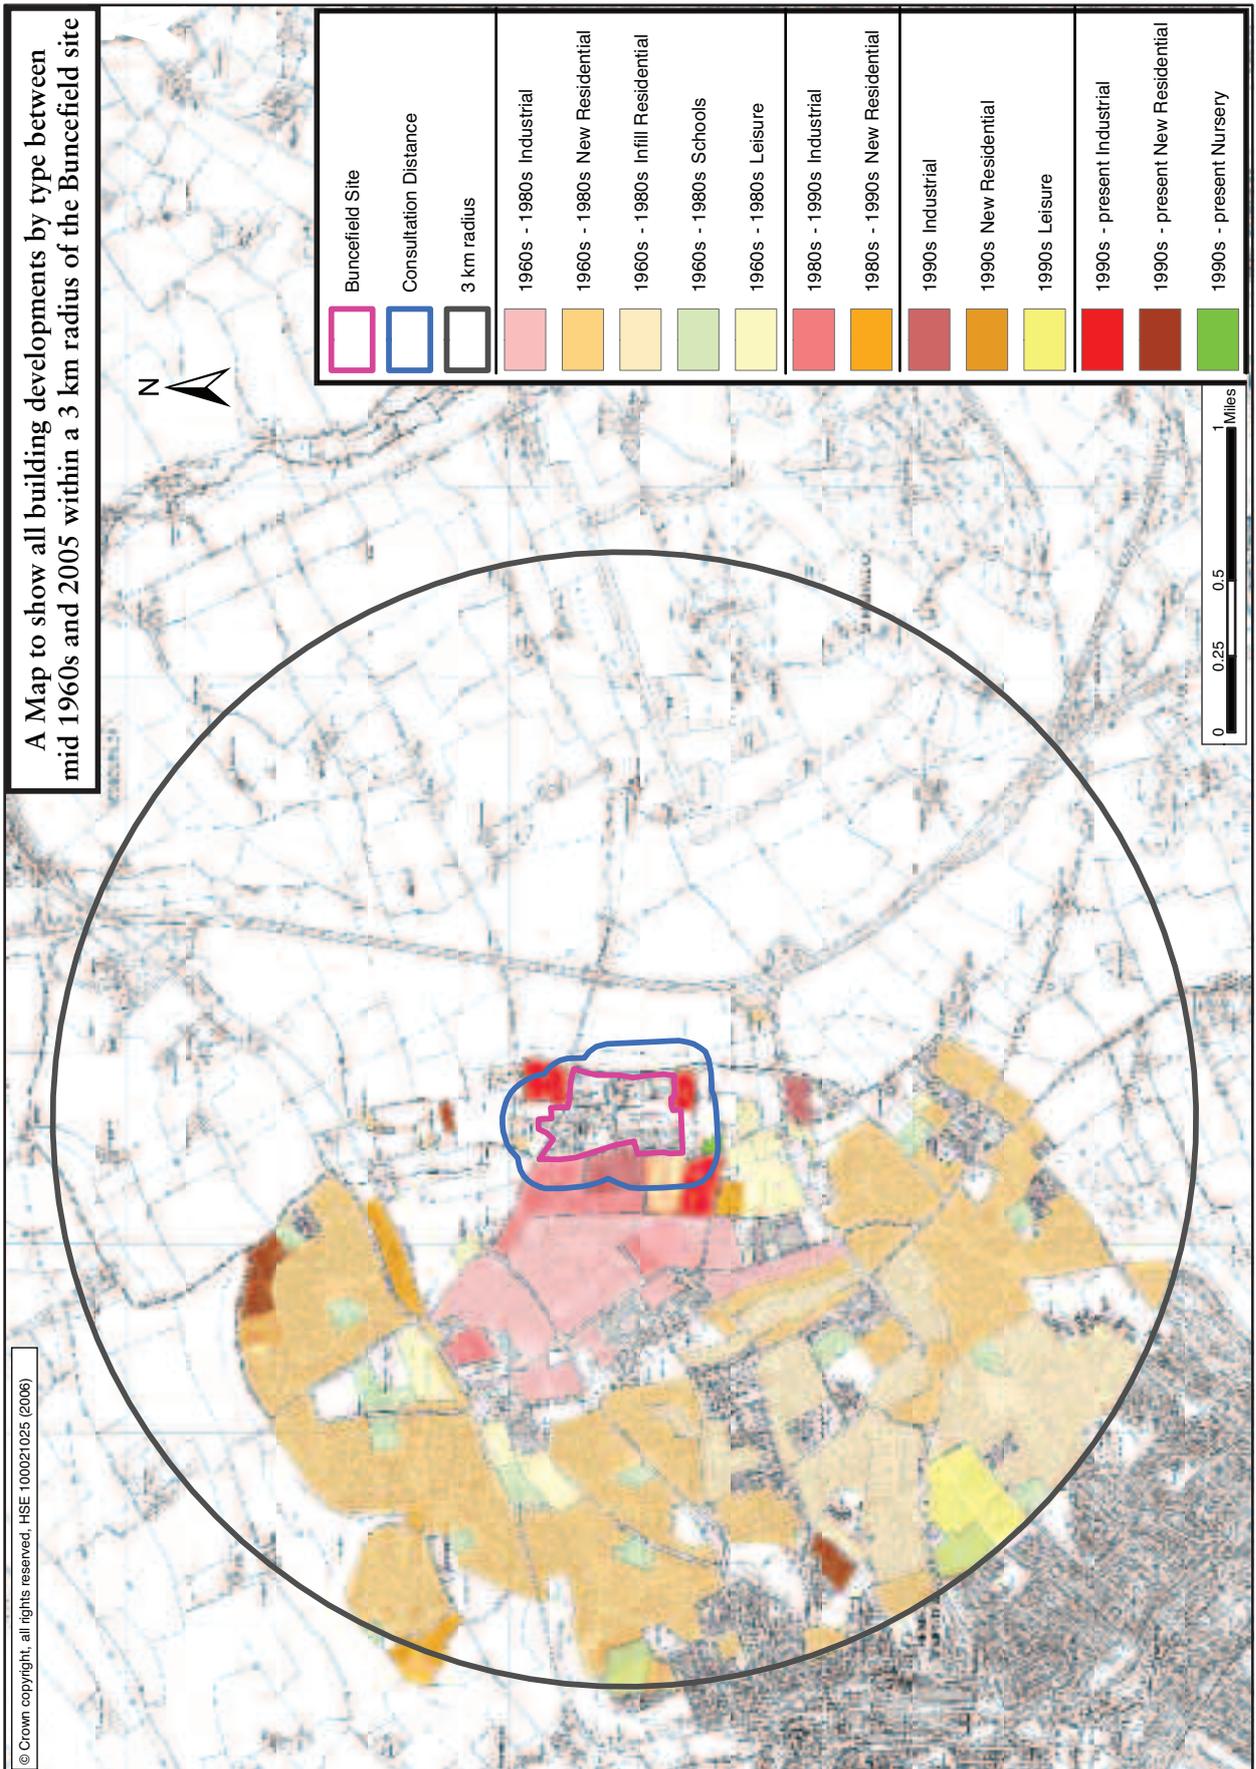
Figure 5 Developments within 3 km of the Buncefield site between 1966 and 2005

2 At the time that the terminal was built in 1968, the site was well screened by hedges and trees, but there were about nine dwellings on the periphery of the site to the north whose amenities were affected by the site, and a farm to the south. One of the nine dwellings to the north was converted in 2000 to create five separate properties. Since 1968 there has been general encroachment and development of adjacent land. This can be seen on the map in Figure 5. The majority of this building development took place during the period from the mid 1960s to the early 1980s, comprising the construction or redevelopment of residential properties and a number of schools and industrial premises to the west of the site, all of which fell within a 3 km radius as shown on the map. Between 1990 and 2006, a few additional industrial premises were built around the site.

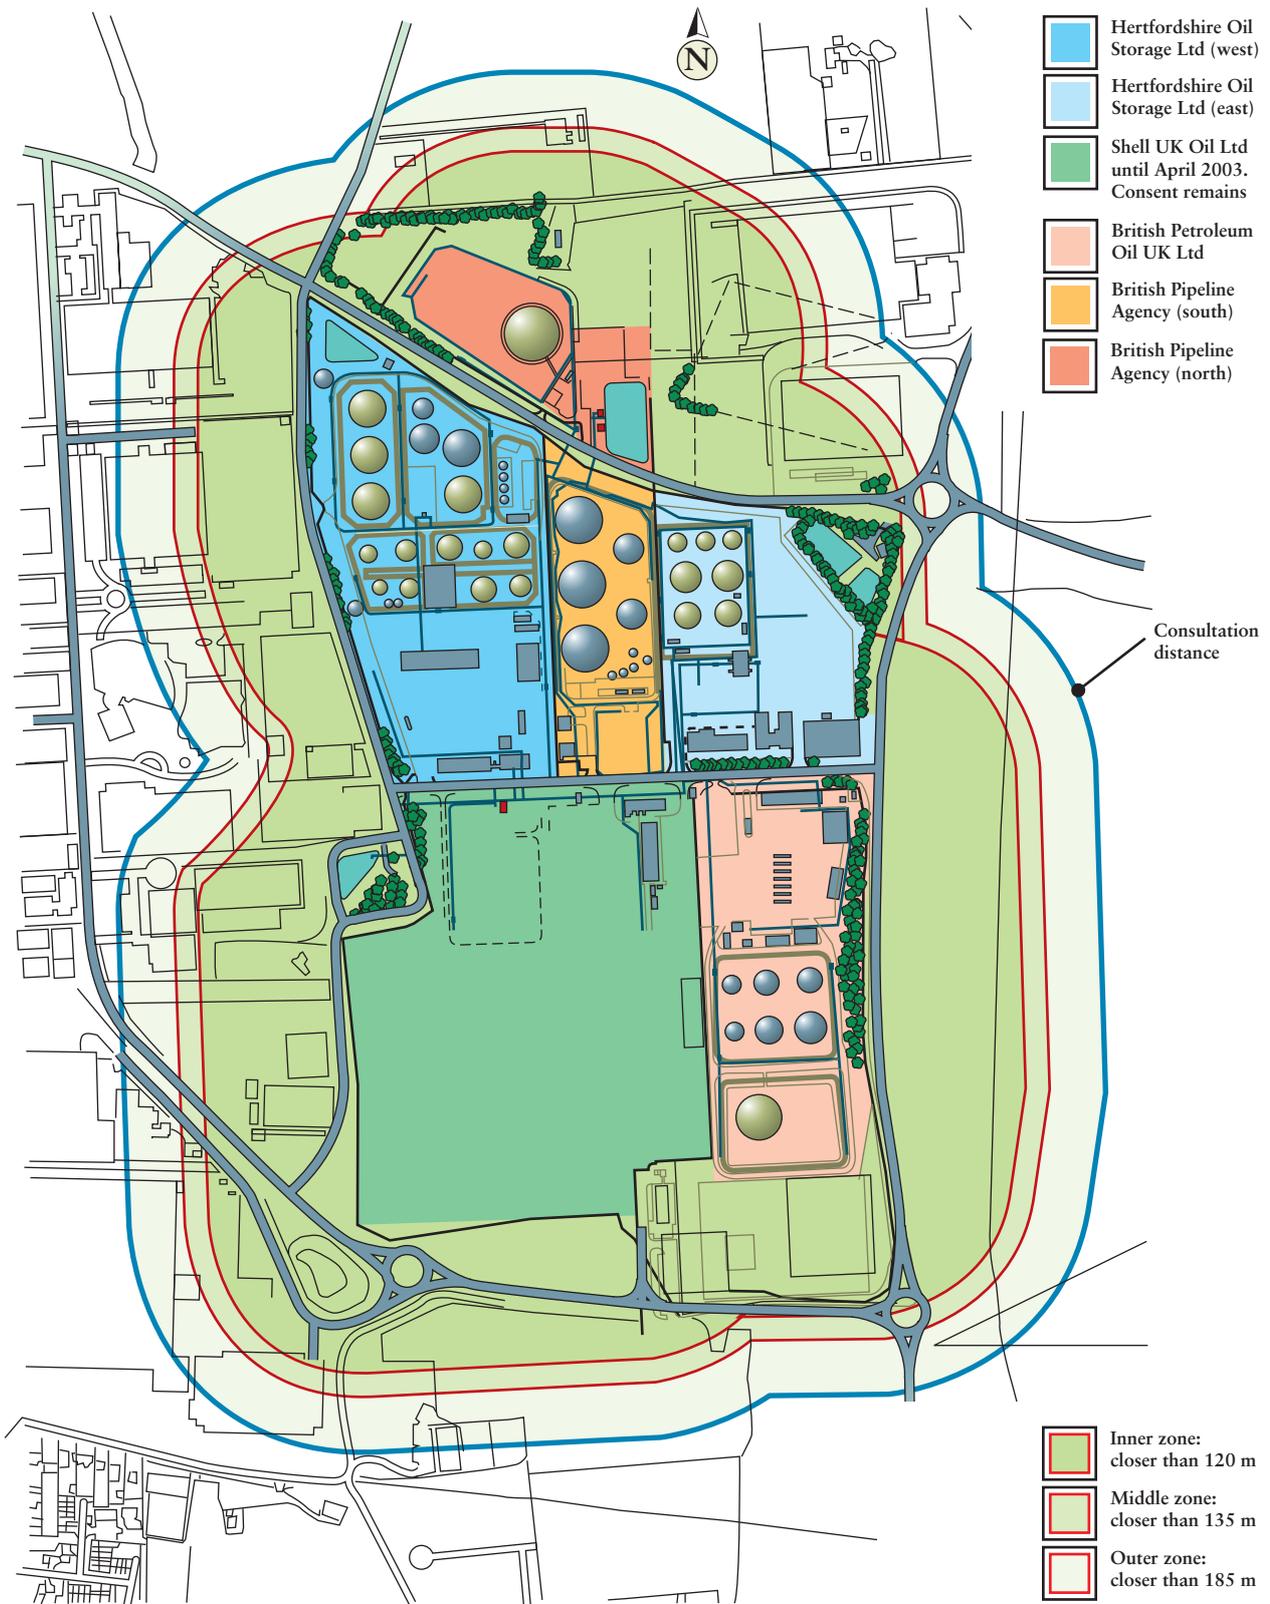
Figure 7 Plan representing the hazardous substances consents and consultation area around the Buncefield depot since July 2001 (for illustration only)

17 In July 2001 another consultation distance was calculated due to an extensive reassessment of the hazards from the site following the submission of a batch of new consent applications from the oil companies. The regulations requiring consent to store flammable substances were changed in 1999 to include additional flammable materials. The consultation distance was reduced from 190 m to 185 m. This was unchanged following a further consent application on 8 July 2005 from BP. The presence of the additional material did not alter the main basis of the calculation which assumed the worst-case event was the catastrophic failure of the largest tank containing gasoline. The consultation distance was reduced slightly owing to a slight change to the inputs in the model used to perform the calculations. See Figure 7 for a representative plan of the site showing the consultation distance since July 2001.
