# Selection and Deployment of Non-Destructive Testing for Through-Life Integrity Assurance of Composite-Repaired Pipes

Adam Bannister, HSE Science Division, Harpur Hill, Buxton, SK17 9JN, UK  
 Aneta Nemcova, HSE Science Division, Harpur Hill, Buxton, SK17 9JN, UK  
 David Johnson, HSE Science Division, Harpur Hill, Buxton, SK17 9JN, UK  
 Matthew Blackburn, HSE Energy Division, Lord Cullen House, Aberdeen, AB25 3UB

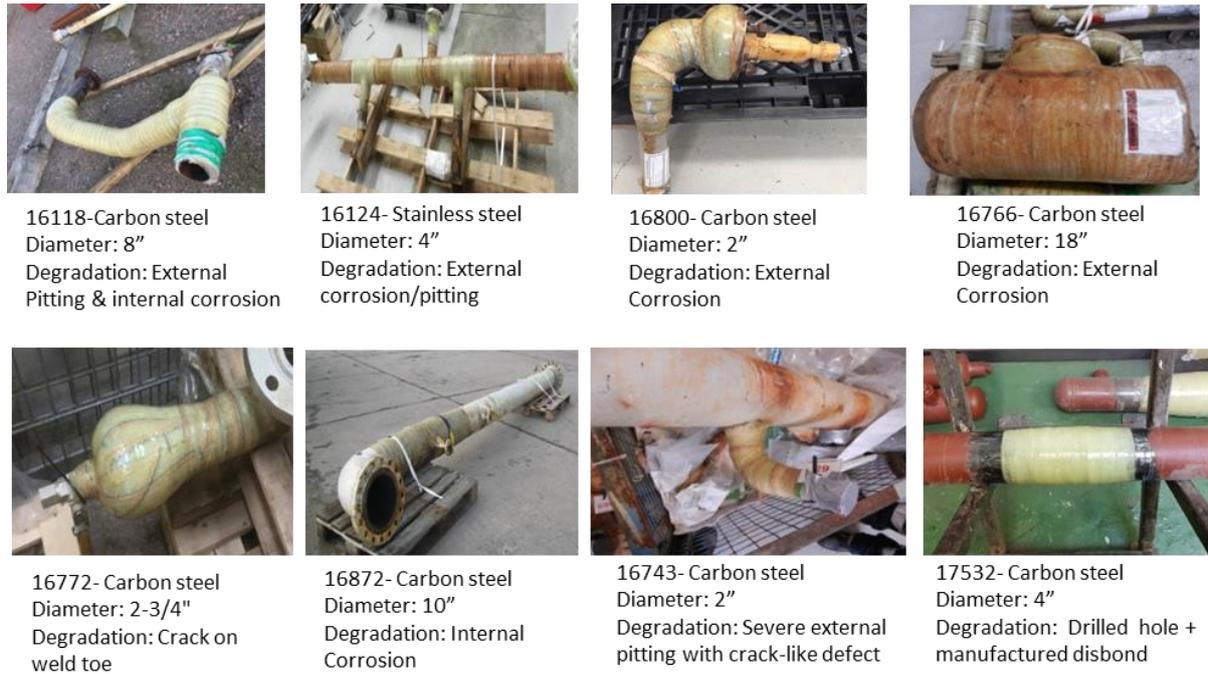
Examples of the types of samples used for the trials are given in Figure 2. The spools comprised a range of geometrical complexities, length, exposed surface of the pipe and surface quality of wrap.

**Figure 2: Examples of composite wrapped pipe spools used in blind NDT trials**
