Investigation into a Microbiologically Induced Corrosion (MIC) failure of an onshore pipeline

Birkitt Keith, Science Division, Health and Safety Executive, UK

Onshore Incident

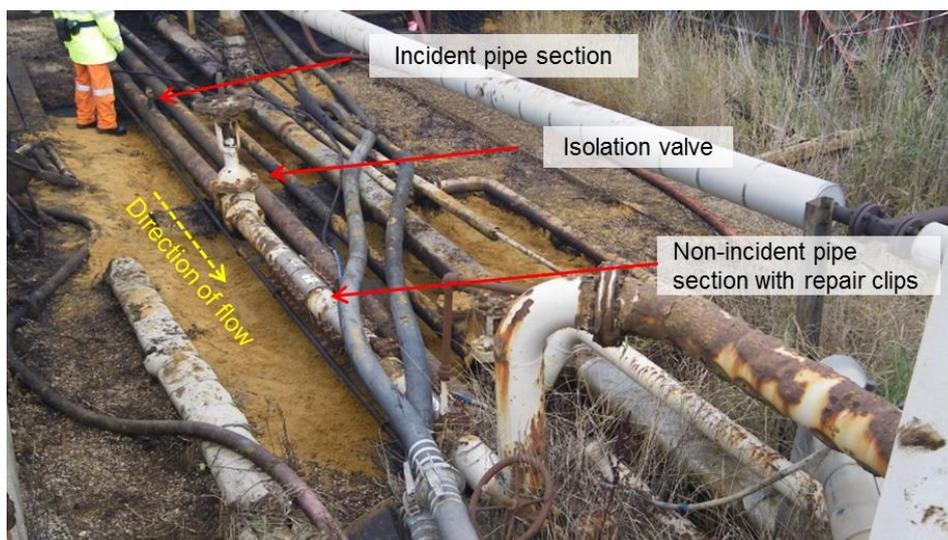
A section, which contained a thinned area that had resulted in the loss of containment event will be referred to as the incident pipe. The other retrieved section, the non-incident pipe, contained six temporary repair clips (clamps). The two sections were removed from the same pipeline and were separated by a single isolation valve see Figure 1.

Figure 1 Location of incident and non-incident pipe sections
