Failure of a 30 inch diameter oil pipeline due to atmospheric corrosion

Birkitt Keith, Science Division, Health and Safety Executive, UK

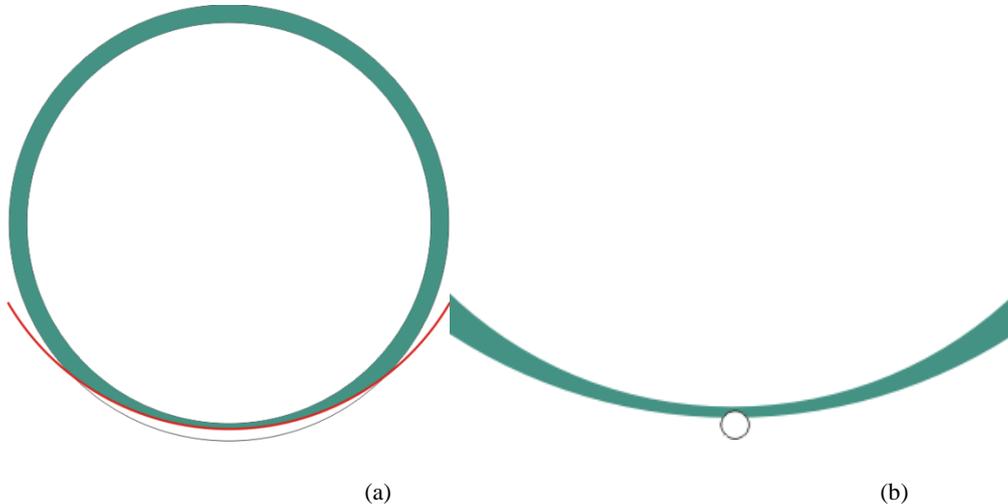
The thinning was achieved using an intersecting arc removing material from the outer surface, as shown schematically in Figure 10a. The axial length of the thinned region was 850 mm. Using an arc of radius 400 mm resulted in a circumferential extent of 316 mm to the thinned area. The model was a quarter model, with symmetry planes in the vertical axial plane and the transverse plane at the thinned end.

Therefore, the dimensions quoted represent half of the full lengths of the thinned region. Using this method, the pipe was thinned to remaining ligament thicknesses of 1 mm and 0.75 mm.

Further reductions to the thickness were achieved by subtracting a cylindrical volume of material (length = 60 mm, radius = 1.75 mm), as illustrated in Figure 10b. A local thinned area down to 0.25 mm was obtained using this method. Within this locally thinned section, some perforations were added, as shown in Figure 11, by subtracting spheres with a diameter of 2 mm.

Figure 10 Schematic diagram illustrating methods of general thinning (a) and local thinning (b)

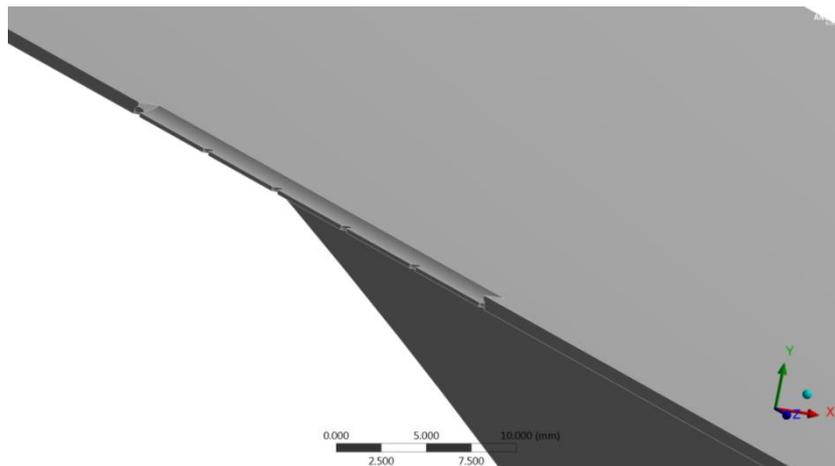
Figure 11 Locally thinned area (down to 0.25 mm) within generally thinned area (0.75 mm)
