## Caribbean Petroleum VCE Case History

Q.A. Baker, J.K. Thomas, D.R. Malik and M.T. Edal, Baker Engineering and Risk Consultants, Inc., 3330 Oakwell Court, Suite 100, San Antonio, TX 78218-3024 USA

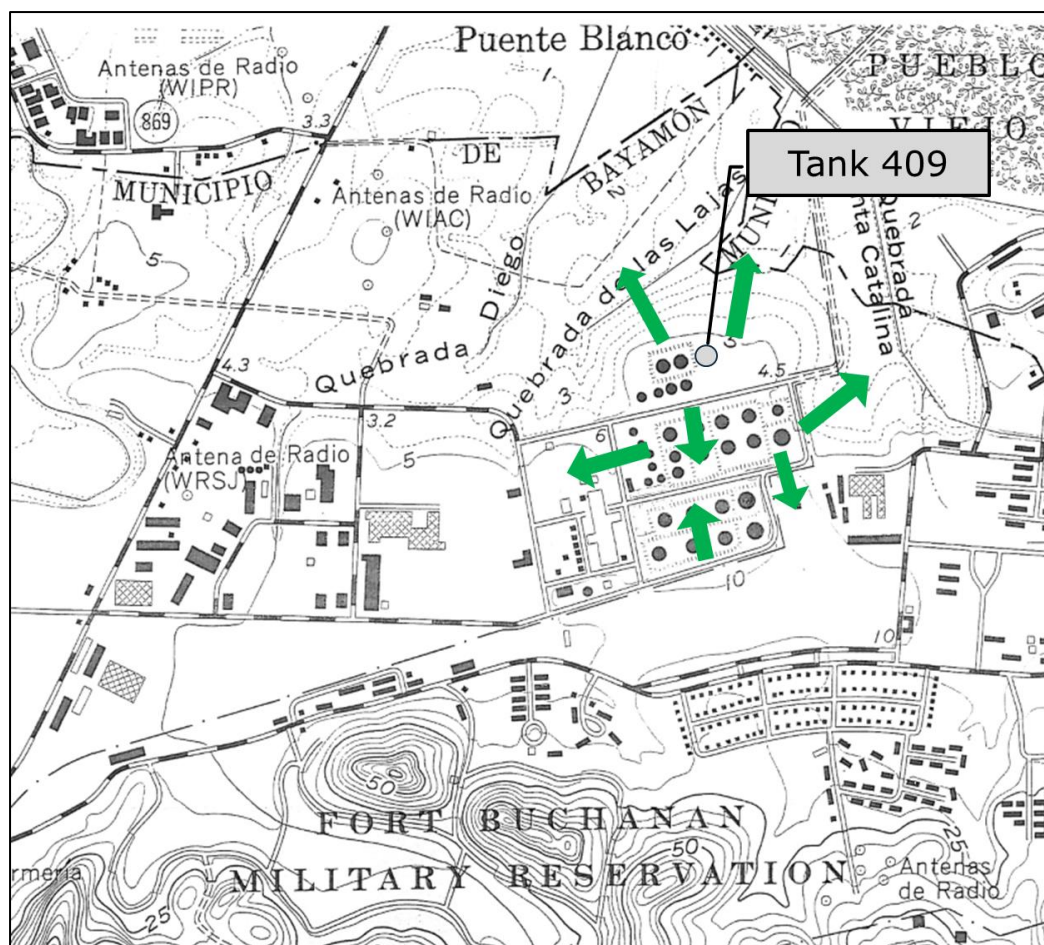
Figure 3. Topography at the CAPECO Facility

The topography in and around the CAPECO facility influenced vapor and mist dispersion. The northeast portion of the tank farm where tanks 405, 504, 411 and 409 were located was a high point in the facility as can be seen in the topographical map in Figure 3. The ground sloped away outside of the dikes for the north group of tanks. The arrows in Figure 3 show the downhill direction from areas in the tank farm.
