## Evangelos Florakis Naval Base explosion

Roger Stokes, BakerRisk Europe Ltd, UK

## Summary

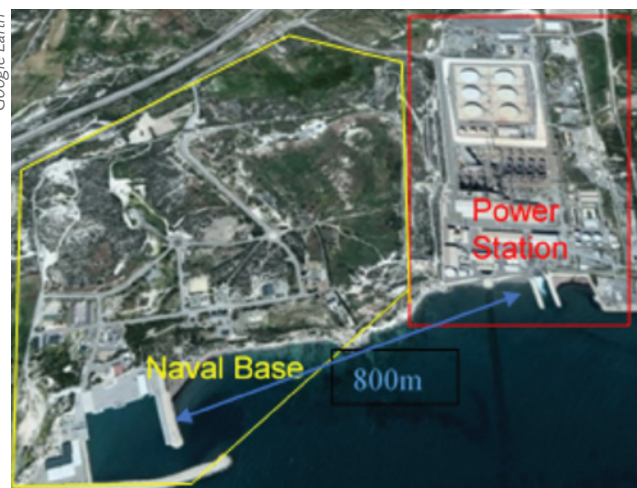
Figure 2 – Aerial view of site

It lies immediately to the west of the Vassilikos desalination and power plant that supplies about half of the power for the island country (see Figure 2).

In total, 98 shipping containers were removed and stored in the open, towards the north-west corner of the naval base, piled three high. They were located some 300 metres from the main building at the adjacent power plant (see Figures 3 and 4).
