Case Study - The Fire at Hickson & Welch Ltd, Castleford, UK

Dr K J Patterson

Health, Safety and Security Manager, Hickson & Welch Ltd

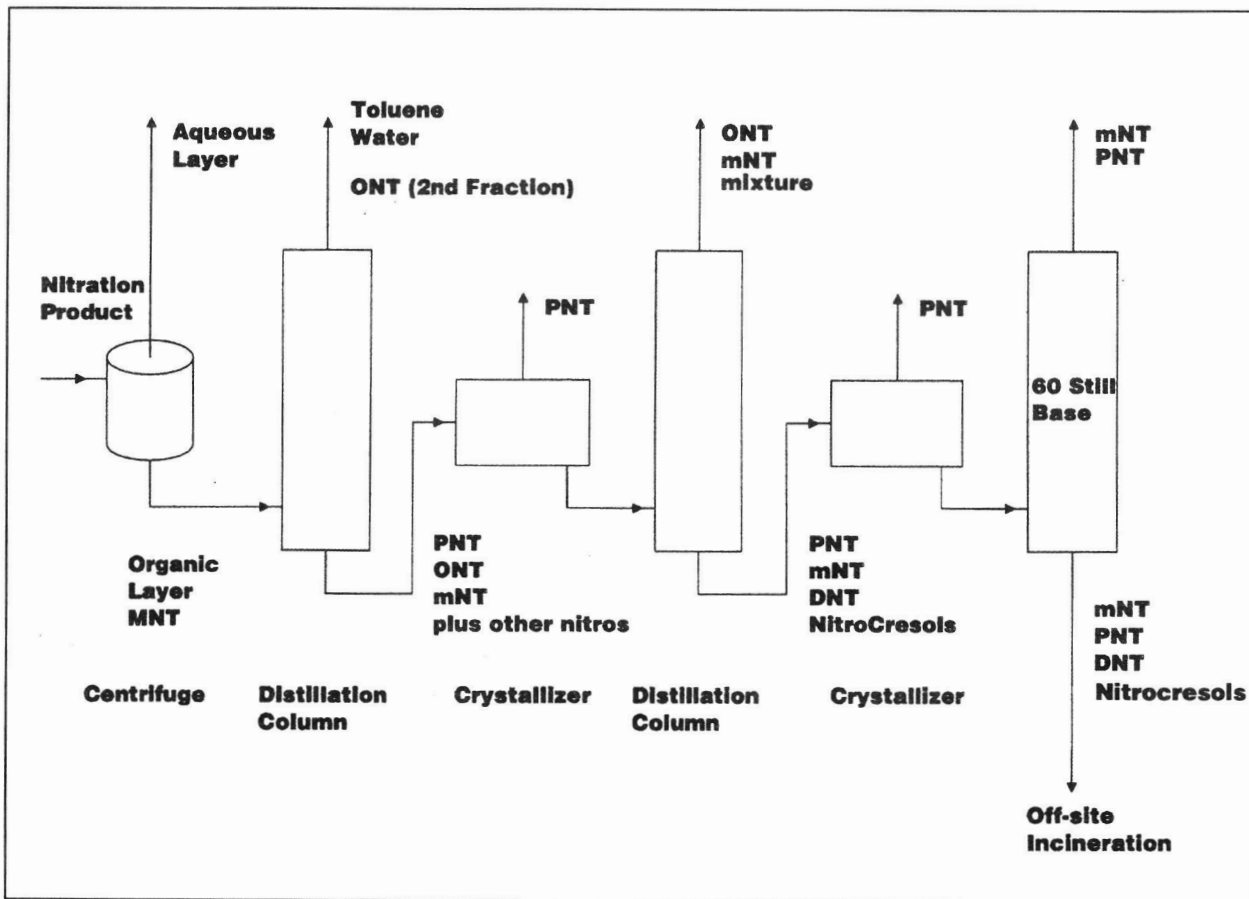
Figure 2:

4.4 The separation of the organic stream from the nitration plant into the pure isomers is done by a series of fractional distillation and crystallization steps. These steps are summarised in (figure 2), omitting any recirculation or repetition, and produce essentially pure products for sale or as a feedstock for use on site. The crystallization and distillation steps are standard unit processes.

Nitrotoluene separation system

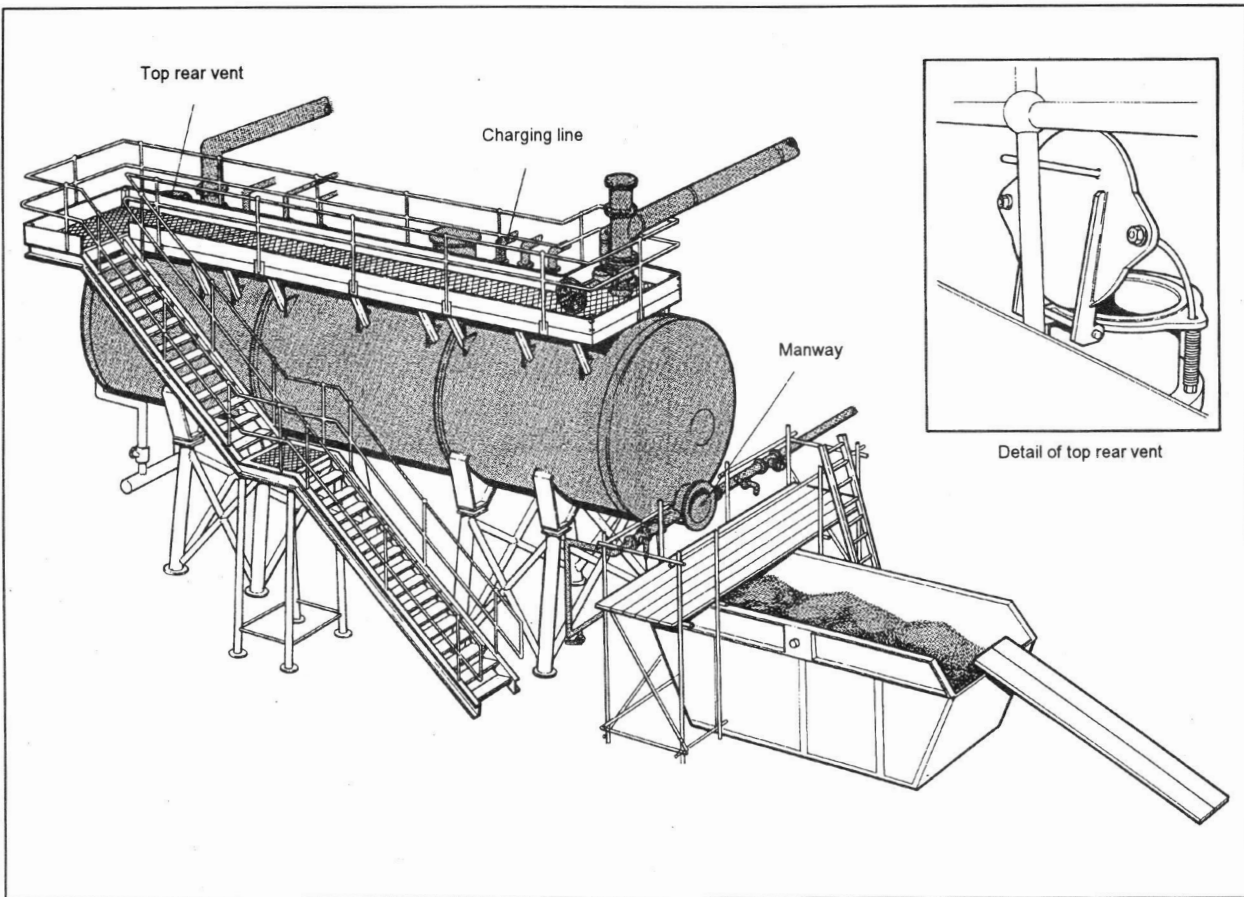
Figure 3:

5.1 60 still base was an insulated, horizontal, carbon steel vessel fitted with three steam batteries. It served as the base vessel for the batch distillation of the mixture of nitro compounds described above. It was supported some 2.9m above the ground and was 7.9m long by 2.7m in diameter with dished ends, giving it a capacity of 45 m³. The steam batteries entered at one end, two side by side about 400mm above the bottom of the vessel, the other between and below them, about 200mm above the vessel bottom. The batteries extended about two thirds of the way along the vessel. At the other end of the vessel the dished end was fitted with a manway, about 400mm in diameter. The off-take line was fitted into the base of the manway mounting and the vessel was sloped gently, by about 70mm, towards this end. An isometric drawing is included as figure 3 and figure 4 shows the principal connections to the vessels.

60 still base
