Process safety practice

It's OK, we have a back-up

Roger Stokes, BakerRisk, UK

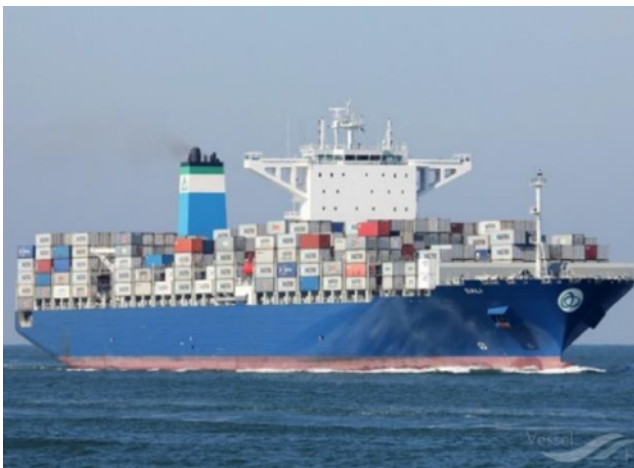
Figure 1 – MV Dali⁴

The MV *Dali* is a 289-metre-long container ship (see Figure 1), propelled by a single 41,480 kW low-speed diesel engine driving the propeller at between 27 rpm (dead slow) and 80 rpm (full). The engine is started by compressed air and since there is no gearbox, it has to be stopped and started in the reverse direction to allow the vessel to go astern. High voltage (HV) electrical power is provided at 6.6kV to the HV bus by up to four diesel generators (DG), with two operating (DG3 and DG4) at the time of the incident and DG2 on automatic standby (see Figure 2). The voltage is stepped down to low voltage (LV) bus 440V by two (100% redundant) transformers. The engine oil lubricating pump and bow thruster is driven by a HV motor, and the engine water cooling pump and hydraulic steering gear pumps are powered by the LV system. An automatically starting emergency generator is provided on the LV system.

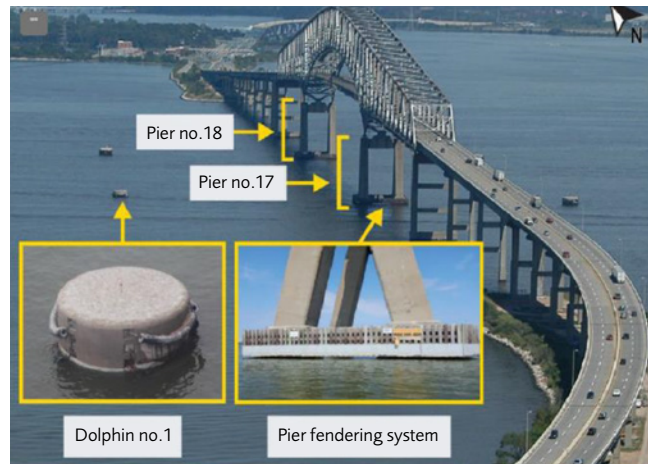
Figure 3 – Francis Scott Key Bridge⁴

The Francis Scott Key Bridge in Baltimore was opened in 1977 and comprises a 2.8-km-long steel and concrete construction supported by multiple piers, with the central shipping navigation channel between pier numbers 17 and 18. The piers were surrounded by a "crushable concrete box and timber fendering system."

- No.1 transformer would lead to an immediate LV outage).
- The bridge piers adjacent to the main shipping channel were fitted with a 100 ft x 84 ft crushable concrete and timber fendering system. It is likely that this was designed when vessels were smaller and was clearly inadequate to protect the bridge in the circumstances of the event.
- Further details are bound to emerge from the ongoing investigation. However, from a process safety viewpoint, key issues would seem to relate to there being a single point of failure (SPOF), whereby a brief interruption of the power supply results in the engine stopping *and* loss of steerage.
