Management and technical factors emerging from the inspection activity after a major accident

Abstract

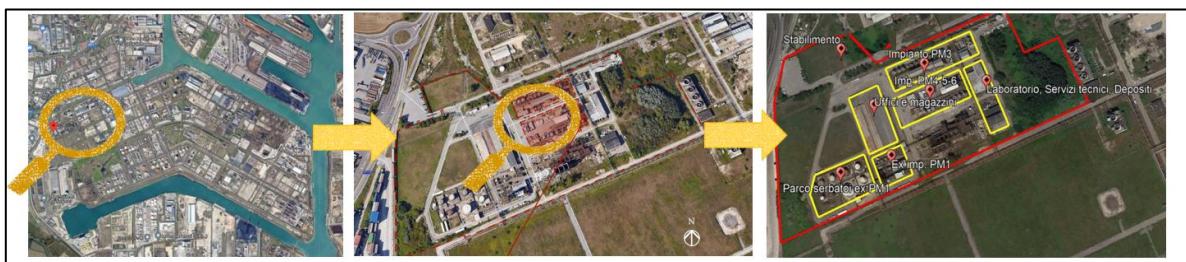
Fig. 1. Site and the installation

The establishment (see Fig. 1 in Appendix) is in an industrial area which is a national chemical and petrochemical hub with a high concentration of major accident establishments. There are vulnerable territorial/environmental elements within a two-kilometers radius of the site, consisting of: built-up areas, industrial/production activities, densely populated areas/buildings, services/utilities, transport, a rail network, an airport, port areas, vulnerable environmental elements (a protected lagoon), aquifers.
