PSM Lessons from a Major Reformer Furnace Failure

RDC Prior, SHExcellence CC, Johannesburg, South Africa

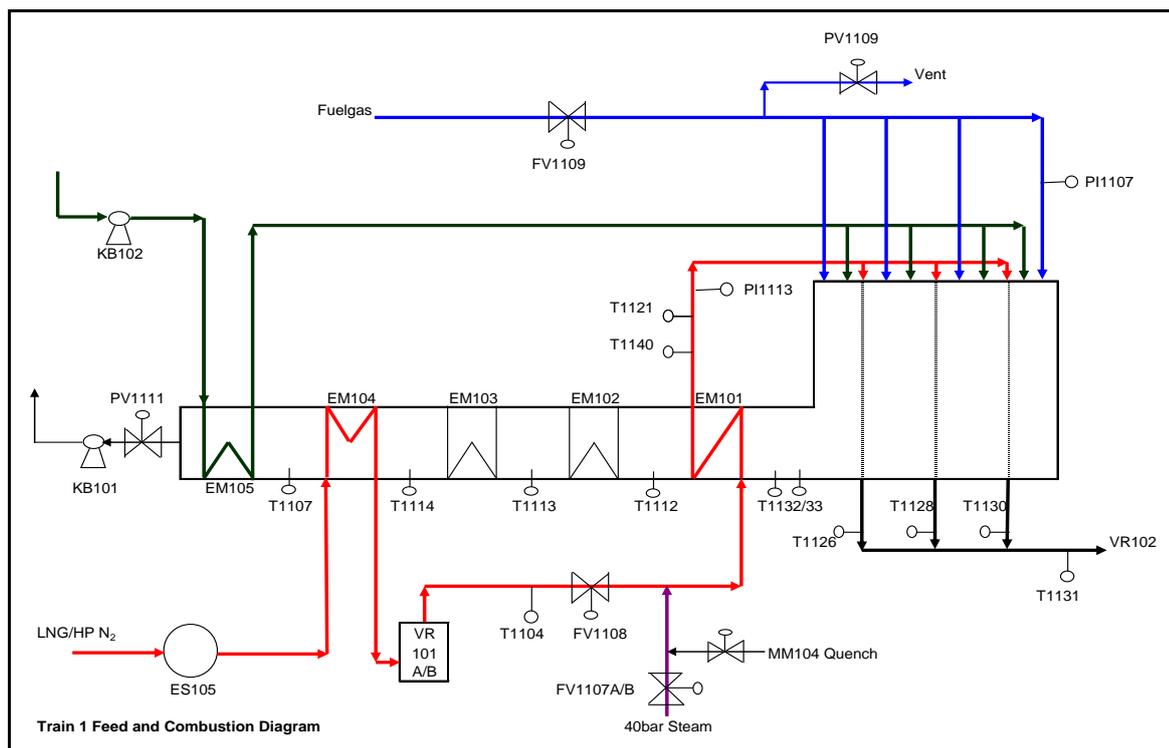
Fig 1 Detailed process flow through Primary Reformer

In normal operation the feed gas is fed via a heat exchanger (ES105) and two preheaters (EM104, EM101) to the furnace tubes. Steam is added to this line before EM101. The steam and gas undergo the endothermic water gas reaction in the tubes. Heat is provided by up to 84 gas burners which heat up the furnace space. The reaction gases pass through 228 tubes in parallel. The flue gases are extracted via an extraction fan and vent to atmosphere. A slight vacuum is maintained in the furnace. In the start-up mode nitrogen gas is introduced into the gas feed line and is heated up so as to heat up the furnace. There are limits to the rate at which the temperature can be raised so as not to damage the furnace and the tubes.
