Runaway Chemical Reaction at Corden Pharmachem, Cork

S. J. Gakhar and S. M. Rowe, Chilworth Technology Ltd, Beta House, Chilworth Science Park, Southampton SO16 7NS

M. Boylan and P. Conneely. Health and Safety Authority, 3rd Floor, 1A, South Mall, Cork

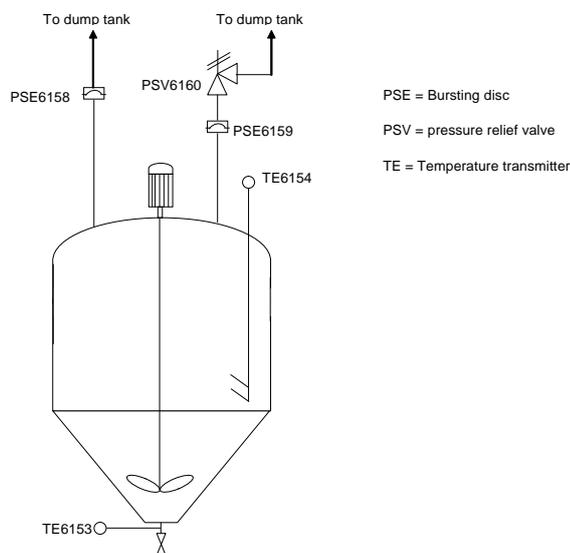
Figure 7: Sketch of key features of K6003

Since the incident occurred in reactor vessel K6003, a basic sketch of K6003 is shown in Figure 7 below with relevant nomenclature. A description follows.

K6003 was a glass lined carbon steel reaction vessel with an operating volume of 2.5 m³ and a design pressure of 6 barg. The reactor had a bolted manway on top sealed with gasket material and internally, the reactor was agitated. There were two temperature sensors in the reactor with one installed in the base of the reactor (TE6153) in the outlet valve. This was referred to as the 'bottom sump' sensor by Corden Pharma Ltd. The other sensor was installed on the baffle (TE6154) and was referred to as the 'top sump' sensor by Corden Pharma Ltd. K6003 was fitted with a pressure relief system comprising of the following:-
