## ACCEPTANCE CRITERIA FOR DAMAGED AND REPAIRED PASSIVE FIRE PROTECTION

KEYWORDS: PFP, Damage, Repair, Cementitious, Intumescent, Acceptance Criteria.

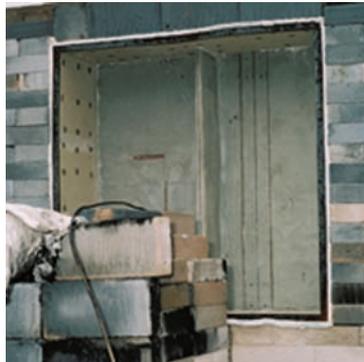
**Figure 1.** Installed Assembly (test 10 specimen, before test)

Figures 1 and 5 show the specimen for trial 10 before and after testing. The purpose of this test was to determine the effect of gouging, cracking and disbondment on Chartek IV.

The left panel was physically damaged (gouged), but was bonded to the steel substrate. After the test, slight enlargement of the gouges was observed. Thermocouple temperatures and thermal images confirm that the main hot spot was recorded behind the horizontal

Prior to the test, the right panel was cracked and the coating was deliberately disbonded from the steel substrate. After the test this panel was much more damaged than the left

panel (above), the material was bowed out from the substrate and cracked. There was considerable enlargement of the induced cracks, particularly the 2 mm crack. The highest temperatures were recorded at the lower ends of the cracks, in the high erosion zone. Thermal images confirm that there is a hot area around all three cracks in the high erosion zone. The time until a 140°C temperature rise was seen behind the cracks was 9 minutes. The highest temperature rise after 60 minutes was 262°C.

The web was physically damaged (cracked) and the coating was deliberately disbonded from the steel substrate. Temperatures rose very rapidly behind the (5 mm) crack on the web. Major damage was caused, with bare steel being exposed for the bottom two thirds of the web. A 400°C temperature rise was achieved after 5 minutes. The maximum temperature rise of 705°C was achieved after 25 minutes, with the temperature rise at 60 minutes being 656°C. These temperatures are consistent with the Chartek IV being stripped off leaving bare steel exposed to the jet fire.

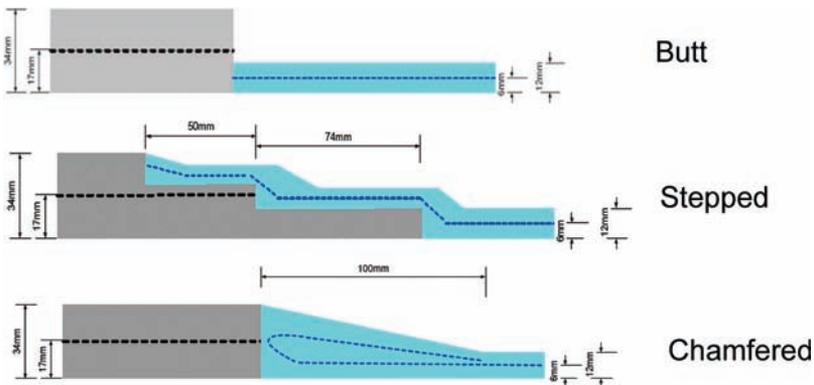
Test number	PFP	Repair
03	Mandolite 550 with hexagonal wire mesh reinforcement repaired with Chartek VII with HK-1 glass/carbon fibre reinforcing scrim	Simple butt joint vertically and horizontally in a panel without a web
11	Mandolite 550 with hexagonal wire mesh reinforcement repaired with Chartek VII with HK-1 glass/carbon fibre reinforcing scrim	Left panel – Stepped cementitious joint across centre line. Right panel – Chamfered intumescent joint across centre line. Web – Stepped cementitious joint on left side and chamfered intumescent joint on front and right side of centreline.
12	Mandolite 550 with hexagonal wire mesh reinforcement repaired with Pitt-Char XP with FM glass fibre reinforcing scrim	Left panel – Stepped cementitious joint across centre line. Right panel – Chamfered intumescent joint across centre line. Web – Stepped cementitious joint on left side and chamfered intumescent joint on front and right side of centreline.

**Figure 4.** Repair joints

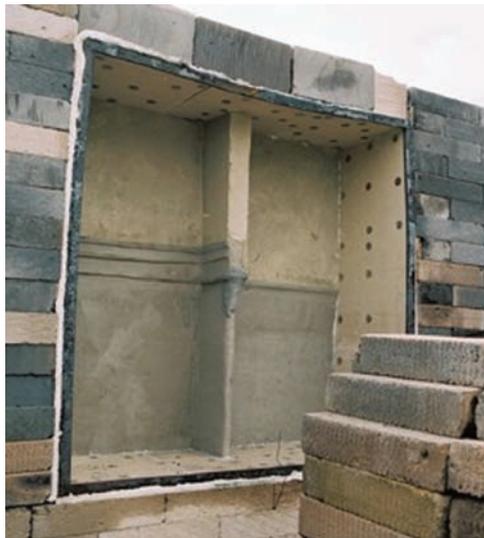
Figures 8, 9 and 10 show the specimen for trial 11 before and after testing. The purpose of this test was to determine the effect of chamfered and stepped repair joints.

The left hand side of the web incorporated a stepped repair joint. On the front of the left (stepped) side of the web, there was some damage to the Mandolite 550 and char had been eroded away near this zone.

**Figure 8.** Specimen for test 11 (before test)
