Characterisation of a vehicle fire on a 7 tonne LPG road tanker

Lorraine Jenney, Spadeadam Testing and Research Centre, DNV GL, UK

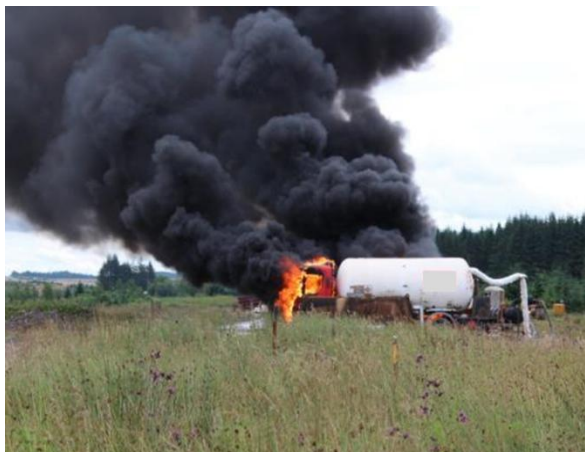
Figure 2- Fully engulfed cab and diesel pool fire under vehicle

A large plume of black smoke formed from the diesel pool fire and from the large volumes of rubber and plastic on the vehicle, Figure 2. The downwind exclusion zone allowed the smoke to disperse safely from the area.

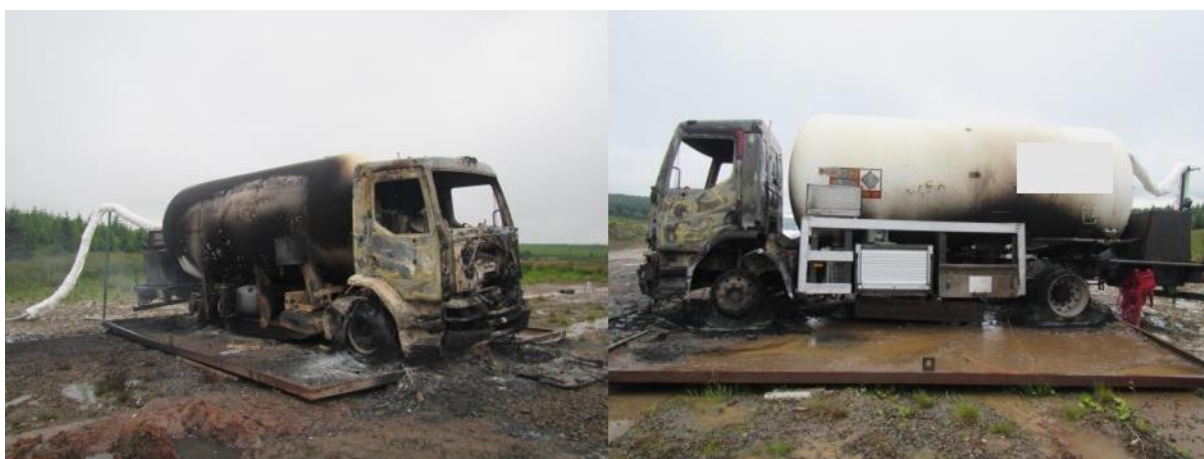
Figure 3- Downwind (LHS) and Upwind (RHS)

Figure 3 shows the difference between the downwind and upwind sides of the vehicle and vessel post-experiment. The downwind side was covered in a layer of soot up the entire vessel with the paint burnt, while the upwind side of the vessel shows far less damage with hazard signs still visible on the side. The heat from the diesel pool fire and the chassis fire has completely melted the aluminium crash barrier on the downwind side of the vehicle, which shows the temperatures experienced here were more than 660 °C, the melting point for aluminium. The diesel tank located on the downwind side of the vessel also burst during the fire and all of the plastic housings for the batteries entirely melted away. The tyres on both sides of the vehicle were left with only the wire inserts as the rubber had burnt away during the experiment.

The roller-shutter boxes containing 80 m of hose were left closed on both the upwind side of the vessel and the back of the vessel prior to the experiment. Both of these boxes and hoses remained intact during the fire and the hoses remained visibly undamaged. The hoses on the downwind side under the vessel were also still in place at the end of the experiment however they had suffered a large amount of damage from the flames.

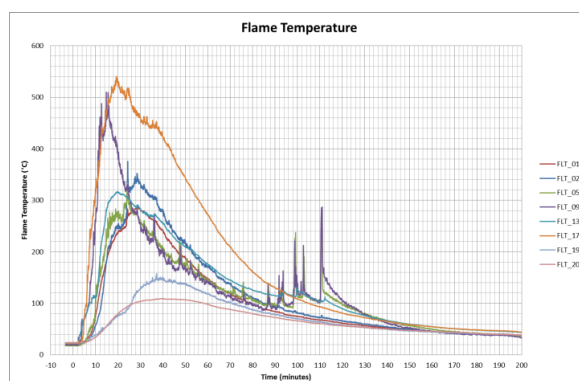
Figure 4- Flame Temperature

The temperature measured in the flame in Figure 4 shows that the peak measured temperature was 540 °C at location FLT_17. FLT_17 was located to the south edge of the diesel bund and in close proximity to the two rear inner tyres. The videos show that the rear inner tyres were alight within 10-15 minutes of the ignition of the diesel pool fire which is prior to the time of peak temperature measurement. FLT_09 also saw a peak temperature of over 500 °C, this thermocouple was located close by the front set of tyres indicating that the peak temperature is from a combination of the diesel pool fire and the burning tyres. During the experiment the diesel in the 1.5 m x 1.5 m bund spilled out into the larger bund, this meant that the majority of the diesel had burnt after 30 minutes. The chassis and the tyres were still smouldering under the vessel until around 90 minutes when the tyres on the upwind side of the vehicle caught fire causing a series of flame temperature peaks in the data at FLT_09 and FLT_05, both close to the front tyres.

The average temperature measured in the flame at each location shown in Table 2. The average temperature taken between 7.5 minutes and 8.8 minutes from the start of the test; where the heat flux was nominally steady on the calorimeters. The temperature measured in the flame continued to increase and peaked at around 27 minutes after the rear tyres started to burn.

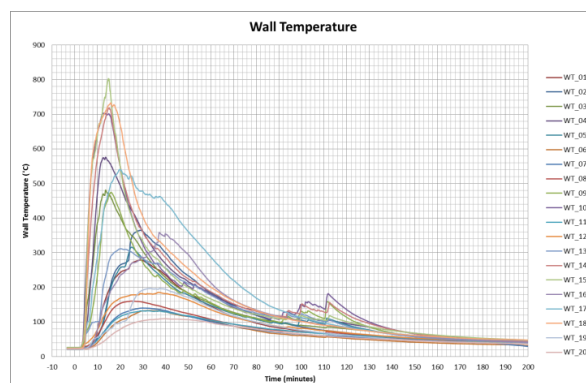
Figure 5- Wall Temperature

The wall temperature of the vessel peaked at 803 °C at thermocouple WT15 located on the mid-height line of the downwind side of the vessel, see Figure 5. The next three highest wall temperature measurements were WT10, WT14 and WT18, which are below WT15 on the downwind side of the vessel at one quarter of the vessel height. All three of these thermocouples measured temperatures in the steel of greater than the 600 °C. The ultimate tensile strength of the vessel would begin to diminish significantly past this temperature⁸. This implies that when the tank is at a lower fill level such as the 50% or 25% it is possible that the metal temperatures will be sufficiently high to result in a BLEVE of the vessel.

After around 16 minutes, the initial peaks from the diesel pool fire begin to decrease. This is due to the diesel spilling out of the initial bund and covering a larger area increasing the rate at which the fuel was burning. Due to the slope of the bund all the fuel funnelled to the downwind side of the vehicle; this reduced the amount of flame around the vessel. After 40 minutes, much of the downwind vessel was at nominally 200-300 °C.

After 90 minutes, the temperature in the vessel increases again due to the front tyres, hoses and cables burning under the vessel.

The average wall temperatures at each location are shown in Table 2. The average temperature was taken between the same nominally steady state heat flux region of 7.5 minutes and 8.8 minutes from the start of the test. These wall temperatures continued to increase and peaked at around 13.5 minutes, after this point the majority of the diesel pool, engine bay and drivers cab had burnt away, only the underside of the chassis and tyres continued to burn. WT_10 which was located above the front tyre on the downwind side of the vessel began to show temperatures that are close to the 600°C threshold.

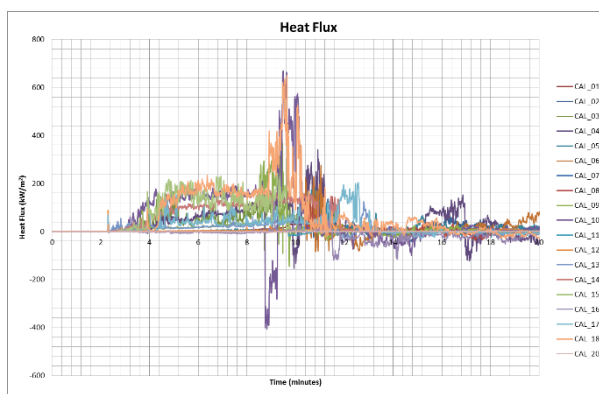
Figure 6- Measured heat flux for first 40 minutes

The calorimeter data shows a spike in the heat flux readings of over 650 kW.m^{-2} , see Figure 6. This is likely an anomaly as it is higher than could be reasonably expected in a pool fire or vehicle fire. This could be due to the instrument cabling being exposed to high radiative heat and being damaged. After 80 minutes all of the calorimeters return to zero, the calorimeters do not show a spike in the heat flux around 90 minutes as seen on the thermocouples when the tyres ignite downwind. The data for each location has been analysed focusing on the first 80 minutes.

Generally, the peak heat flux on the vessel is around 200 kW.m^{-2} and occurs in the first 10 minutes from the start of the experiment. This is consistent with previous published values for surface emissive power from pool fires on land⁷.

The calorimeters along the BDC of the vessel recorded negligible readings in comparison to those further up the vessel wall. The most likely cause of the comparatively low temperatures measured at some calorimeter locations is much of the material underneath the vehicle is metal and non-flammable. This material is acting as a protective barrier to radiant heat from the pool fire and tyre fire. The air gap between the vessel and the chassis is also allowing the wind to flow between the fire and the vessel wall, which could also be reducing convective heat flux on the centreline of the low parts of the vessel.

The upwind calorimeters show limited heat flux on the vessel. At the time of testing the wind speed was 5.7 m.s^{-1} in a WNW direction. The wind was pushing most of the flame to the east side of the vessel. The peak in heat flux registered on some sensors at around 20 minutes onwards coincides with the front tyres taking fire. In a lower wind speed the flame from a diesel spill, or in this experiment from the diesel bund, would be more evenly distributed up both sides of the vessel.

The downwind side of the vessel saw much higher heat flux in the first 20 minutes of the fire compared to the upwind side. The heat flux on the downwind side of the vessel was around 200 kW.m^{-2} this is around the expected value for a pool fire. If there was no wind during a vehicle fire then the total heat gain of the vessel could be higher as the flames will be more uniformly distributed across the vessel. More of the flame would be in contact with the vessel wall and this would transfer more heat into the vessel increasing the wall temperature and increasing the likelihood of failure. This must be considered when developing a propane burner to replicate the vehicle fire.

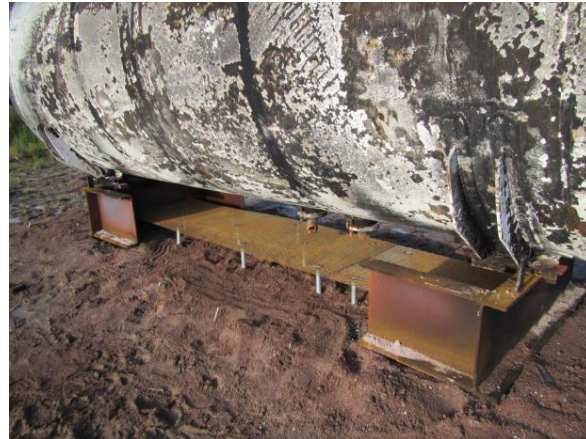
Figure 9 Modifications to the Burner Array Commissioning Run 2

The steel mesh was welded in place using steel tubes secured into the ground. The mesh was positioned 100 mm from the top of the centre nozzles.

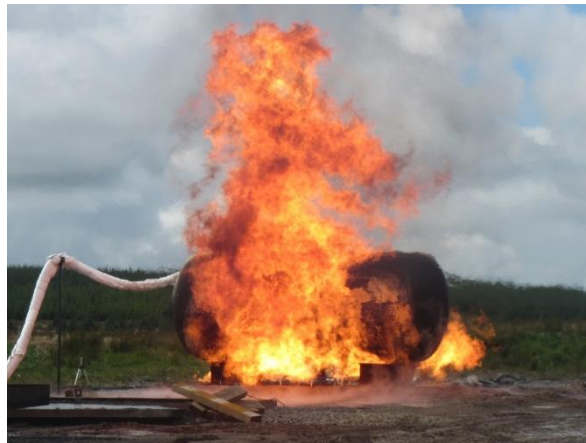
Figure 10 Commissioning Run 2

The photograph from Commissioning Run 2 shows that the ends of the vessel are no longer totally engulfed by the flames, this reduced the heat flux on the ends of the vessel. However, the total heat flux on the vessel increased due to the mesh helping to spread the flame to cover both sides of the vessel. The centreline of the vessel still showed heat flux readings far greater than the initial vehicle fire, see Table 4.

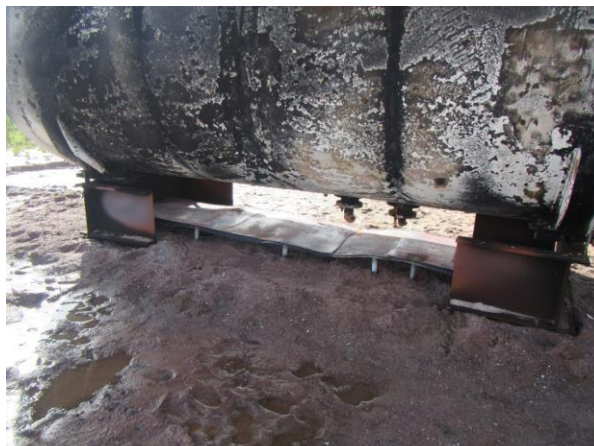
Figure 11 Steel Plate for Commissioning Run 3

For Commissioning Run 3 a solid steel plate was welded on top of the mesh to create a solid barrier between the nozzles and the vessel as shown in Figure 11, this was used to reduce the level of heat flux on the bottom of the vessel. The sheet used was 3 mm thick plate, the plate was thin enough to deflect the flame away from the vessel whilst still allowing some heat to be transferred through the steel.

Commissioning Run 3 was much more comparable to the vehicle fire, again summarised in Table 4.

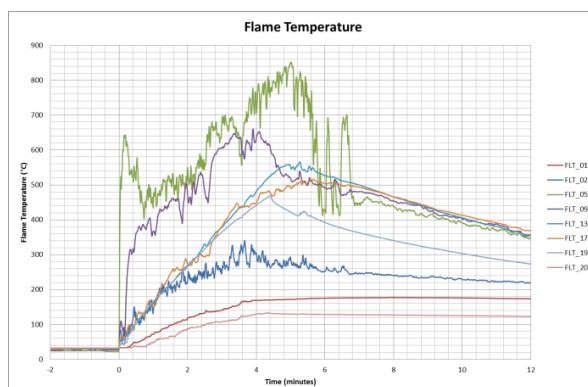
Figure 12 Flame Temperatures on Commissioning Run 3

The temperatures measured in the flame around the bottom of the vessel on Commissioning Run 3 are, in the majority, similar to those seen in the vehicle fire at around 500 °C, see Figure 12. The wall temperatures in Figure 13 are also similar to those seen on the vehicle fire with two measurement locations reaching the failure threshold of around 600 °C, the test was stopped after a short period of time, however it is likely that the other thermocouples would reach similar temperatures. If this propane burner arrangement was allowed to run for 25 minutes as was the duration of the significant heat flux seen in the vehicle fire then it is likely, depending on the fill level of the vessel that the material of the vessel could fail leading to a rupture or BLEVE of the vessel.

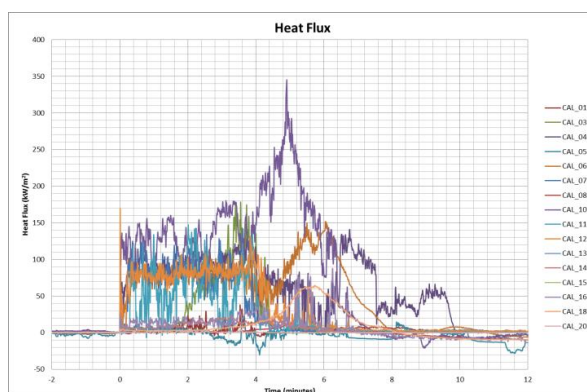
Figure 14 Calorimeters in Commissioning run 3

The heat flux graph for all the measurement positions shows that while the highest heat fluxes are lower than the peaks seen in the vehicle fire it is much more uniform across the vessel than in the vehicle fire, see Figure 14. As the table of results and the graphs of heat flux and temperature show similar values to the vehicle fire, it can be concluded that the propane burner arrangement in Commissioning Run 3 is suitable, with the findings of this paper to replicate the vehicle fire and for use in the continuation of the test program into the possibility of a BLEVE event with 7 Te road tankers when subjected to fire.
